Customer	Dexp	Model Name	H20D7100E	Line	L02	w/o	4118054	Date:	06.25.2018

Part №								rev.:	Prepared by:	
Problem	Abnormal picture							1	Sergey K.	
STATION:		Quantity:		DUTY:		Report No.:

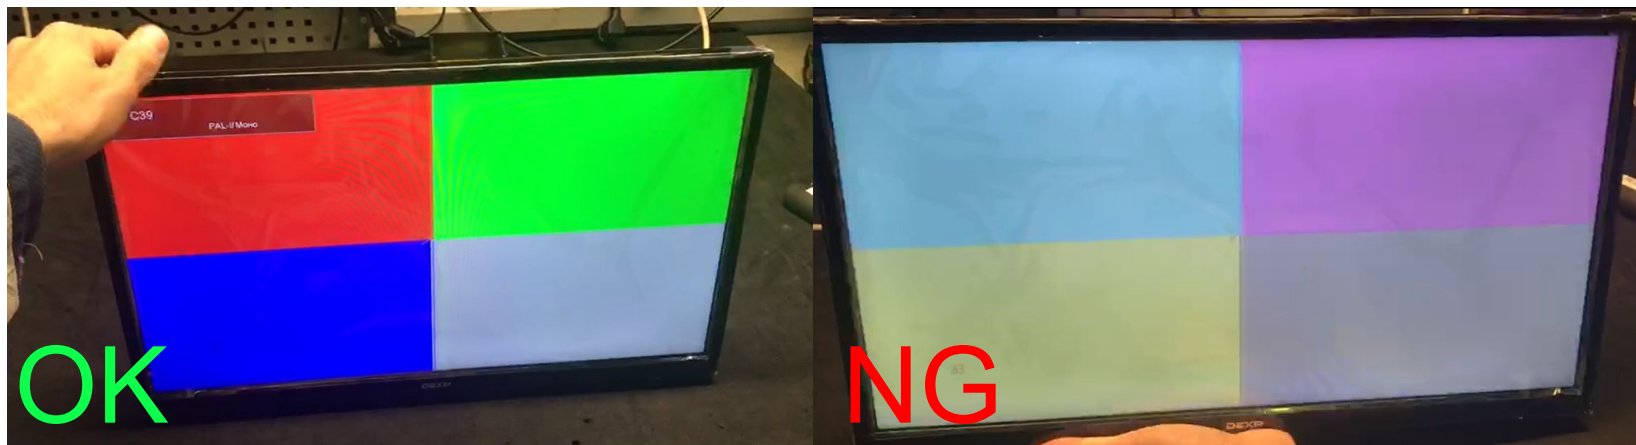
During production WO 4118054 3940 pcs H20D7100E_SDEEL1 we faced with problem. At the end of work order few TVs has been moved to repair station with abnormal picture.

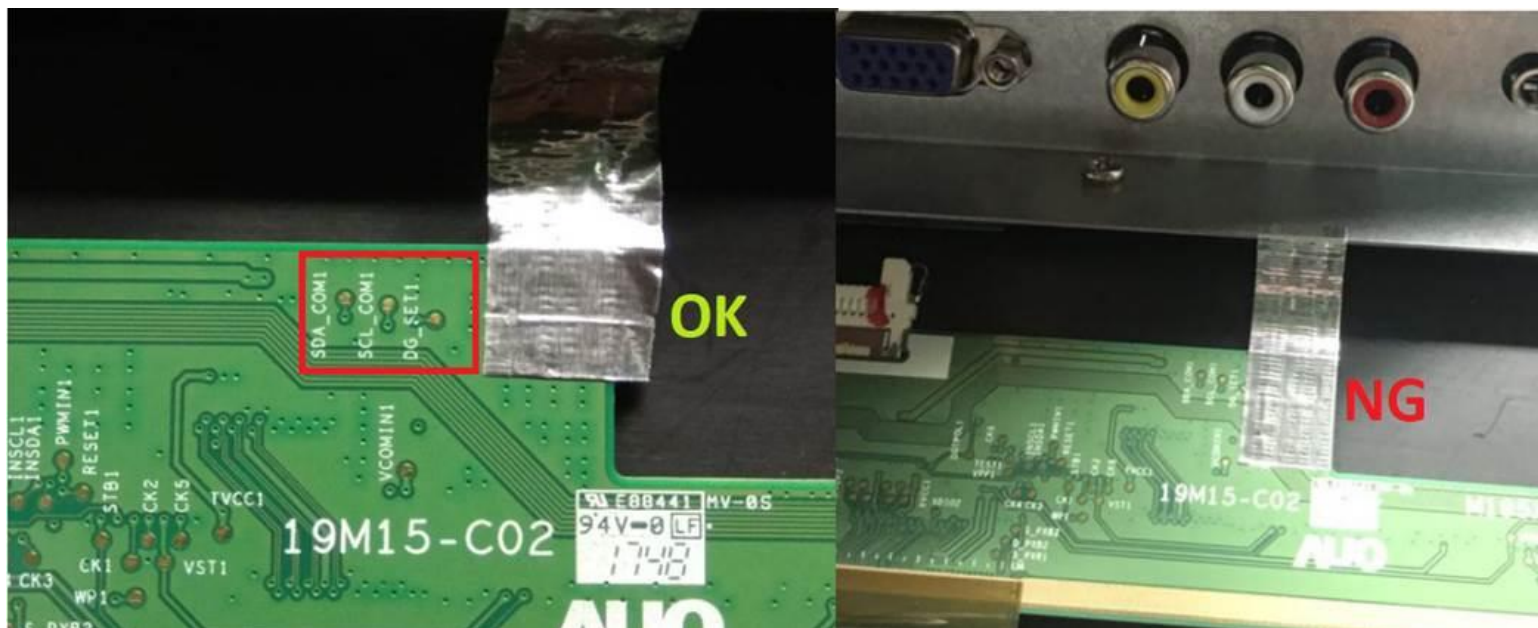
Analyze shown that abnormal picture caused by circuit DG_Set1 contact with metal IO bracket by aluminum tape.

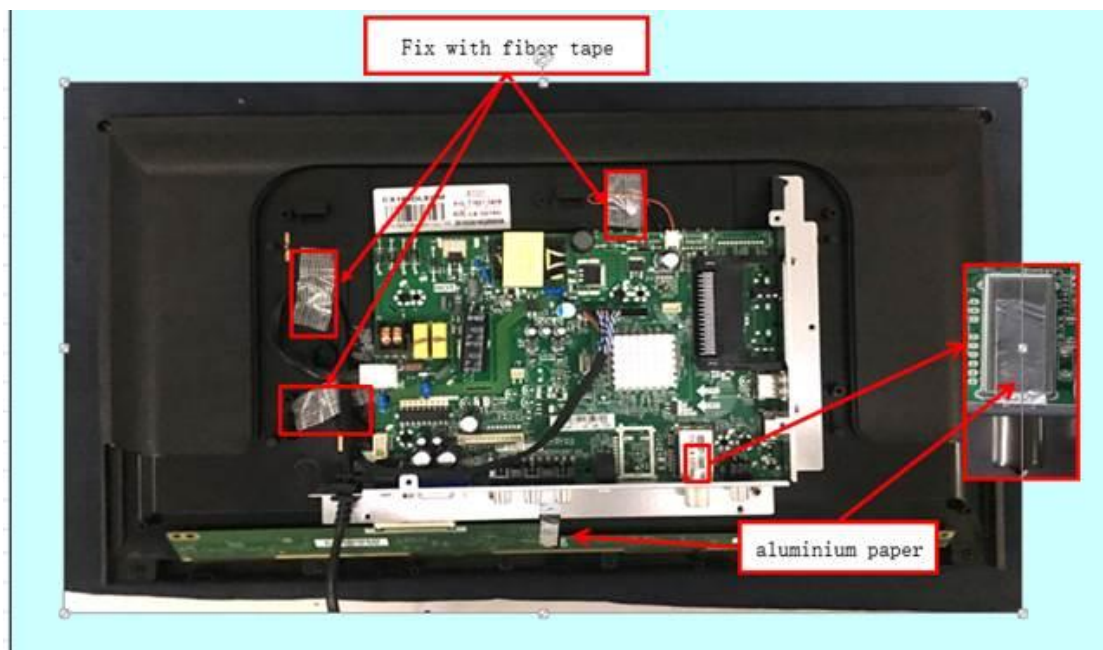
Tape was pasted like in original SOP

There is **NO** any warning information or red zones in this SOP.

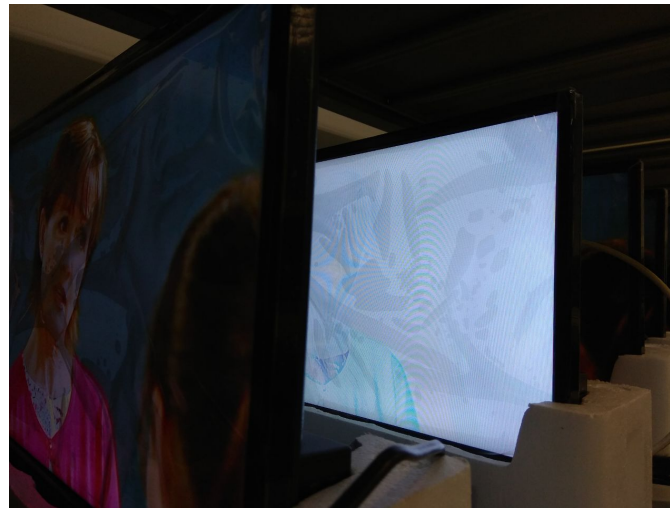
We tested 60 TVs and found 1 that shows abnormal picture.
