PB46CUG04X-3-7AAG

8D FA report

What happened	喇叭無訊號
When detected	2019/07/03
Where detected	Production Assemble line
Why detected	One speaker function test no signal
How many	1 PCS
How detected	Remove Speaker and Wire cold soldering of black wire to pin

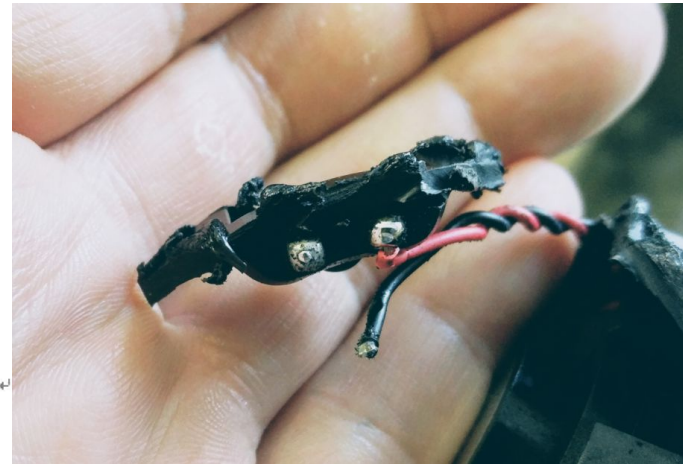
Now we assembling P46 speakers we got. (我們開始組裝 P46)
Production line test each speaker after assy cable. (產線焊接後檢驗每個喇叭)
They found one P46 with no signal. (其中一個無訊號)
Open this P46 to find out the problem. (試著打開機殼)
Speaker head is OK, wires black & red are OK. (喇叭頭是好的, 黑紅線也是好的)
Problem is cold soldering of black wire to pin! (問題點在於黑色線冷焊)
So this wire was in the open air and has no contact to pad. (如附件, 並未焊接在 PAD 上)
Picture is in attach.

Then try to heat pin with red wire and pin was melt out from plastic but red wire was soldering well to pin.
Please ask VECO to pay more attention for cold soldering of wires to pins because it is very critical parameter. (日後生產請務必注意冷焊、空焊問題)
If we test speaker and all be OK but after install in the car it will defect we will have a BIG BIG problem with that. (若日後組裝在車體內仍有此現象會造成很嚴重的問題)

>1: Check the soldering bit and the wire in the beginning, as soldering wire, bare wire of the connector must solder into tin. It should stay for 2S when finish one side, while the other side become cold than solder it. To do this is to prevent one side not cold enough and to affect the connection of the solder. After soldering, put the speaker on the tooling (do not hold the wire) then to work on the flowline.
