1.问题点Question

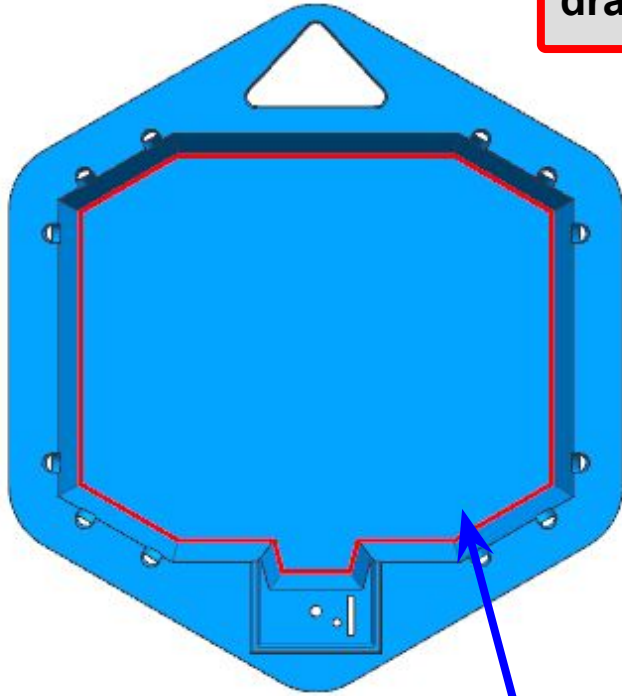
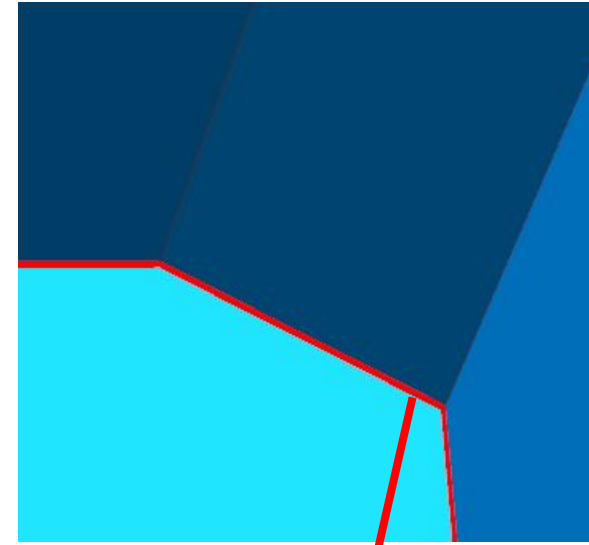
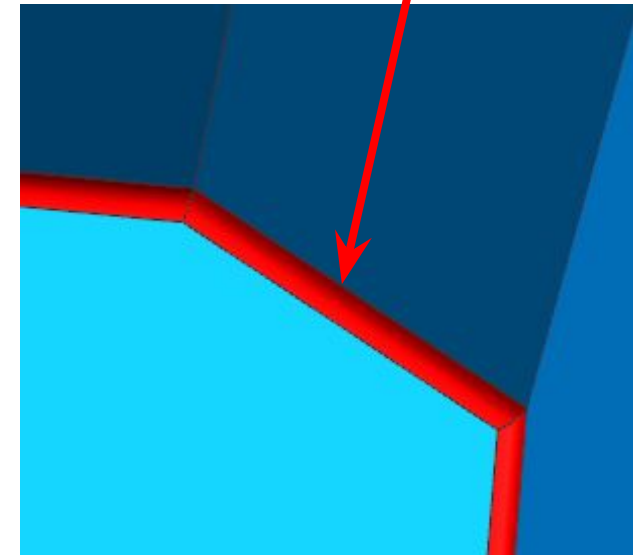
The red line of the product is a sharp corner, the product is not easy to produce, it is recommended to add a round corner of R2mm as shown in the figure. please confirm if it is okay?

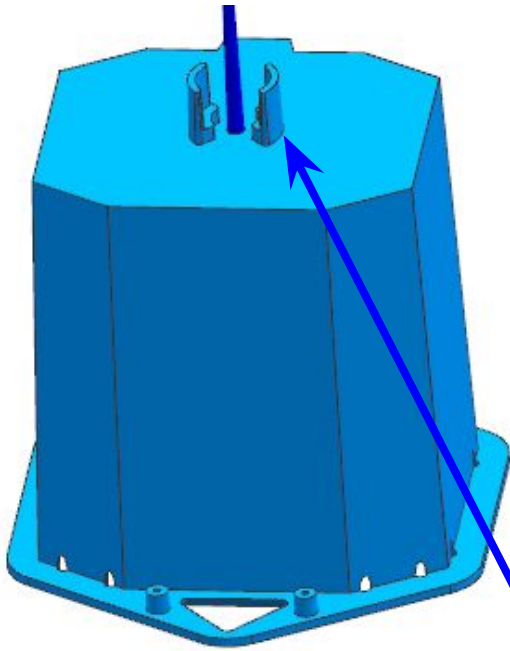
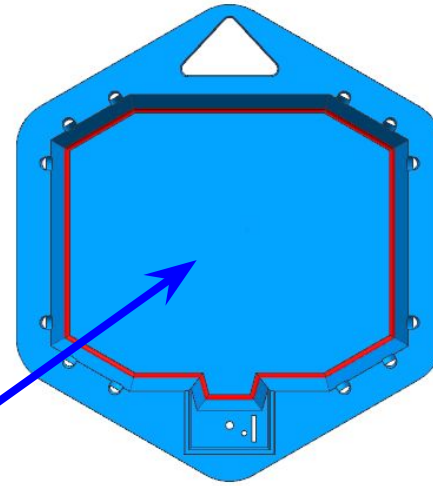
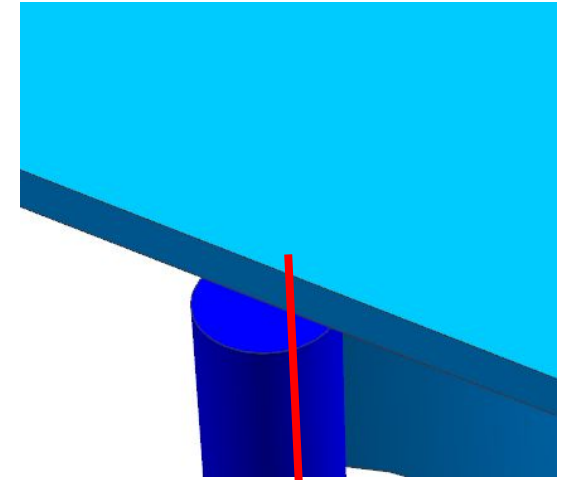
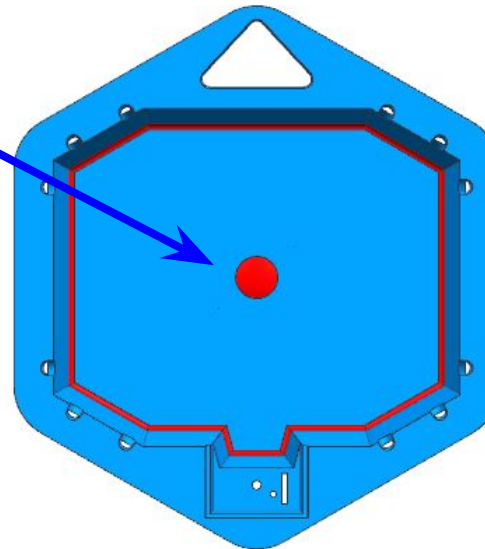
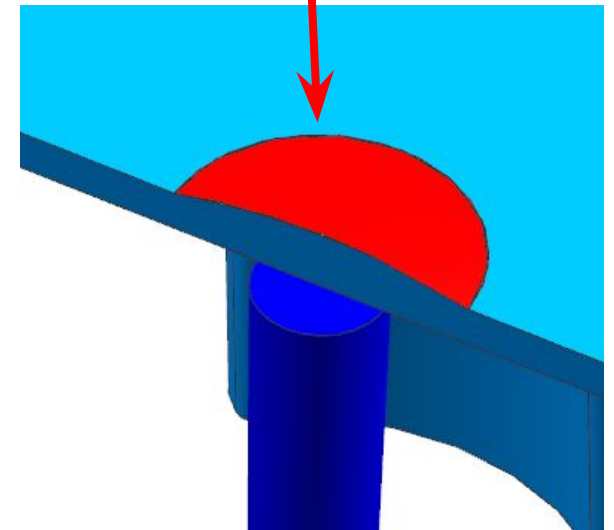
The blue shape is the position of the glue point, it is recommended to add a 14X1mm diameter boss in the red area of the product as shown in the figure to facilitate product production. please confirm if it is okay?

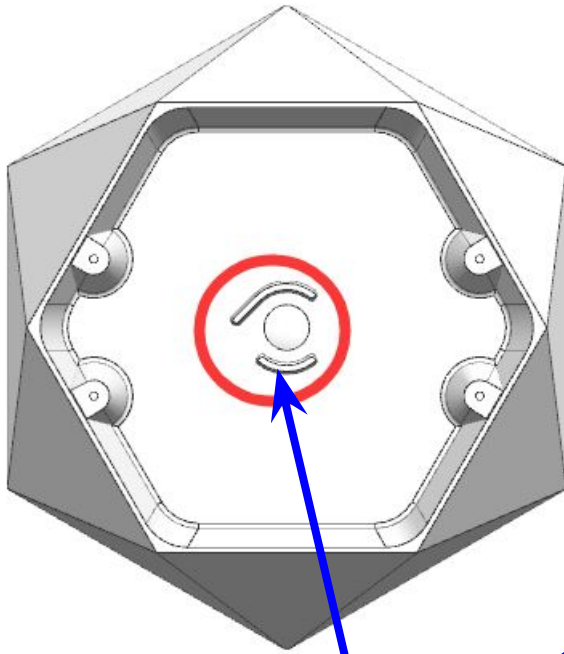
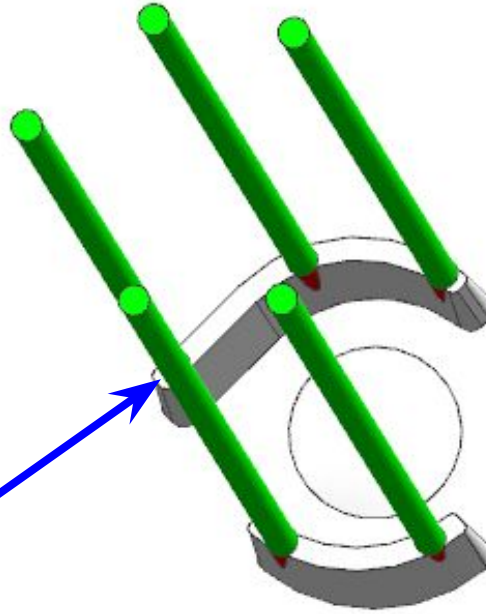
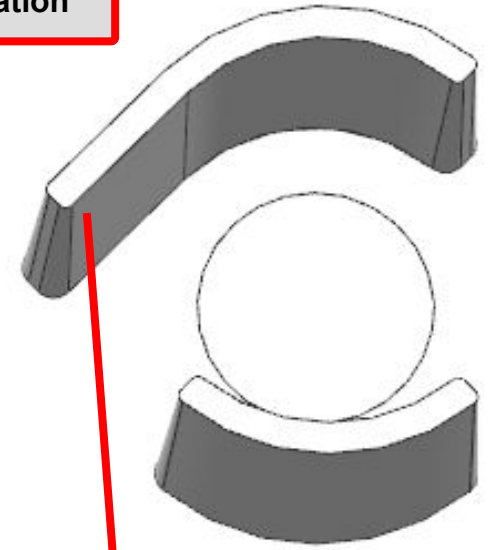
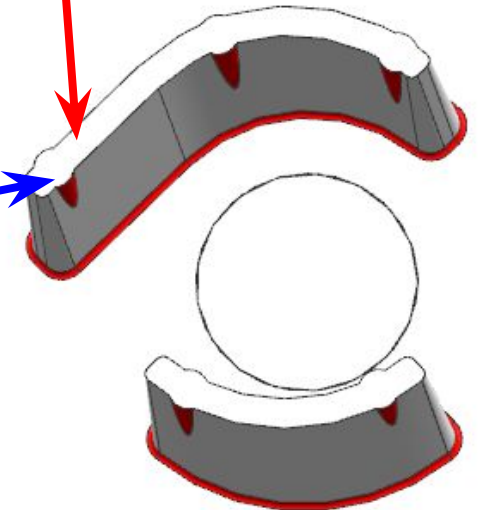
The shape inside the red circle is easy to break and difficult to eject. It is recommended to add R0.5mm at the bottom and add 5 pieces 3mm eject pin. The product is suggested to add thickness in the red area as shown, please confirm if it is okay?

Solve the above 3-6 points: add eject pin, welding, modifying BOSS hole, the cost: 380USD, please refer to the quotation for details.

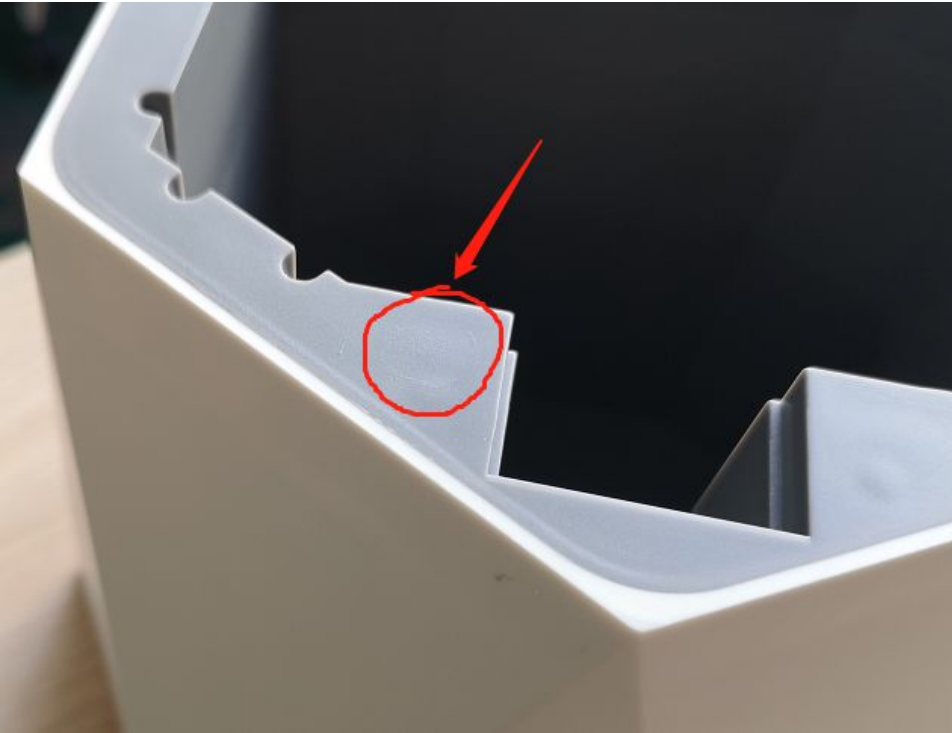
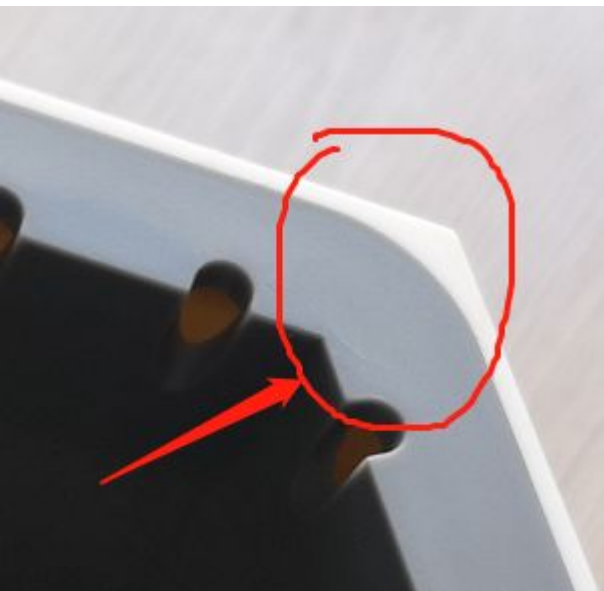
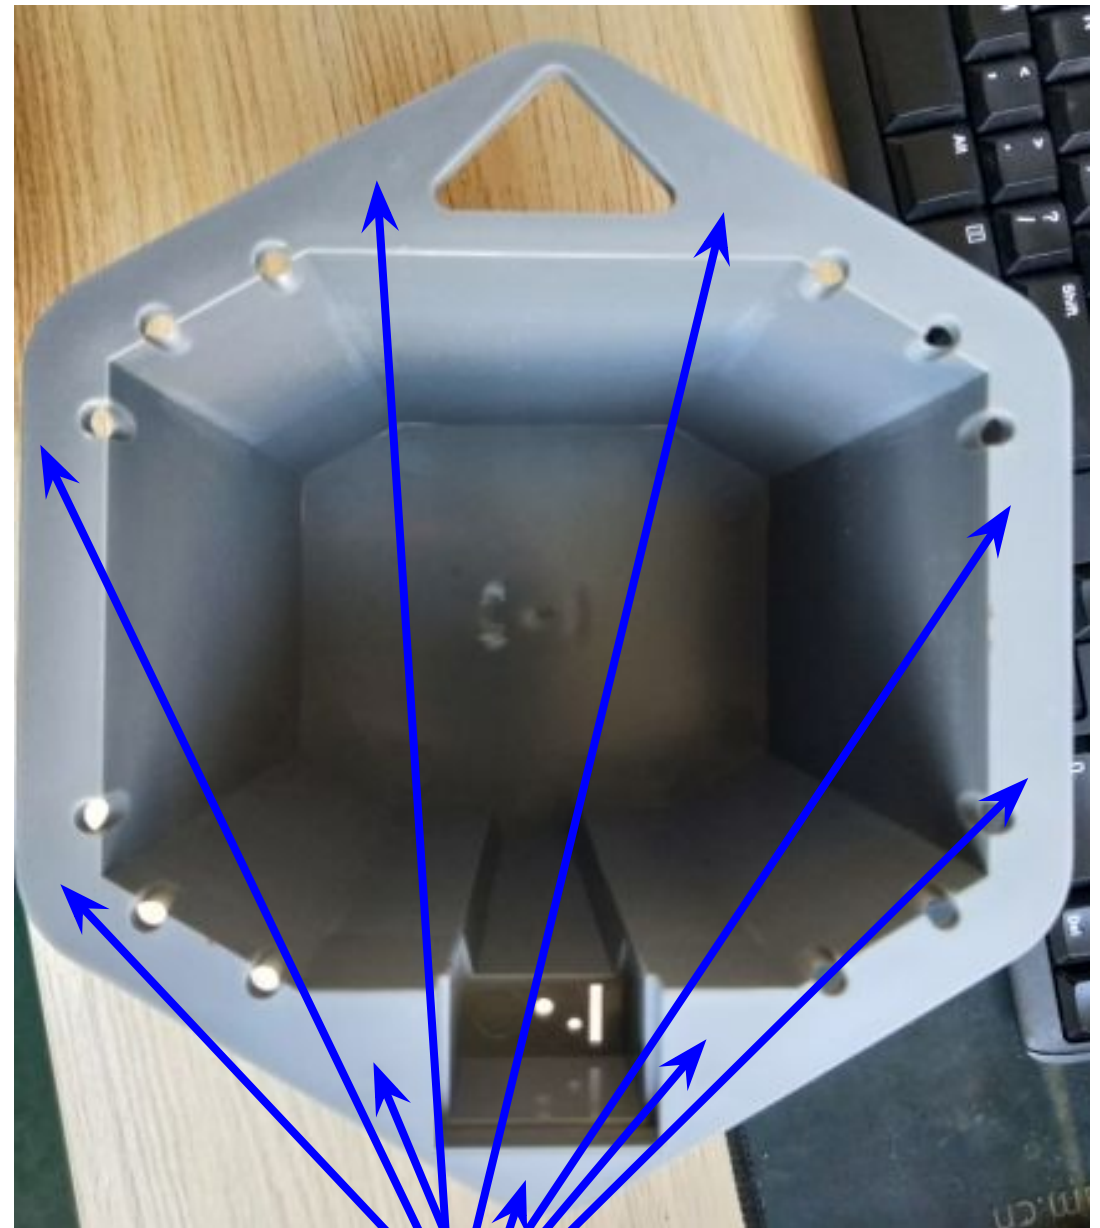
The product has the problem of welding trace and pin mark . Corresponding to the mold position, it needs to be dug out and re-welding.

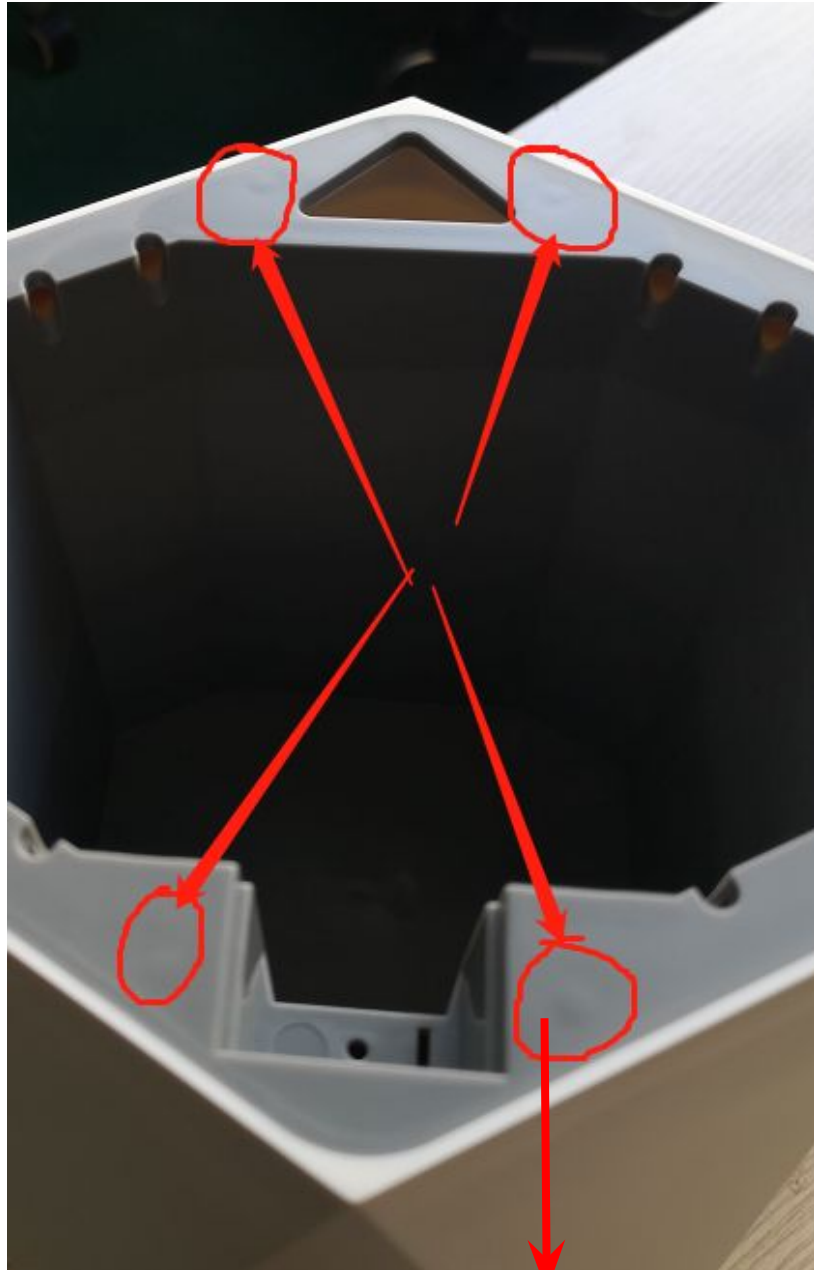
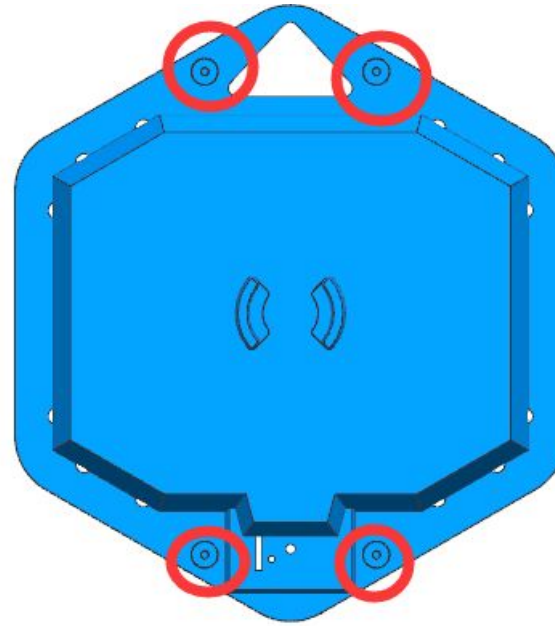
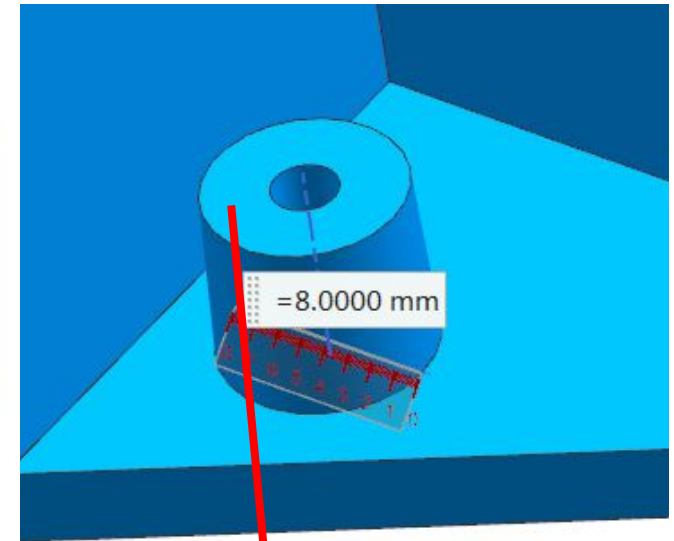
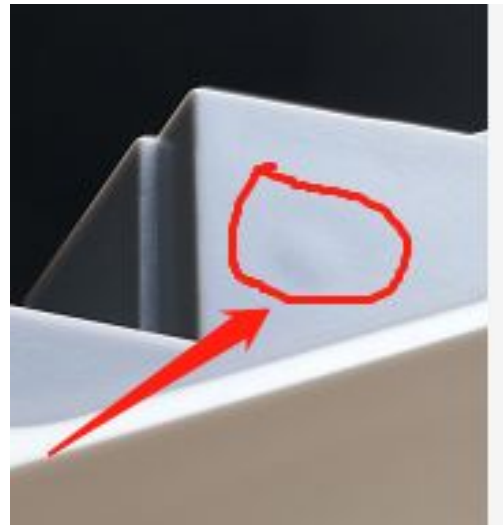
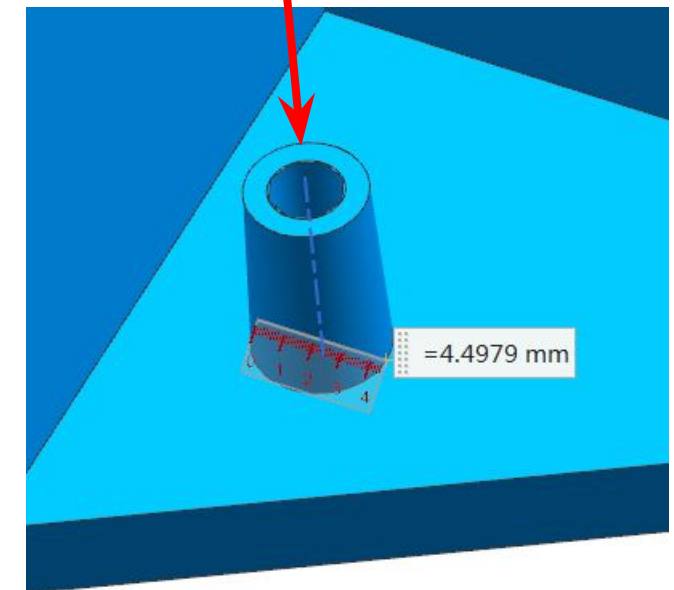
There is shrinkage at 4 places of the product. It is recommended that the diameter of the cylinder be changed from 8mm to 4.5mm to reduce shrinkage. if it is okey ?

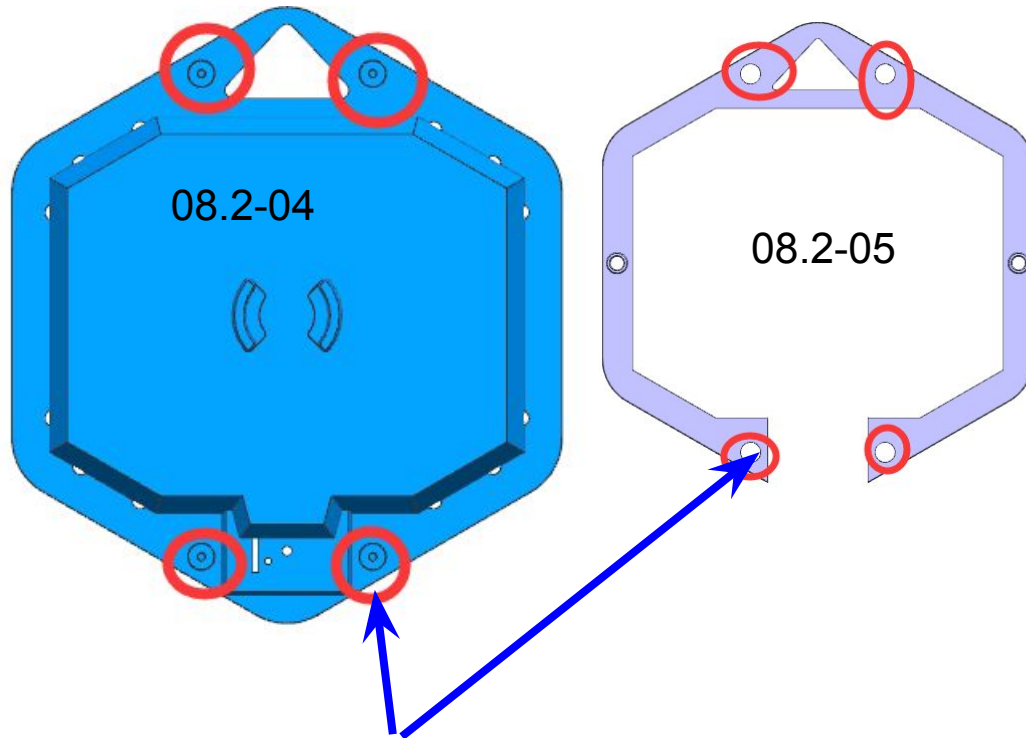
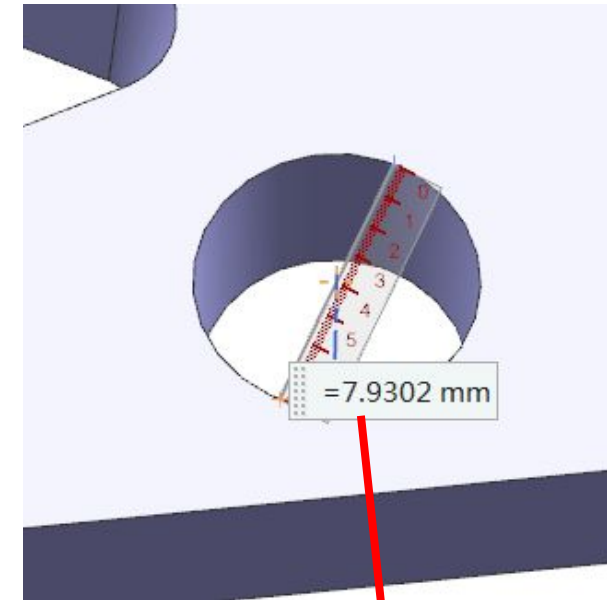
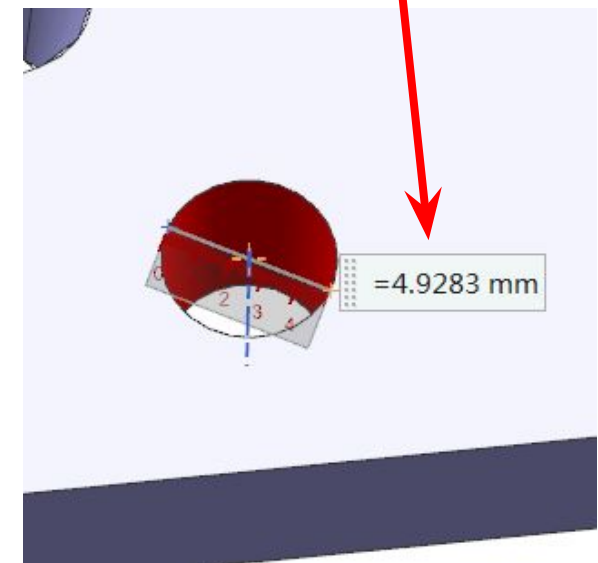
08.2-04, if the position of the cylinder is modified, and the size of the circular hole corresponding to 08.2-05 must also be modified together, as shown in the figure. if it is okay?

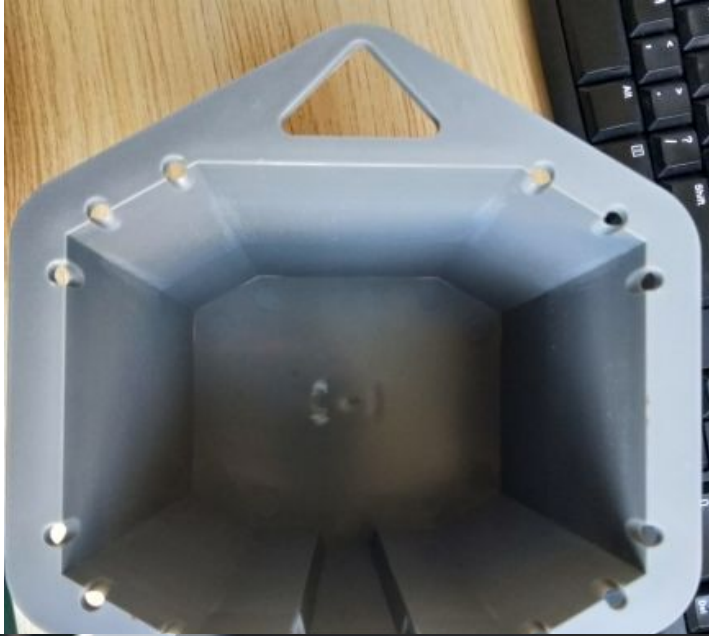
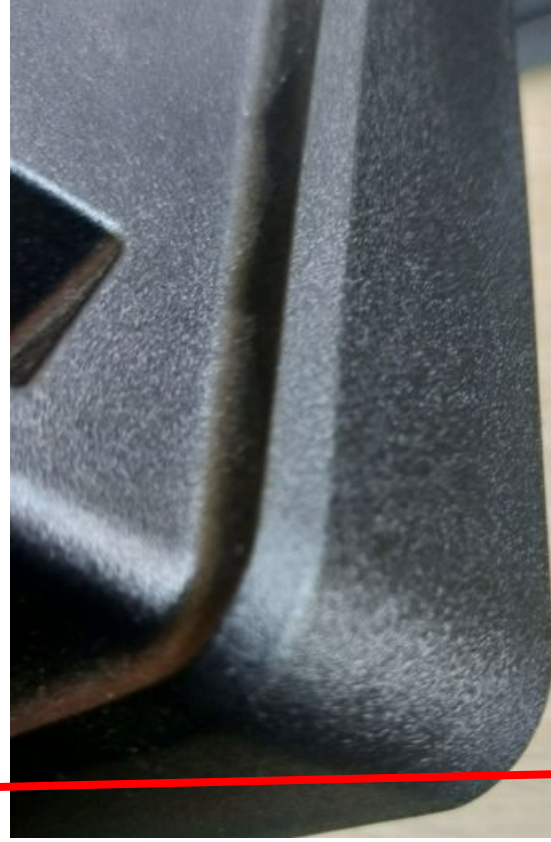
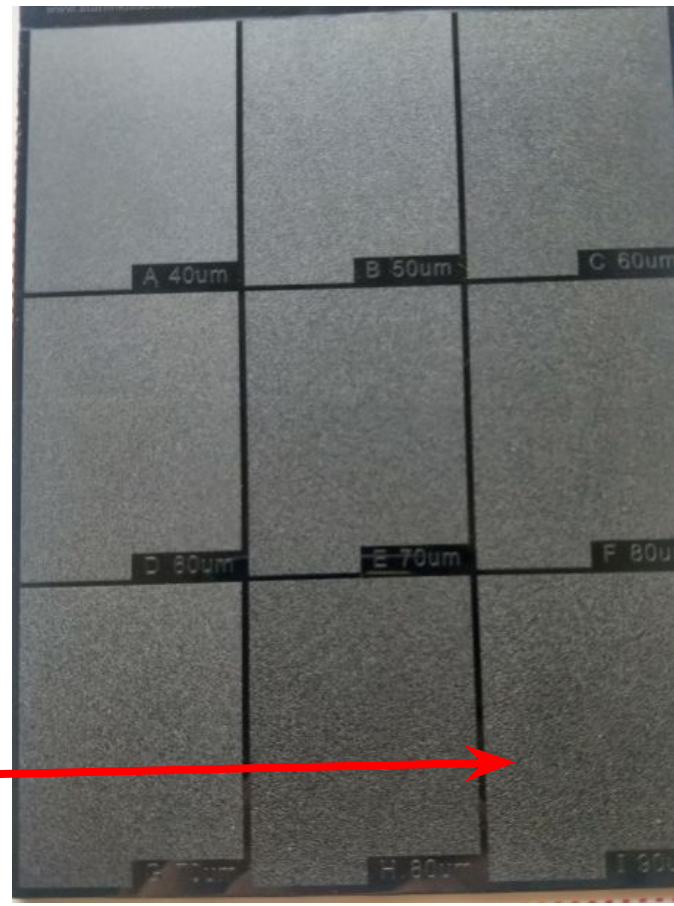
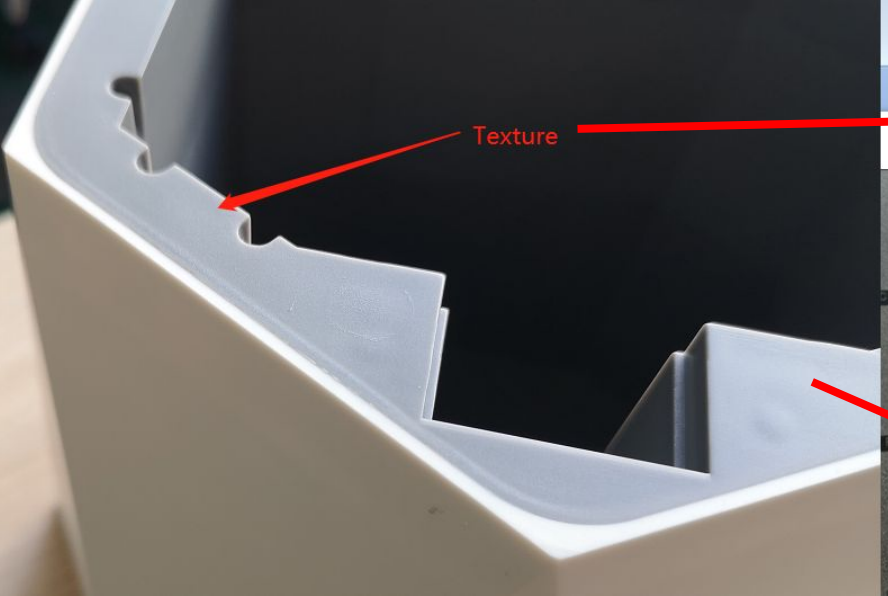
There is a eject pin mark on the surface of the product. It is recommended that the surface treatment of the product be changed from VDI24 to I90UM. It will

In order to solve the eject pin mark left by the previous mold welding, we will remake the matte surface, the cost: 530USD, please refer to the quotation for details. (Note: It may not be completely no trace, but it will improve.) If it is okey ?

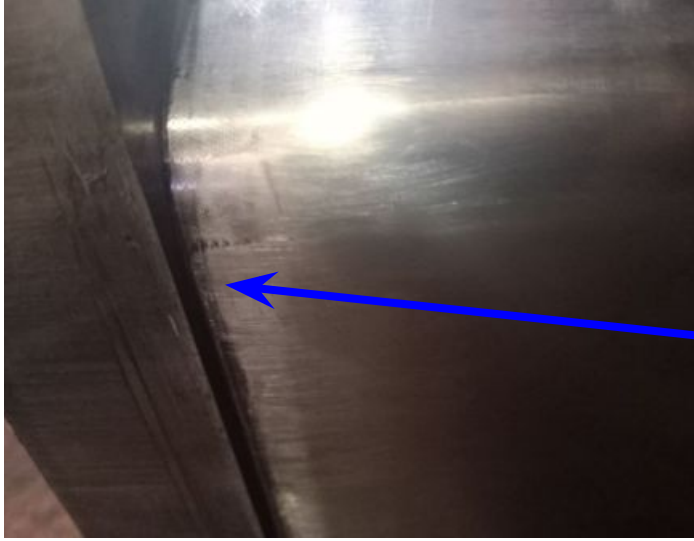
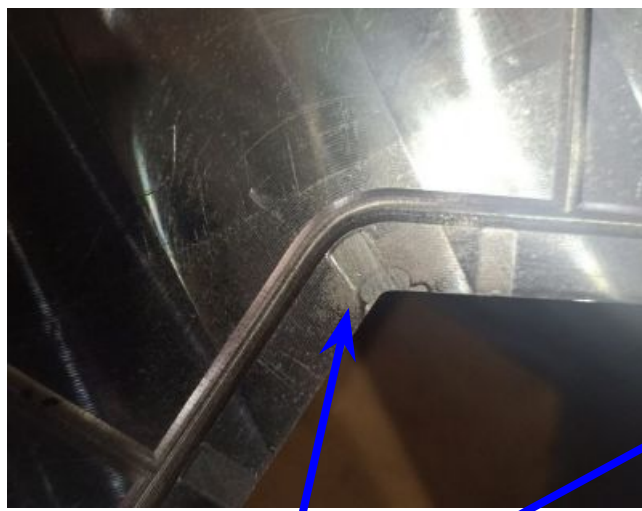
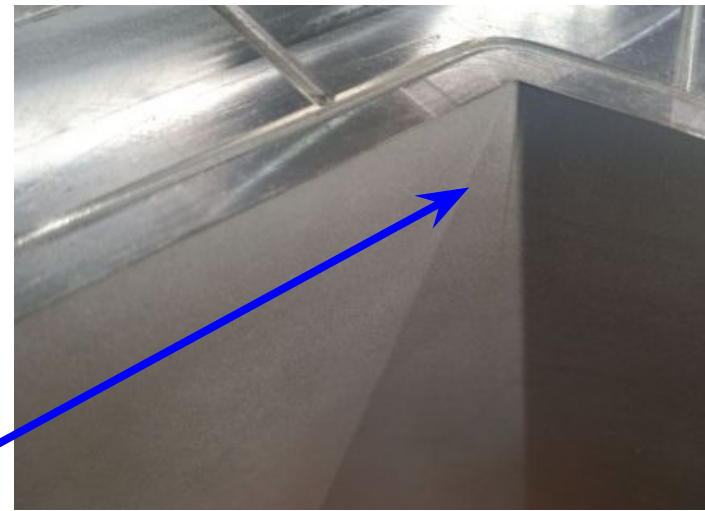
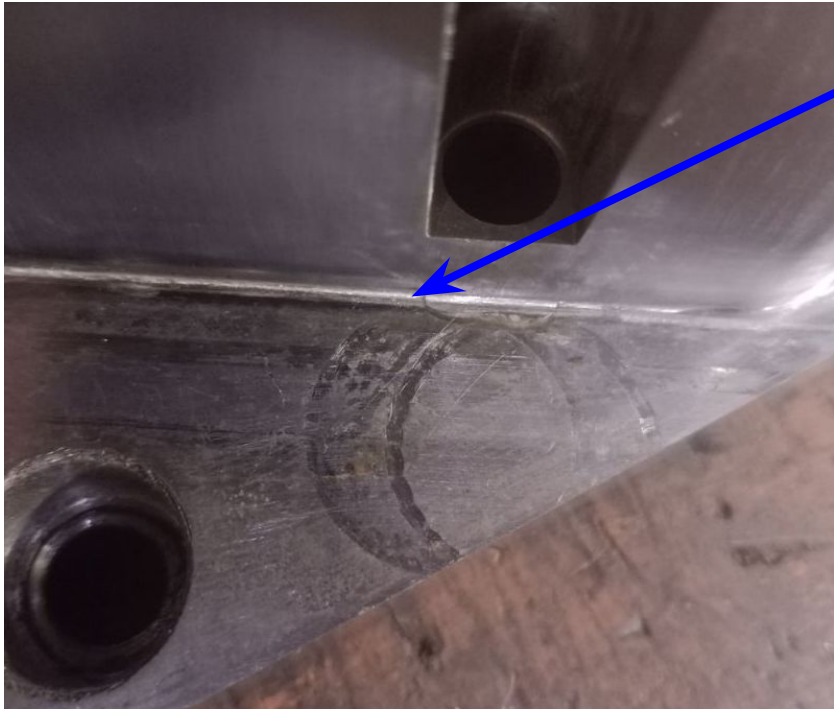
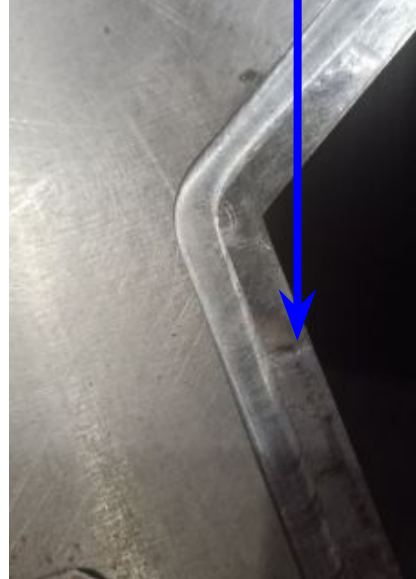
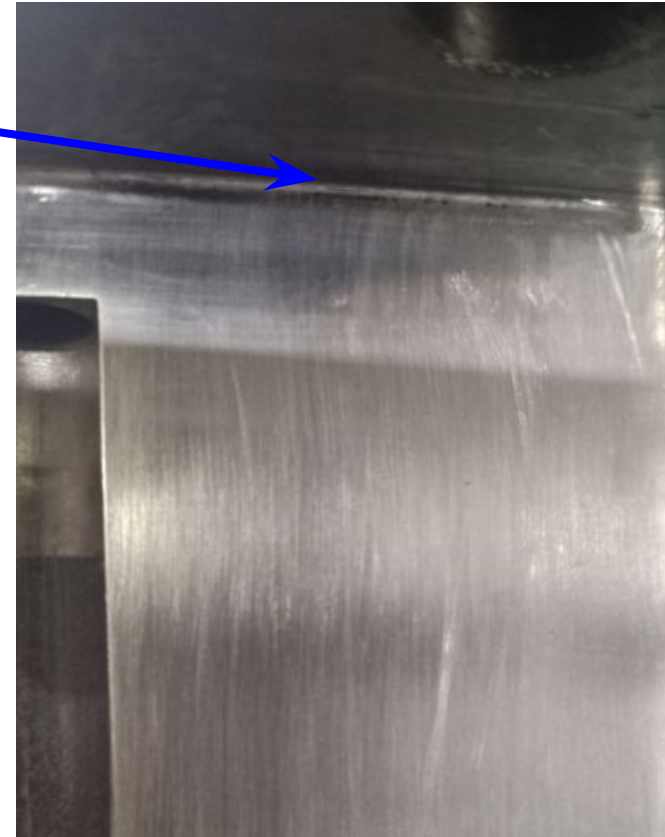
There are many places where the mold has been welded by RJC before of another half mould. There will be marks on the surface of the product. Please know and confirm?

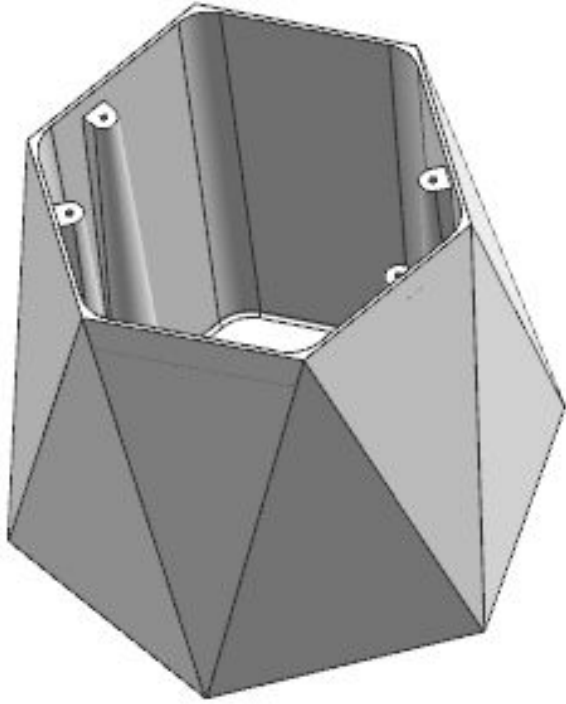
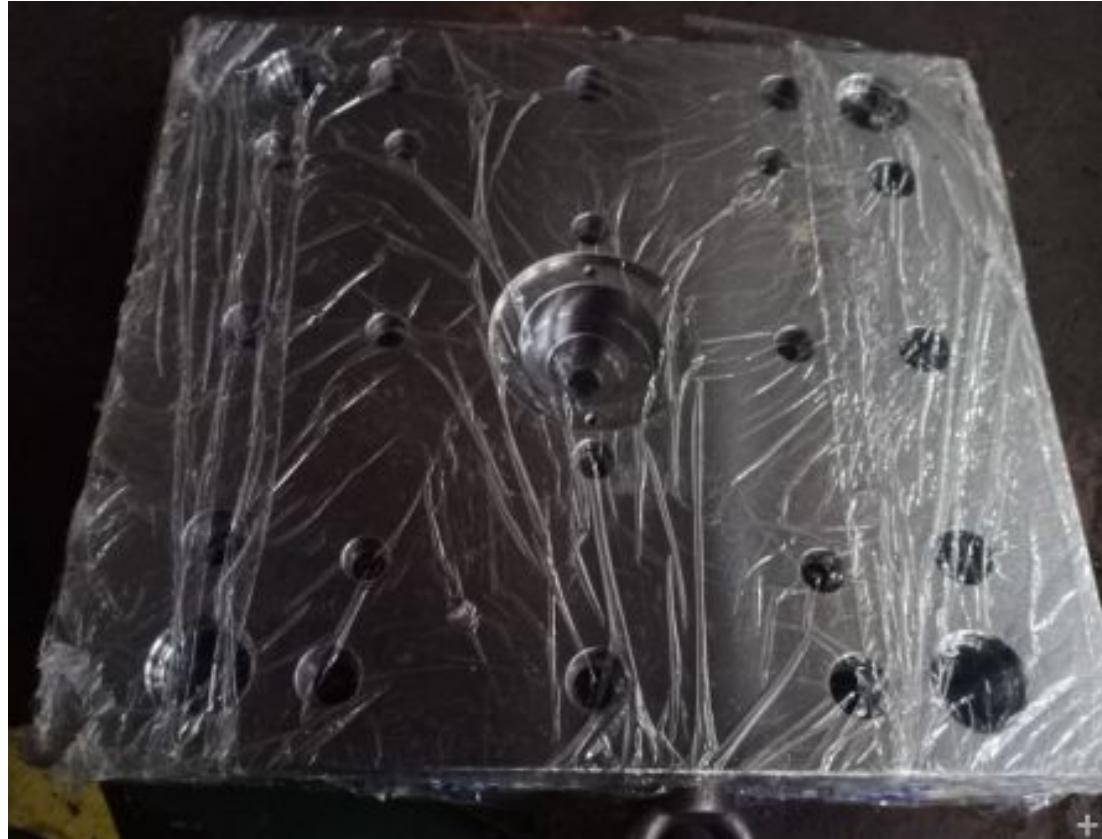
The template on the mold is very thin and deformed before, and the product is prone to burrs. We have replaced new template. Please know.

To solve the above problems from 2-4 points: increase the air pins, replace the template, increase EGP, etc., mold repair cost: 380USD, please refer to the quotation for details.

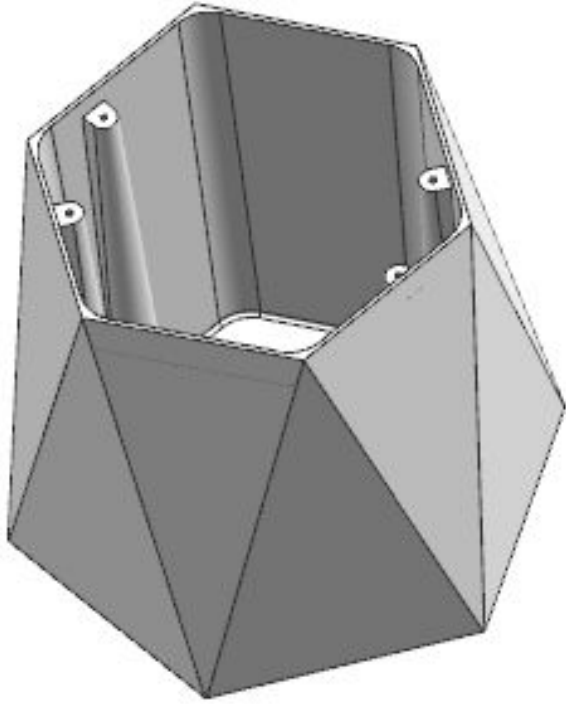
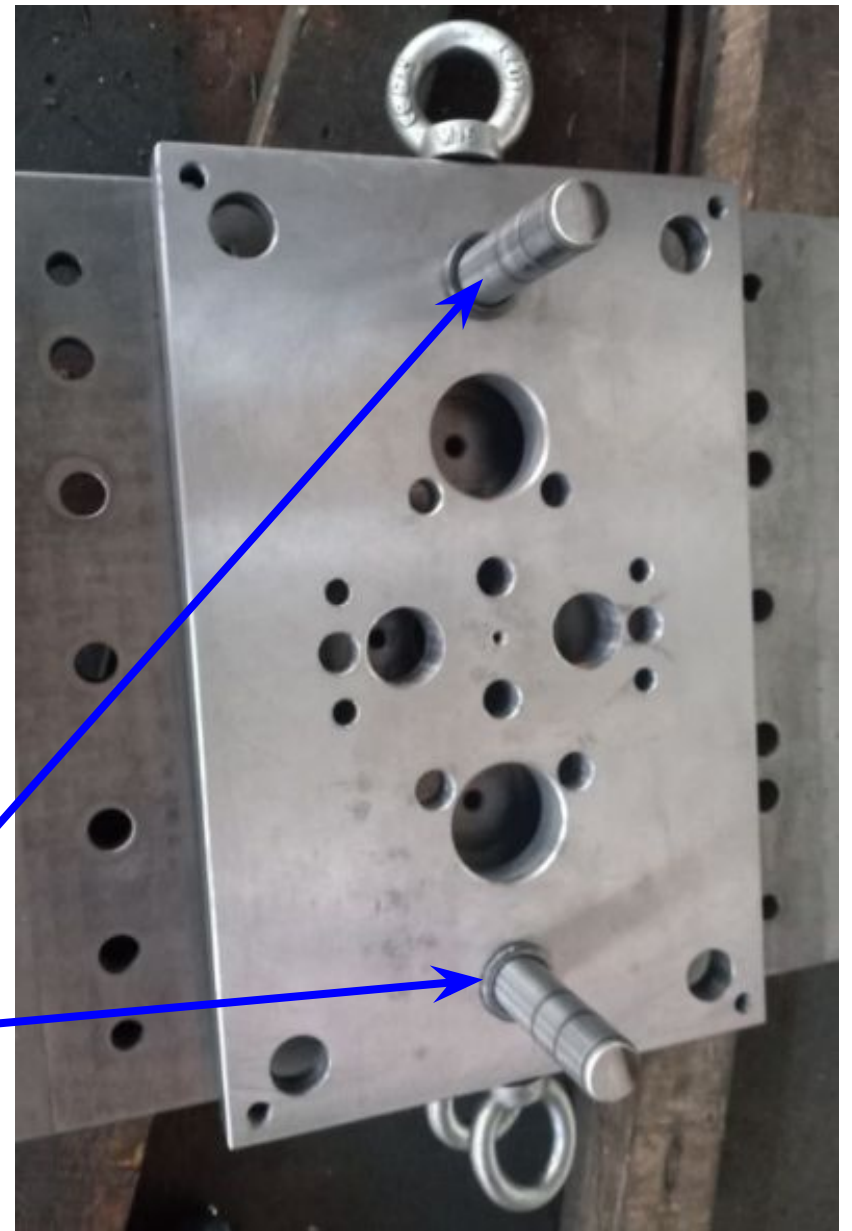
There was no EGP on the mold before, and the mold ejection was unbalanced. We have added 2 EGPs. Please know.

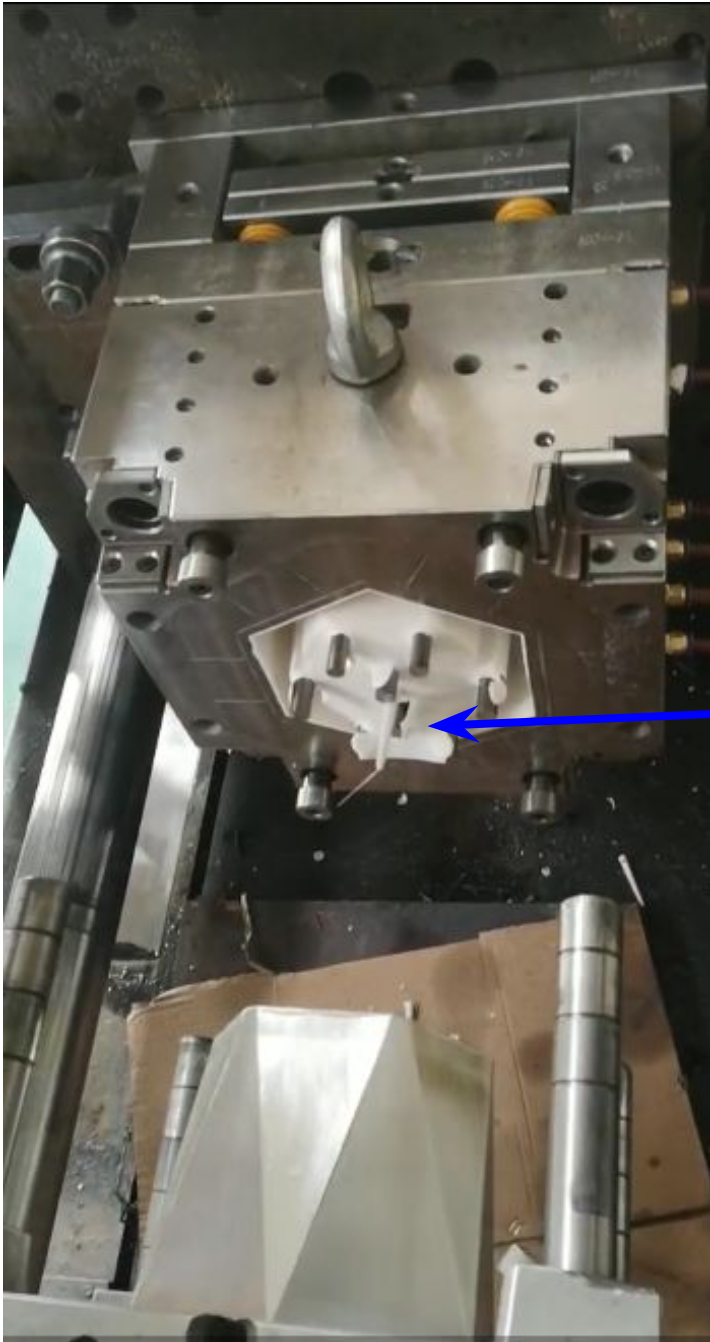
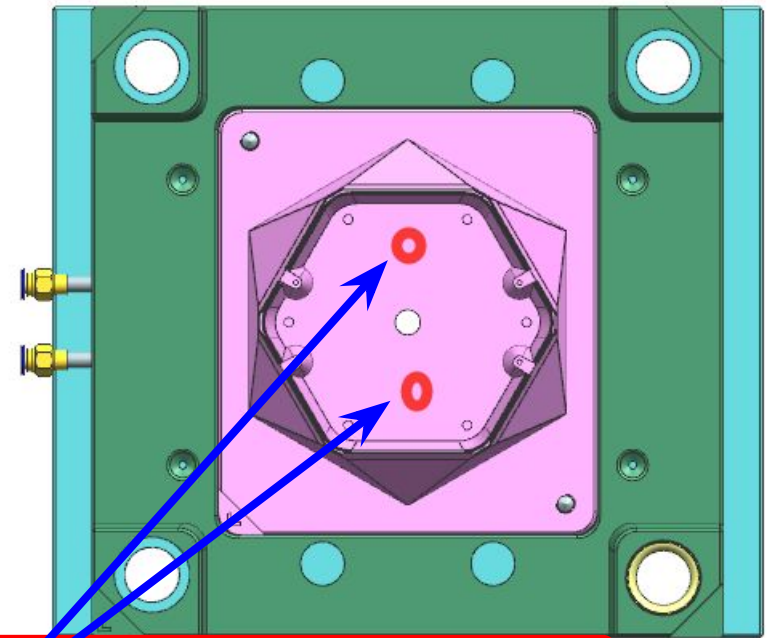
the front mould

Due to difficulty in ejecting the product, it is recommended to add 2 air pins to the front and rear molds to assist the ejection of the product. (As shown in the red area)

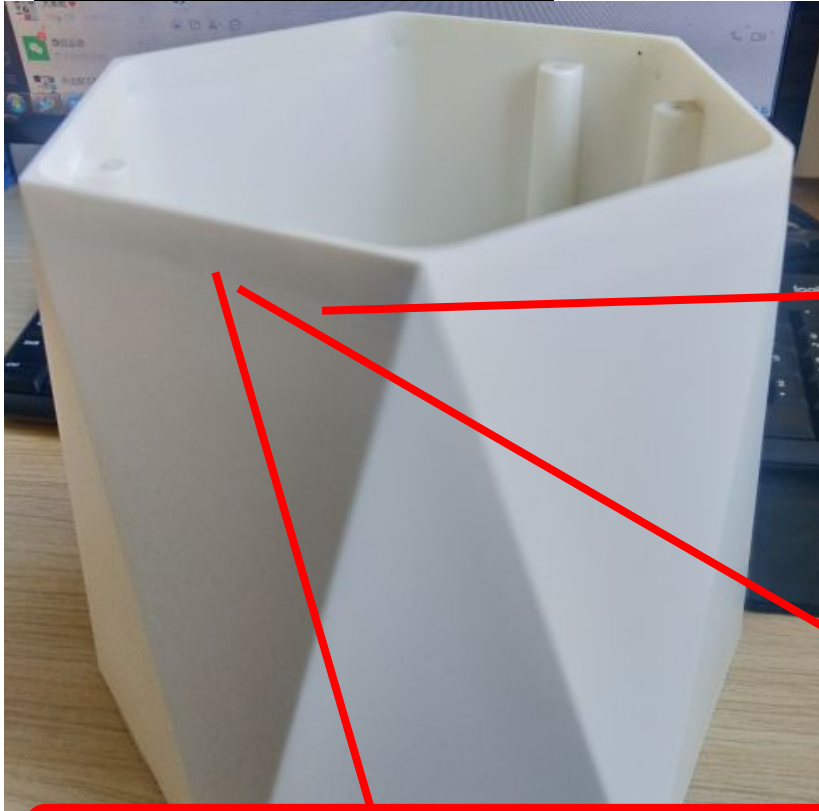
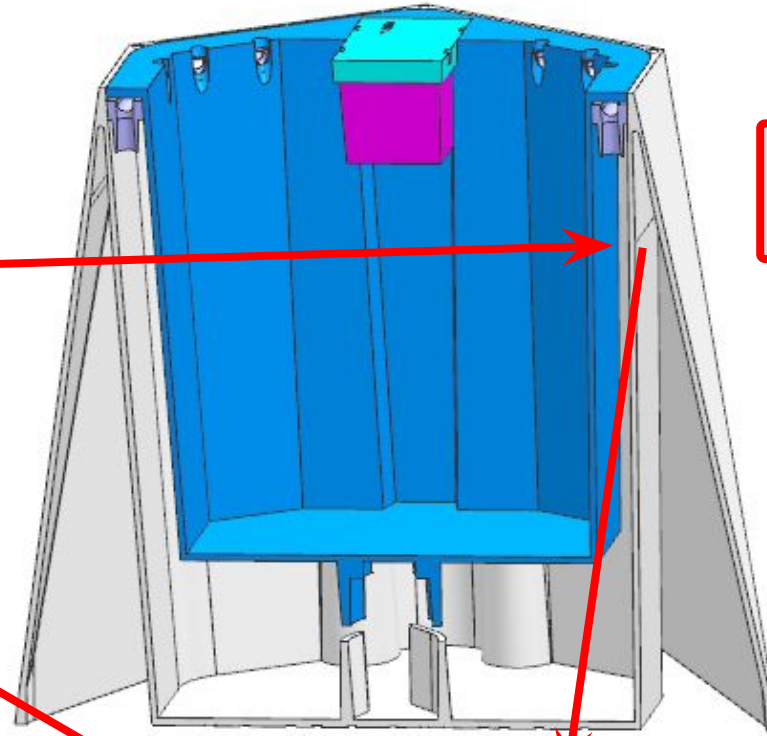
there is line
around of top

We will try to increase the thickness on the side of the product to solve the problem of shadow lines caused by uneven product thickness. However, it cannot be guaranteed to be completely no line, because it cannot be increased too thick, and the outer side may cause shrinkage problems if it is too thick. This is a contradiction question.

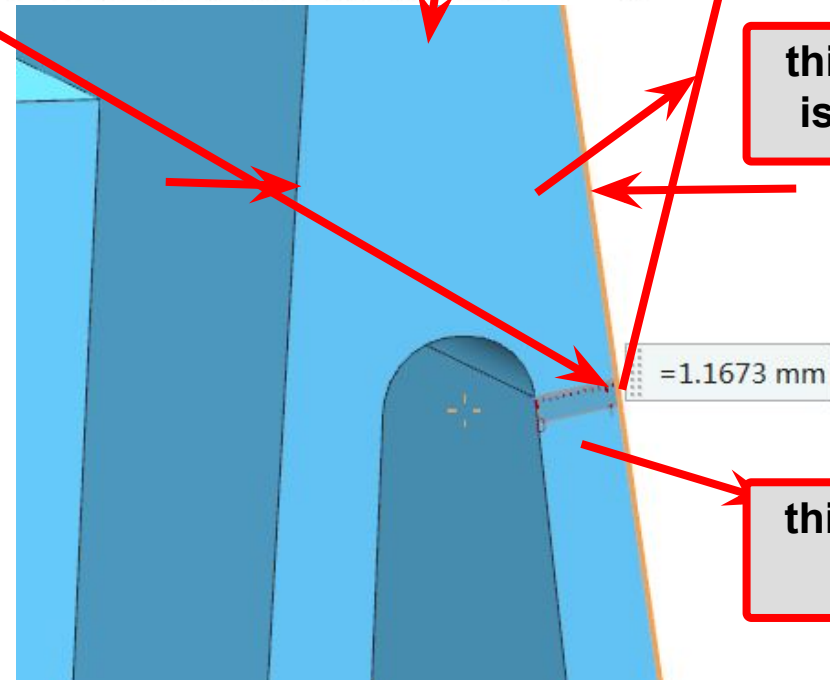
this area
is thick

this area is
thin

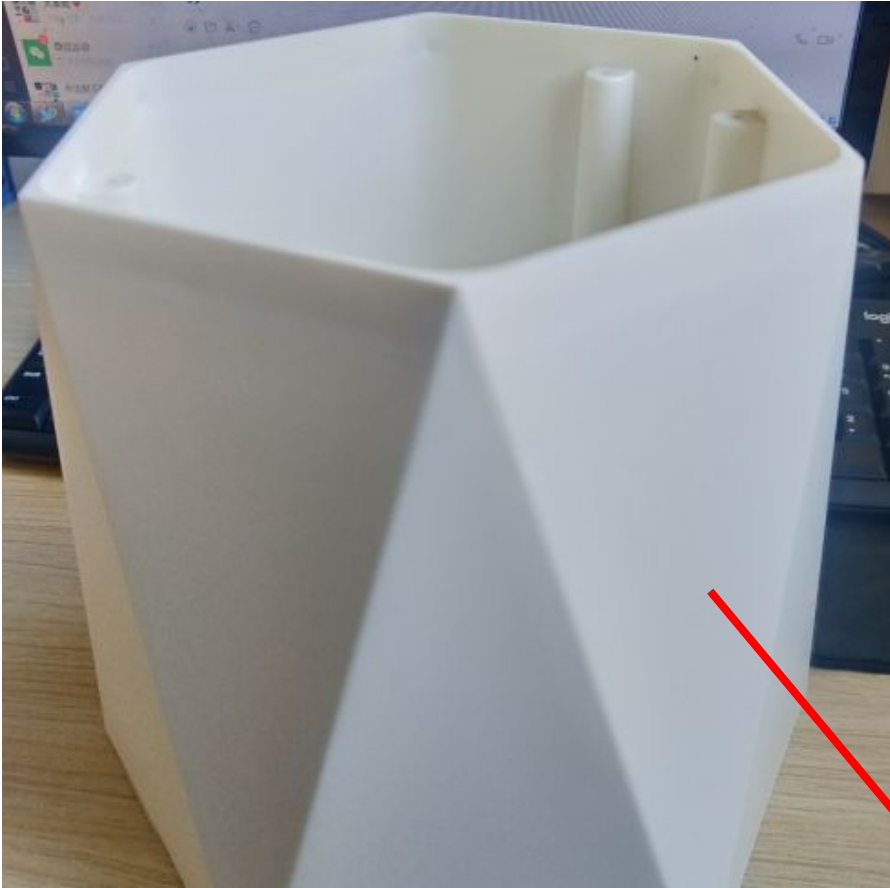
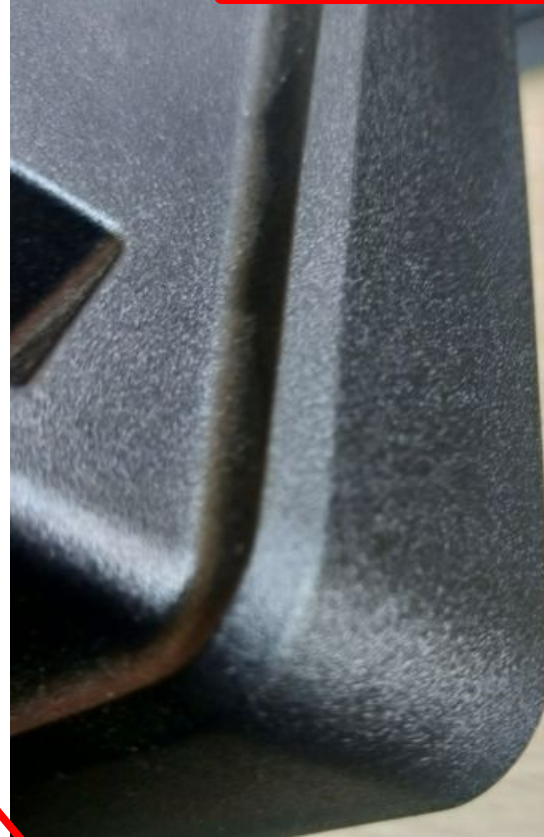
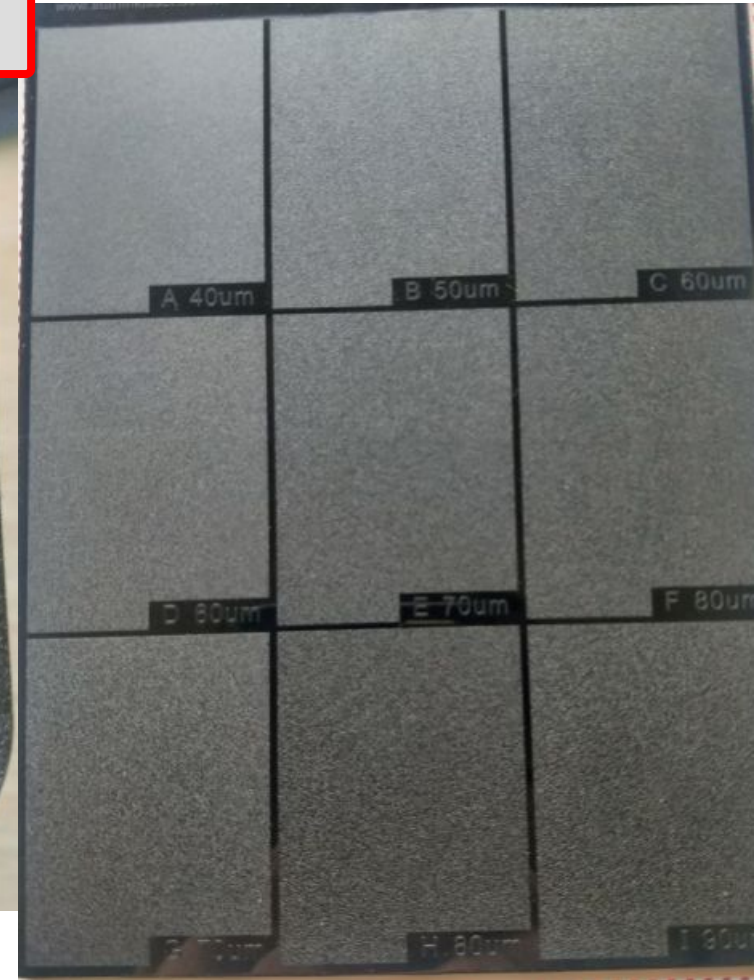
There is line around the top surface. It is recommended that the surface treatment of the product be changed from VDI24 to I90UM. Will lighten traces of the line.

We suggest to remke the matte surface all over the side, cost: 910USD. Please refer to the quotation for details. (Note: It may not be completely no line, but it will be improved.)
