# iRADVC7000/9000s

- 1.Coating error
- 2.Coating failure at rear side of sleeve
- 3.Toner leaking

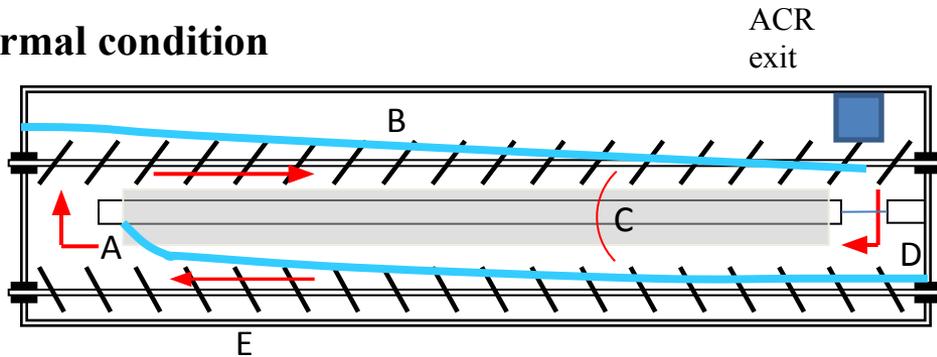
**1. Normal condition**

**If the developer circulation is normal,** the developer exists in the distribution shown in the dotted line.

Toner flows as the arrows show.

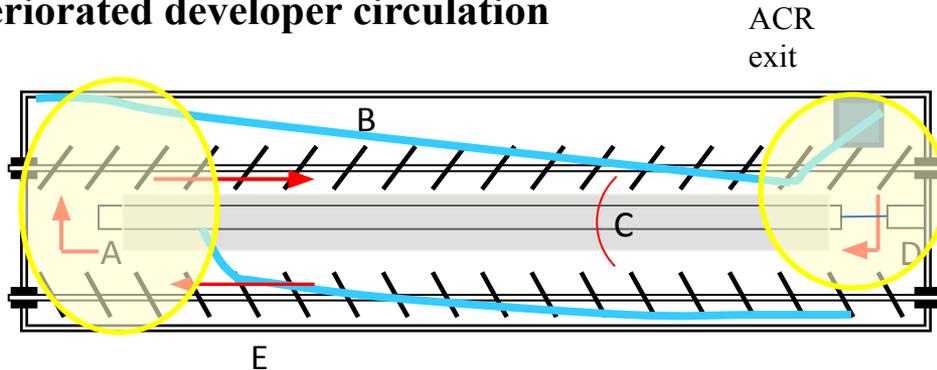
**2. Deteriorated developer circulation**

**If the developer circulation is deteriorated,** the developer exists in the distribution shown in the dotted line.

Poor developer flow tends to occur at 2 points.

Front/A-B front: Developer accumulates and hardly flows.

Rear/D: Developer accumulates and hardly drops.

-If developer remains unmoving in the front/A-B front side, developer leakage at the front or developer leakage due to increased amount of toner may occur.

-If developer remains unmoving in the rear (D) side, excess developer is discharged, and the amount of toner inside the developing assembly may decrease.

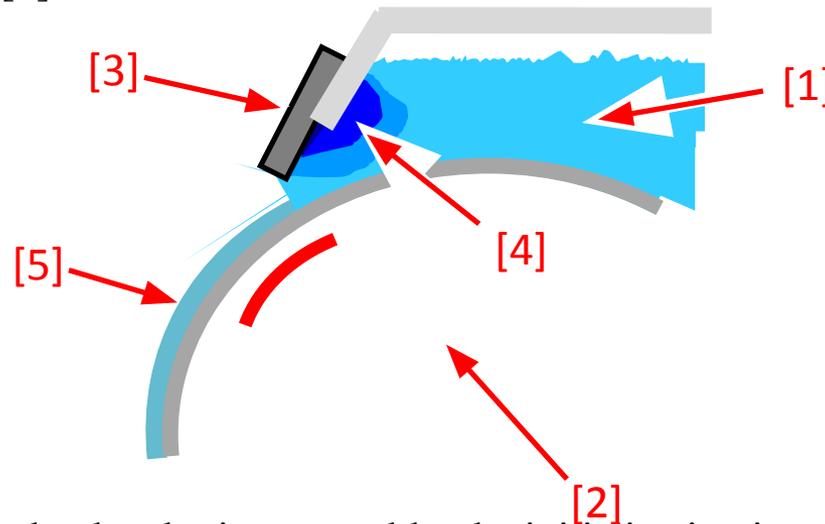
When a large number of originals with a low density is printed, toner [1] is not consumed and turns into agglomeration [4] in a space between the developing sleeve [2] and the blade [3], consequently causing coating failure [5] on the sleeve.

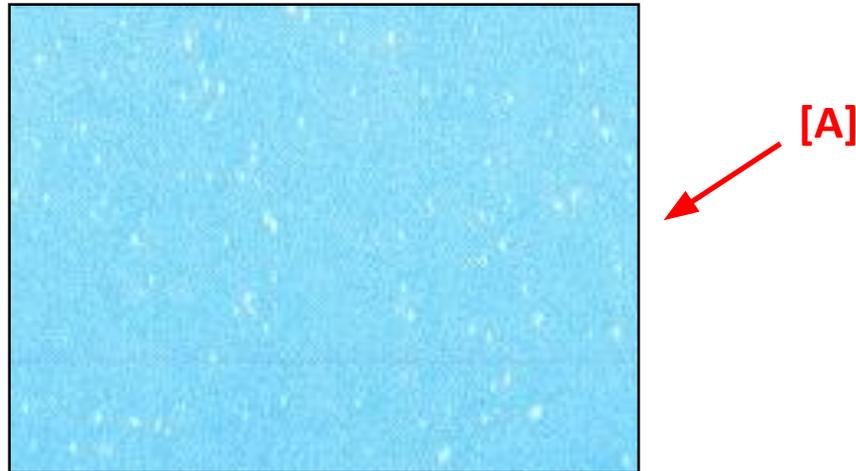
P-1 White spots image

In case of less color jobs, white spots may appear on image due to shortage of the toner amount in the color developing assemblies of Y, M and C is reduced.

When there are less color jobs, the toner supply control of the color developing assembly does not operate as expected resulting in toner supply shortage.

[A] White spots (2 - 3mm in diameter)

Upgrading the Dcon version to v62.02 to modifies the toner supply control failure.

Upgrade to the following software if the above symptom occurs.

Dcon v 62.02

STEP 2: Making prints/copies of solid PG image in the affected color until the white spots disappear.
