Fig. 1. Schematic representation of the multilayer in a multi-chip module of type A (a) and of type B (b).

Fig. 2. (a) Temperature swing distribution at the interfaces of both stacks in Fig. 1 (black: type A, white: type B); a-b: Si, b-c: Si-solder, c-d: solder-Cu, d-e: Cu-ceramic, e-f: ceramic-Cu, f-g: Cu-solder, g-h: solder-base plate. (b) Temperature at the interfaces for a dissipated power of 100 W and a heat sink temperature of 40 °C (black: type A, white: type B).

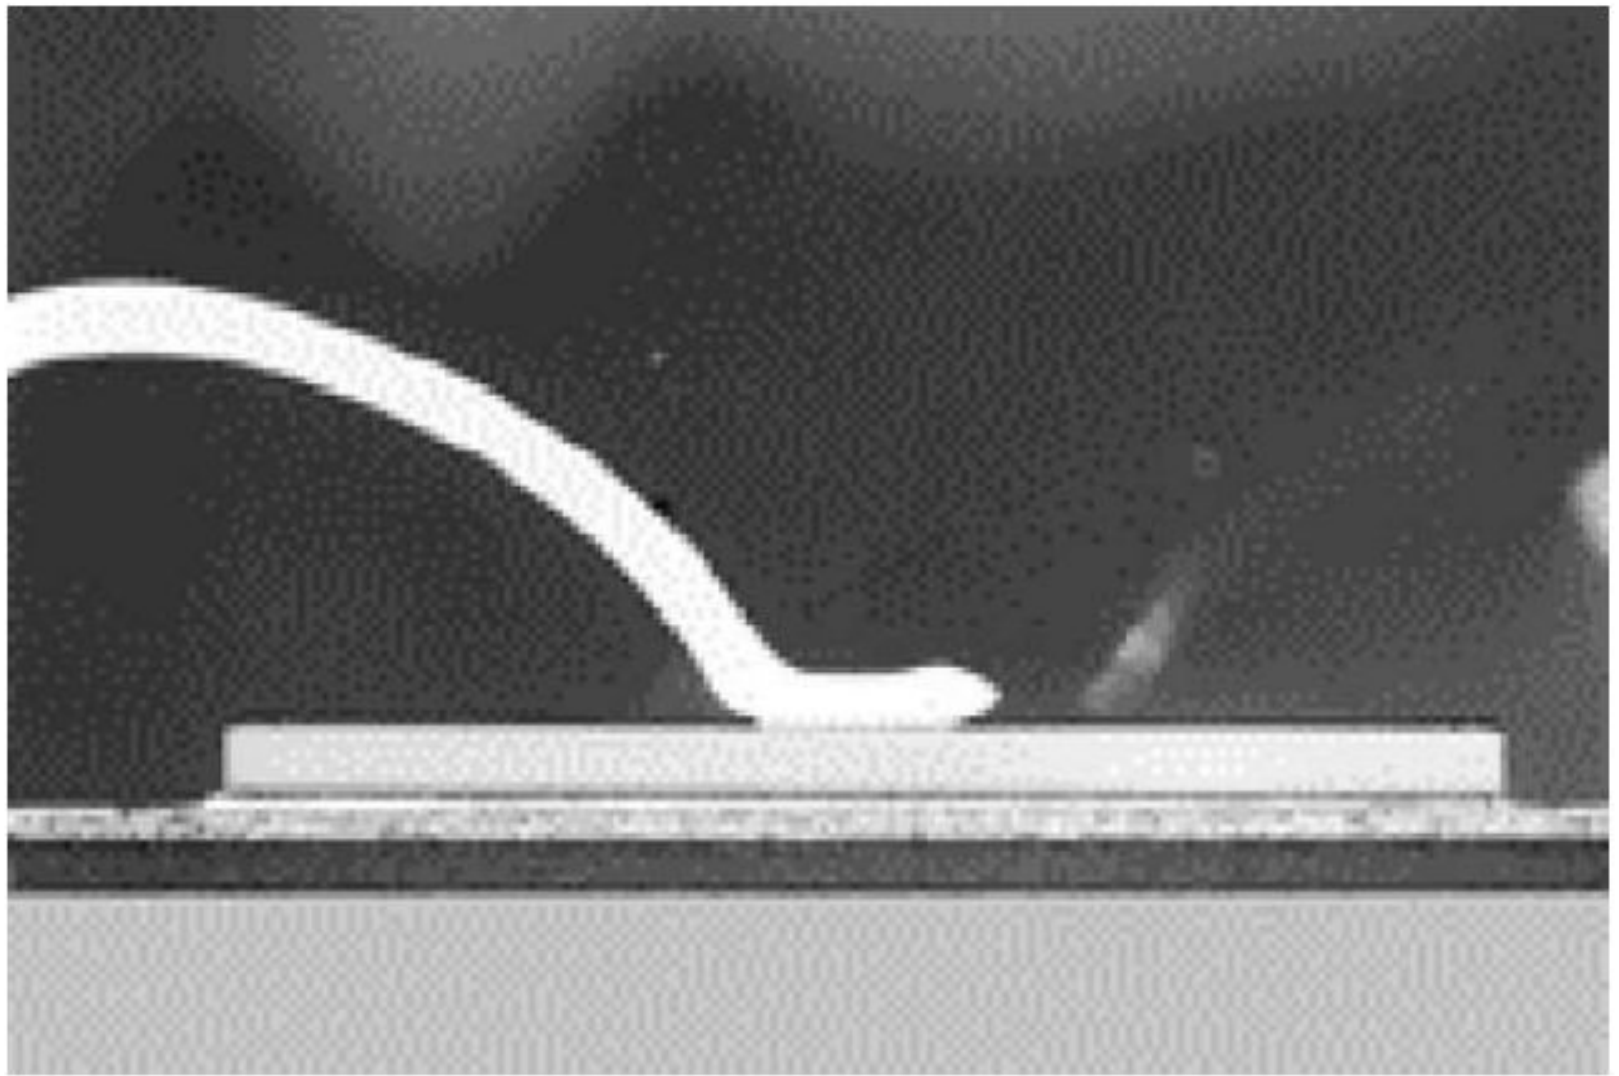
Fig. 3. Cross-section through the gate bond wire of an IGBT module of type A (cross-section, optical image $3\times$).

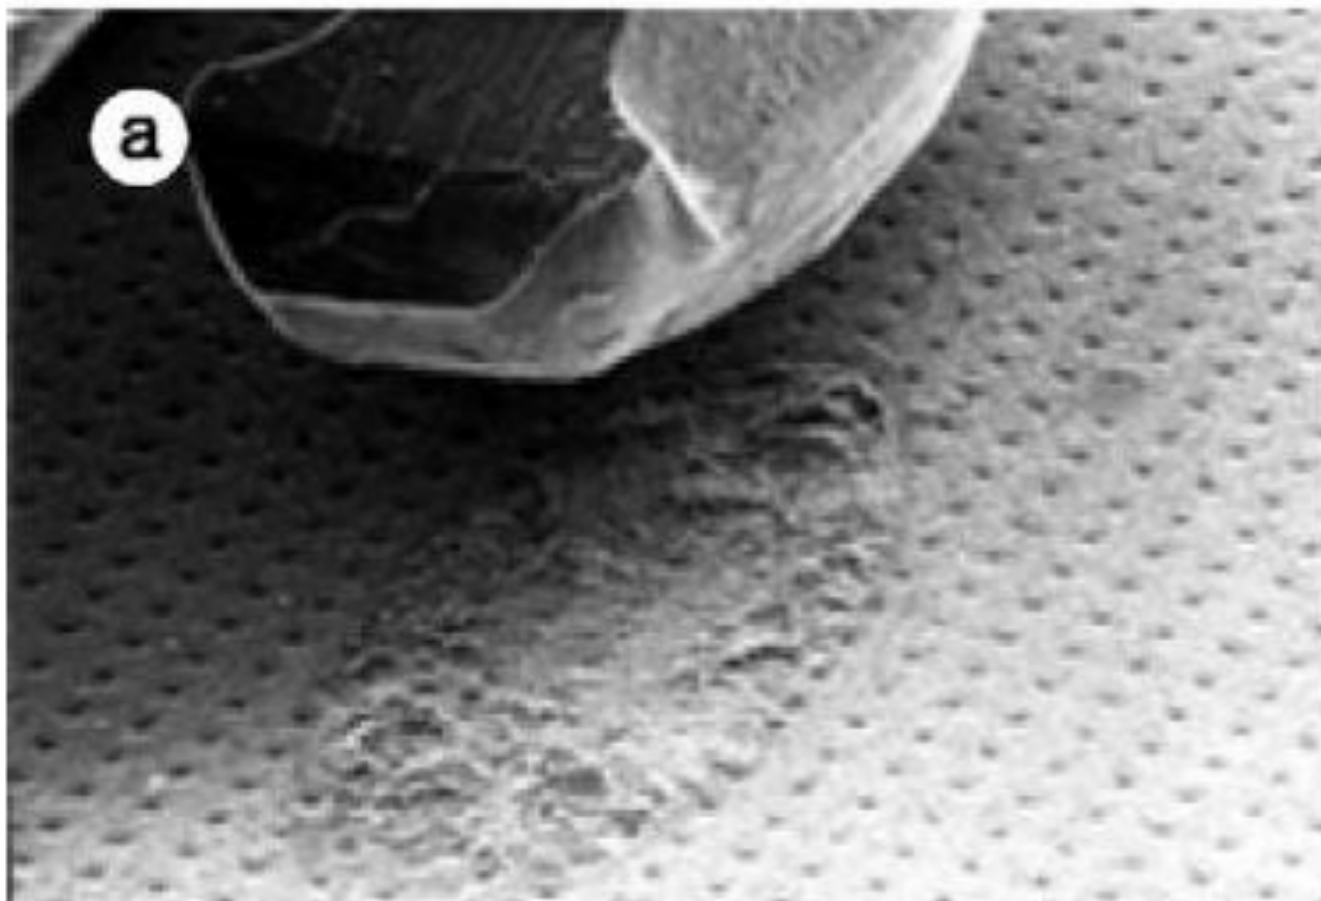
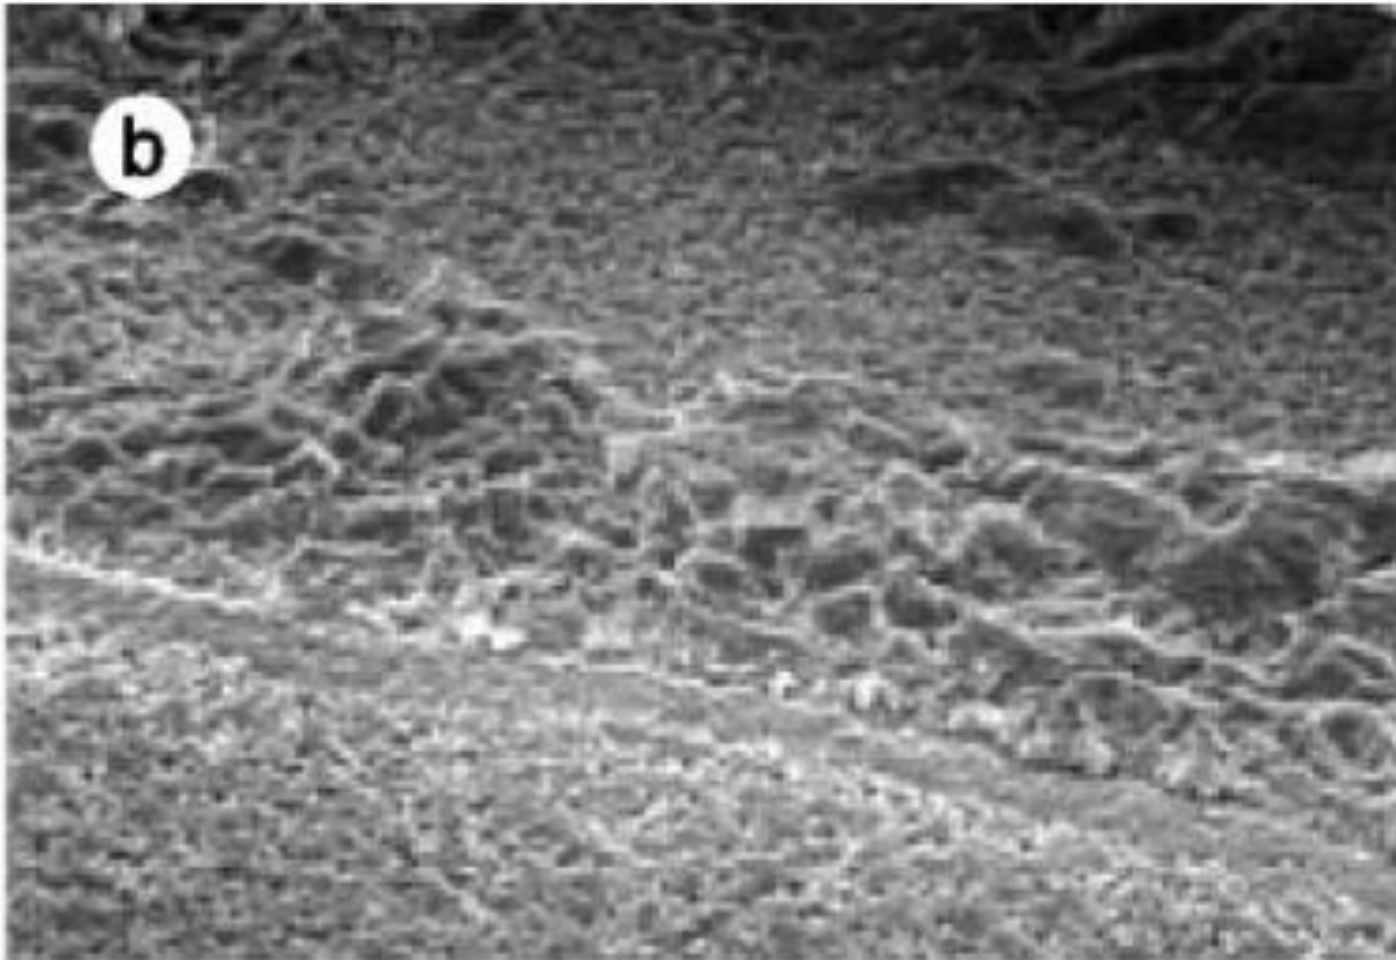
Fig. 5. (a) Bond wire lift off (SEM image, 40 \times). (

(b) Close view of the footprint of an aluminum bond wire after lift off (SEM image,

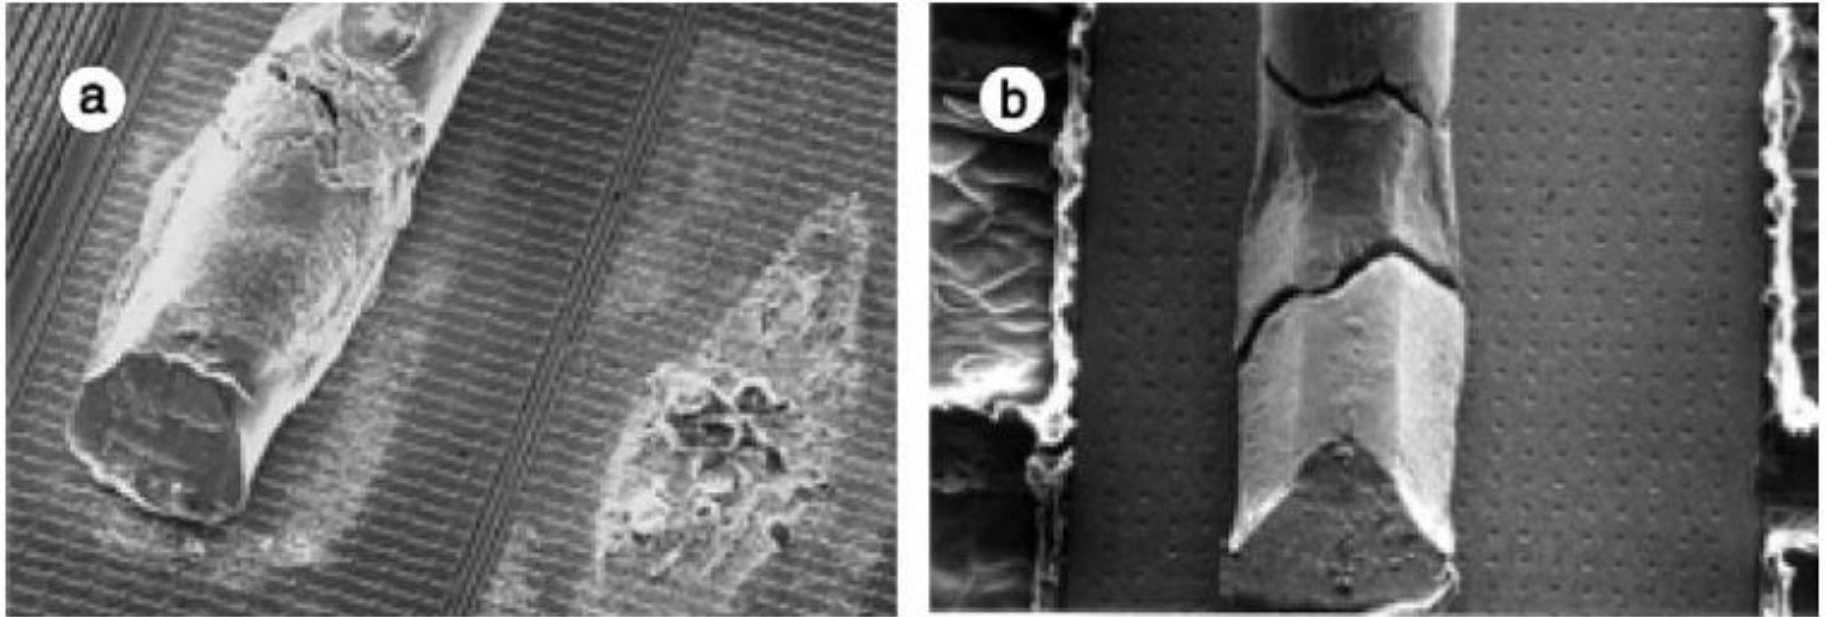
Fig. 7. (a) Bond wire heel cracking due to low-cycle fatigue stressing (SEM image, 25 \times). (b) Bond wire cracking due to improper bond wire coating (SEM image, 25 \times).

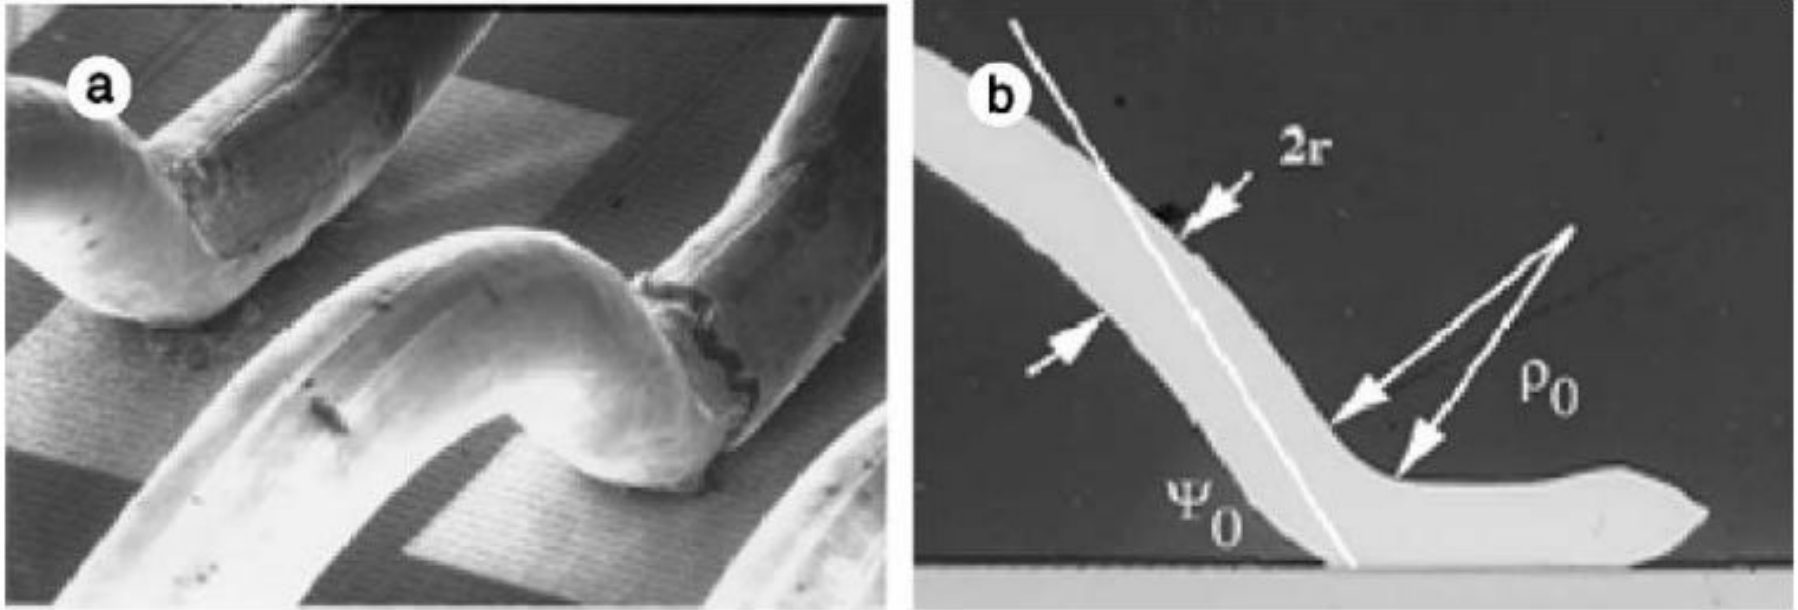
Fig. 8. (a) Heel cracking in a double wire bond. Crack initiation can also be observed in the double bond in the back (SEM image, 25 \times). (b) Parameter definition for the lifetime model.

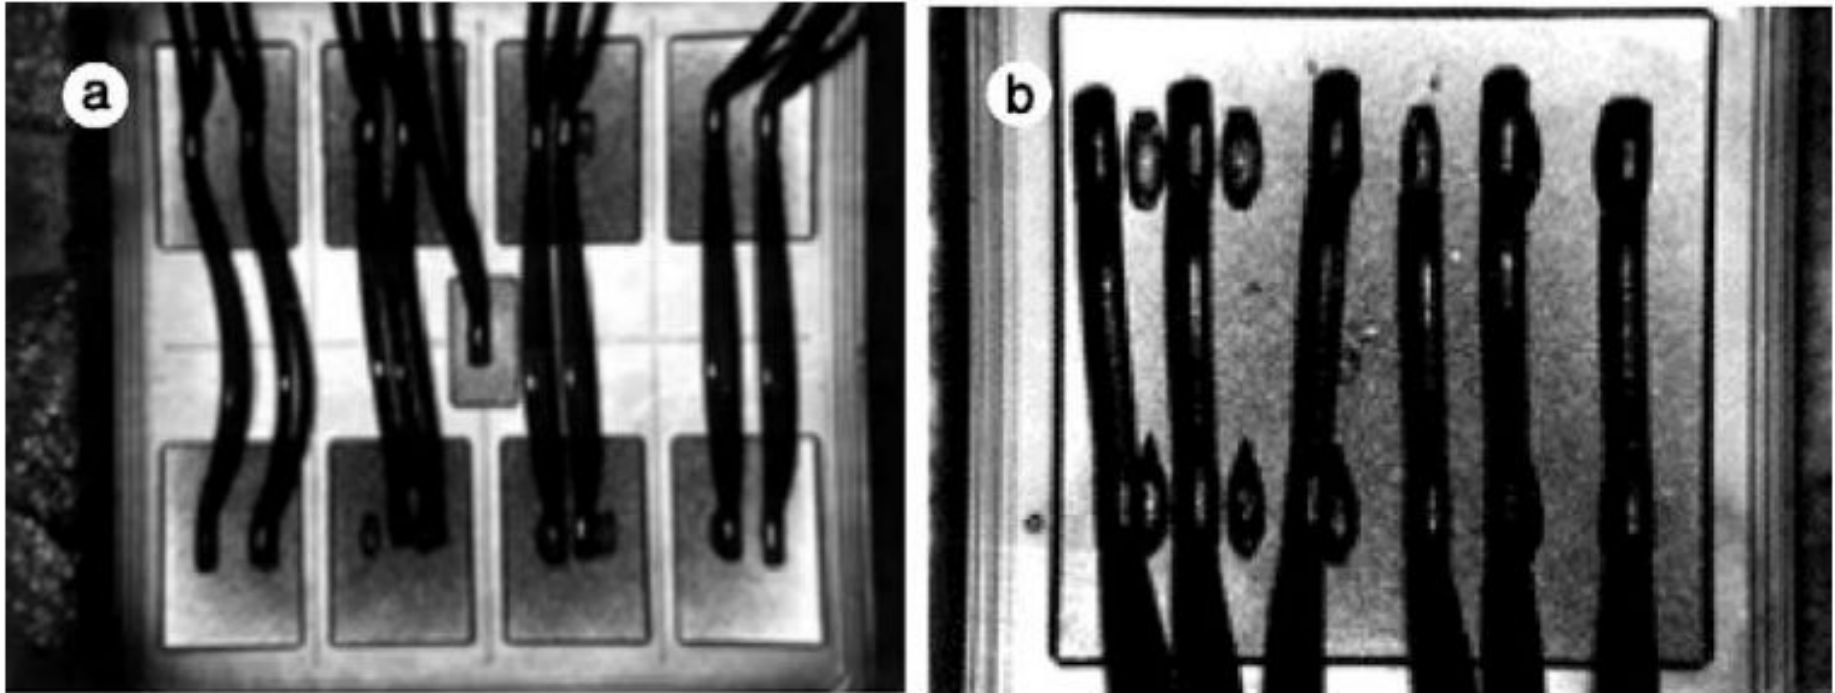
Fig. 9. (a) Reconstructed emitter and gate metalization of an IGBT (optical image, 4 \times). (b) Reconstructed metalization of a free-wheeling diode (optical image, 5 \times).

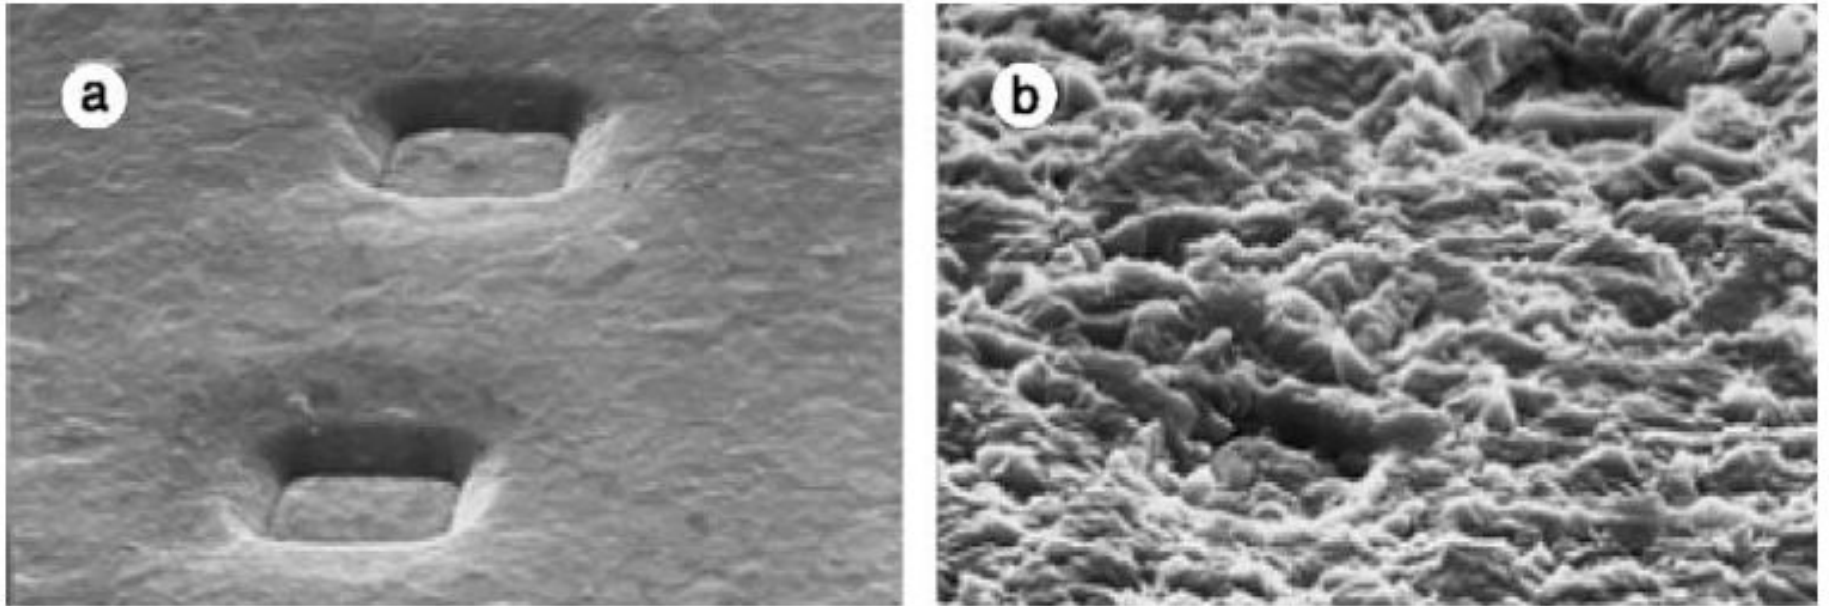
Fig. 10. (a) Emitter metalization of an IGBT chip before power cycling (SEM image, 1000 \times). (b) Reconstructed emitter metalization after 3.2 millions of power cycles between 85 and 125 $^{\circ}\text{C}$ (SEM image, 1000 \times).

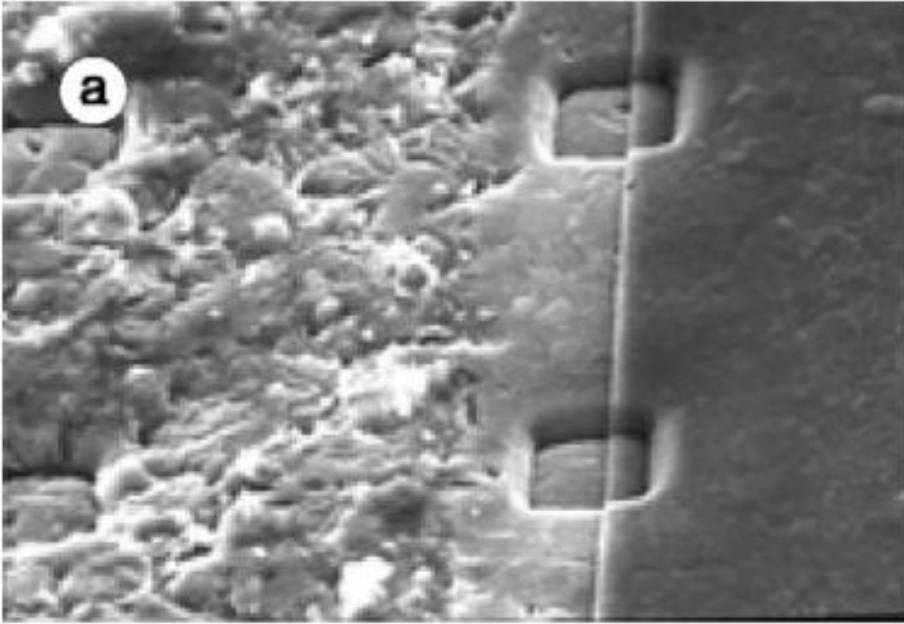
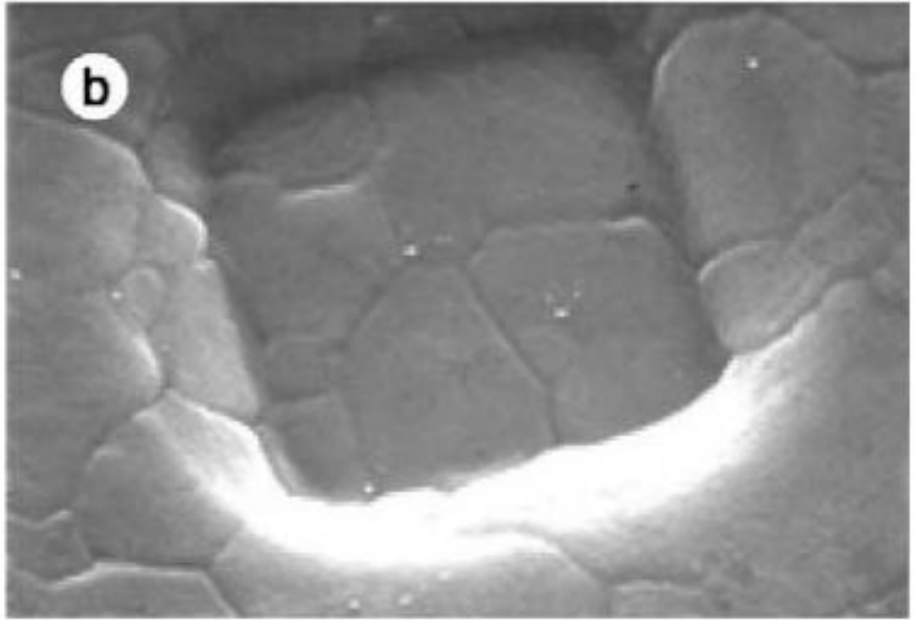
Fig. 11. (a) Reconstructed emitter metalization after removal of the polyimide passivation (SEM image, 800 \times). (b) Grain boundary depletion in a passivated emitter contact after power cycling (SEM image, 1500 \times).

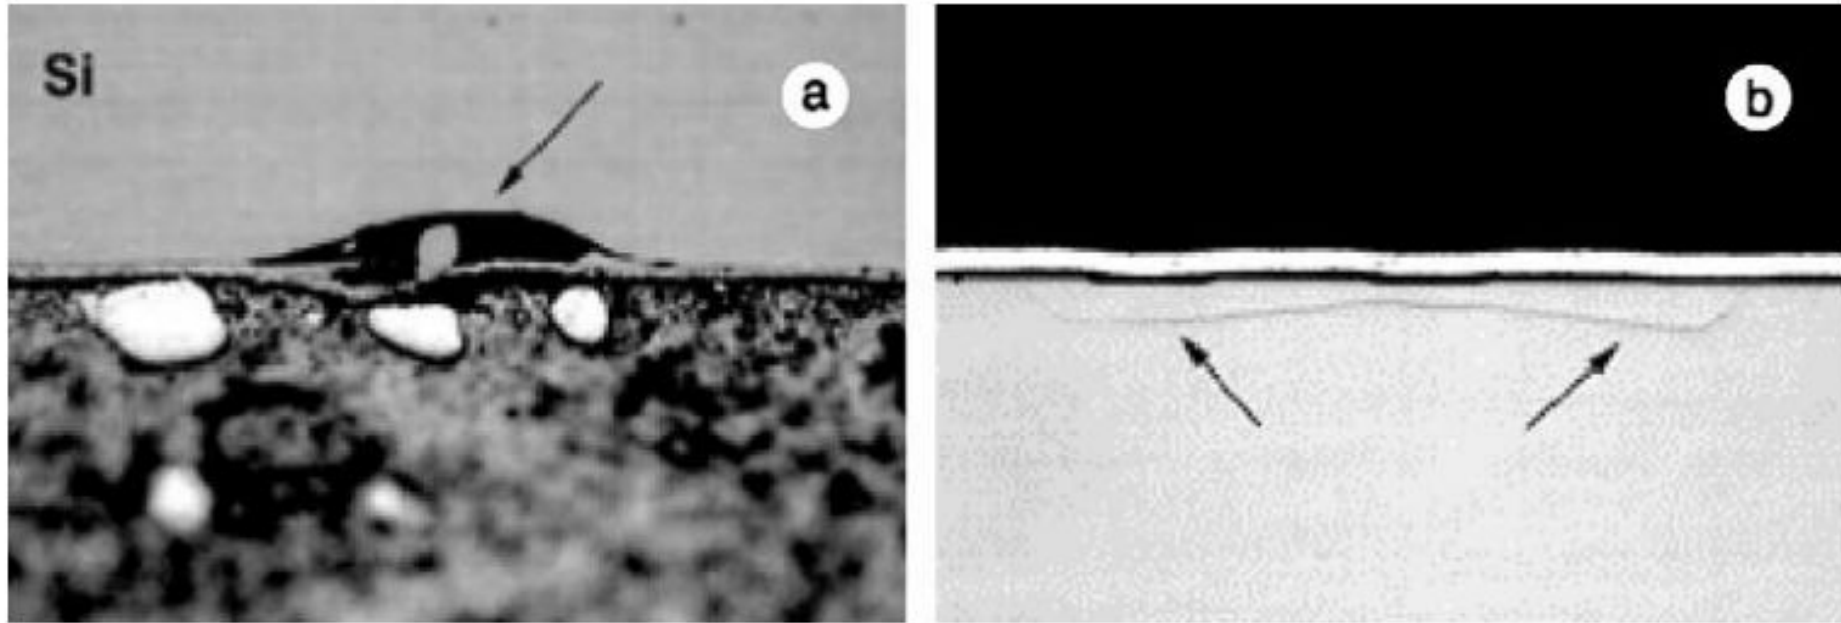
Fig. 12. (a) Notch in the silicon chip (micro-section, optical image, 250 \times). (b) Crack in the silicon chip due to bending stresses in the base plate (micro-section, optical image, 300 \times).

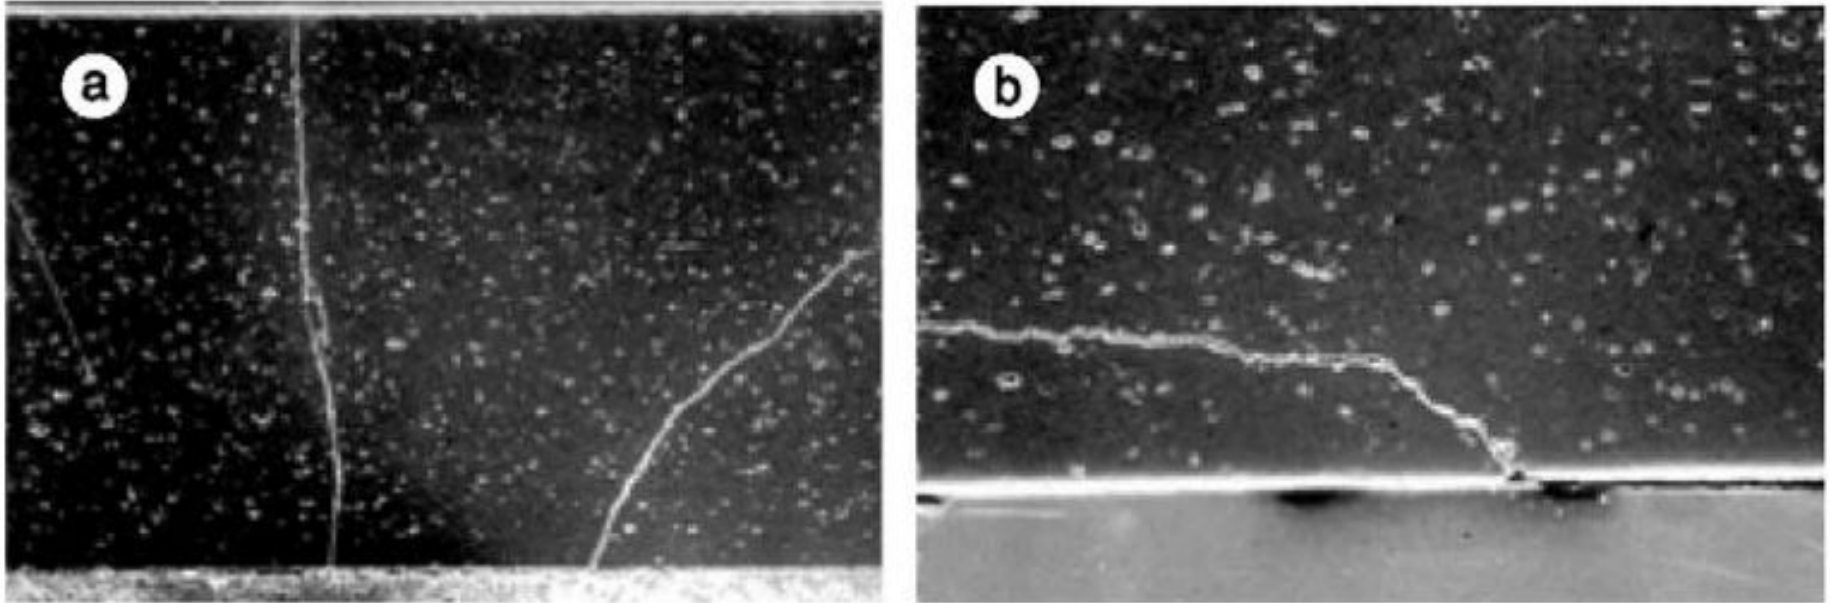
Fig. 13. (a) Vertical crack within an Al₂O₃ ceramic substrate, due bending stresses (micro-section, SEM image, 400×). (b) Crack within an Al₂O₃ ceramic substrate initiated from an inhomogeneity in the solder layer (micro-section, SEM image, 600×).

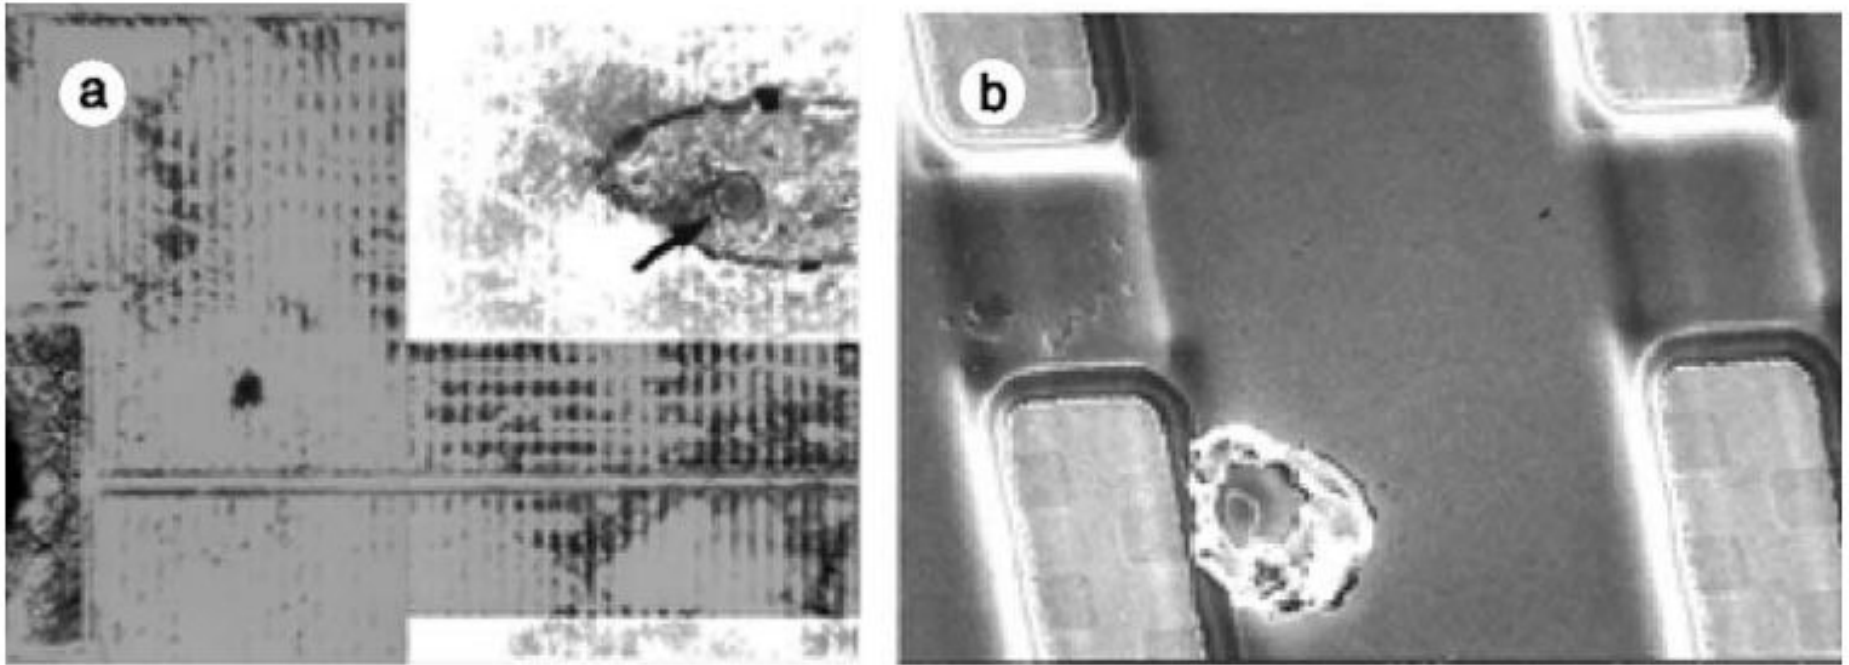
Fig. 14. (a) Localization of a leakage path between emitter and gate by liquid crystal microthermography (80 \times). (b) The hot spot is located below an emitter bond wire, and it is due to a mechanical damage of the polyoxide (SEM image 500 \times).

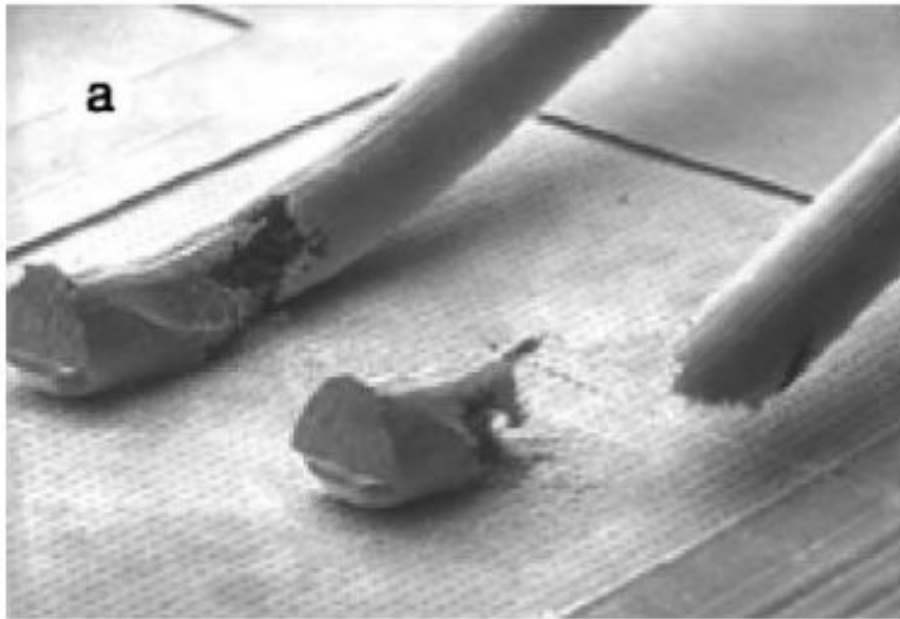
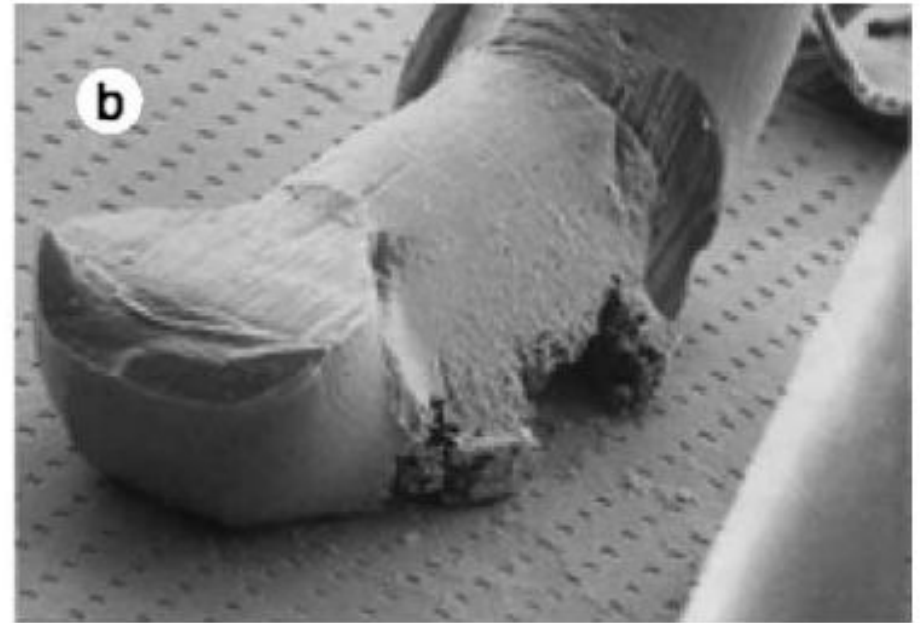
Fig. 15. (a) Rupture of emitter bond wires due to stress corrosion (SEM image, 30 \times). (b) Detail of a corroded emitter bond wire (SEM image, 80 \times).

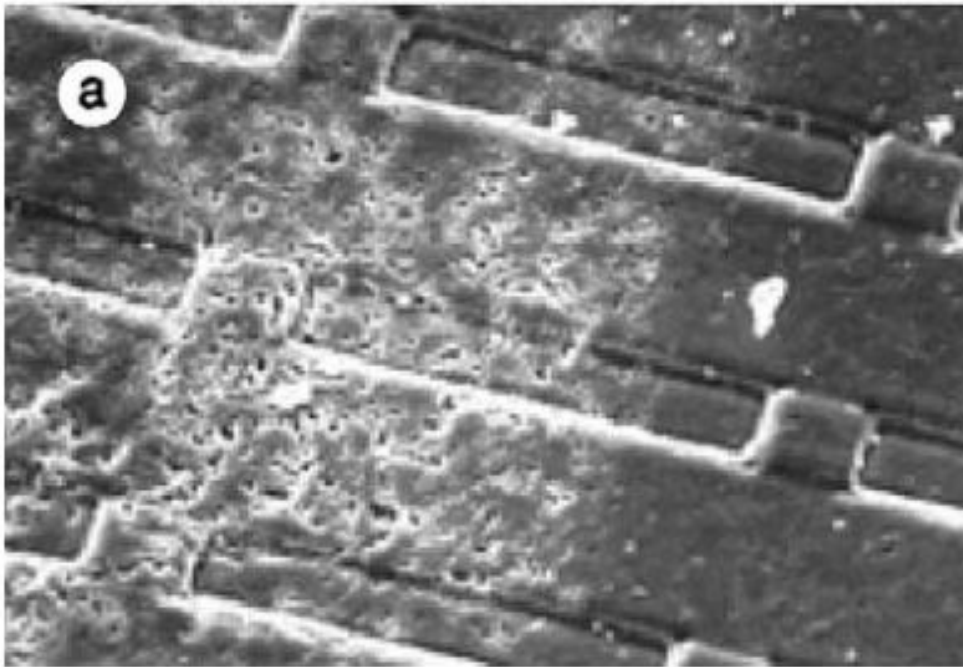
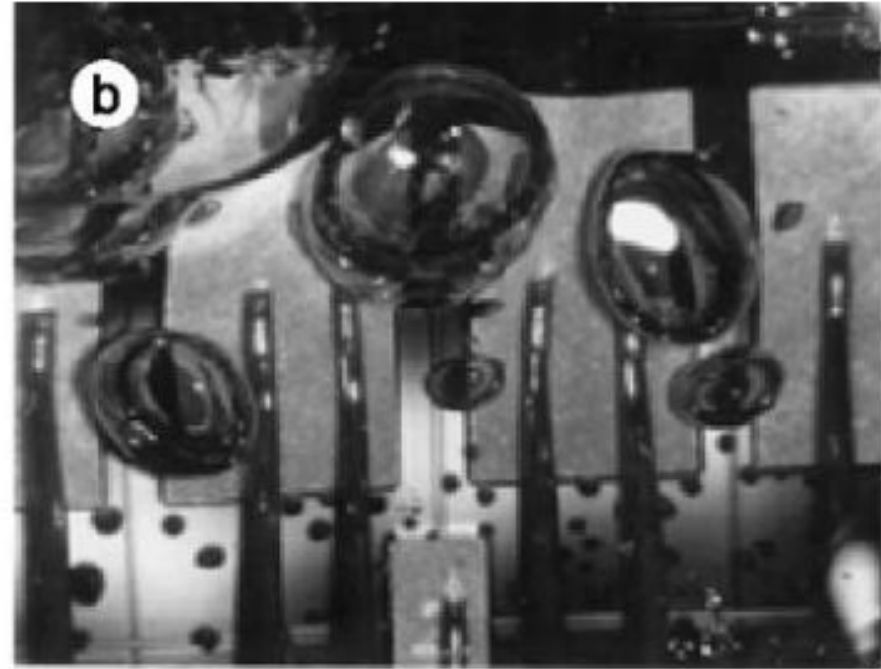
Fig. 16. (a) Corroded emitter bond pad close to an emitter bond wire (SEM image, 160 \times). (b) Formation of gaseous inclusions into the silicone gel during power cycling (optical image, 8 \times).

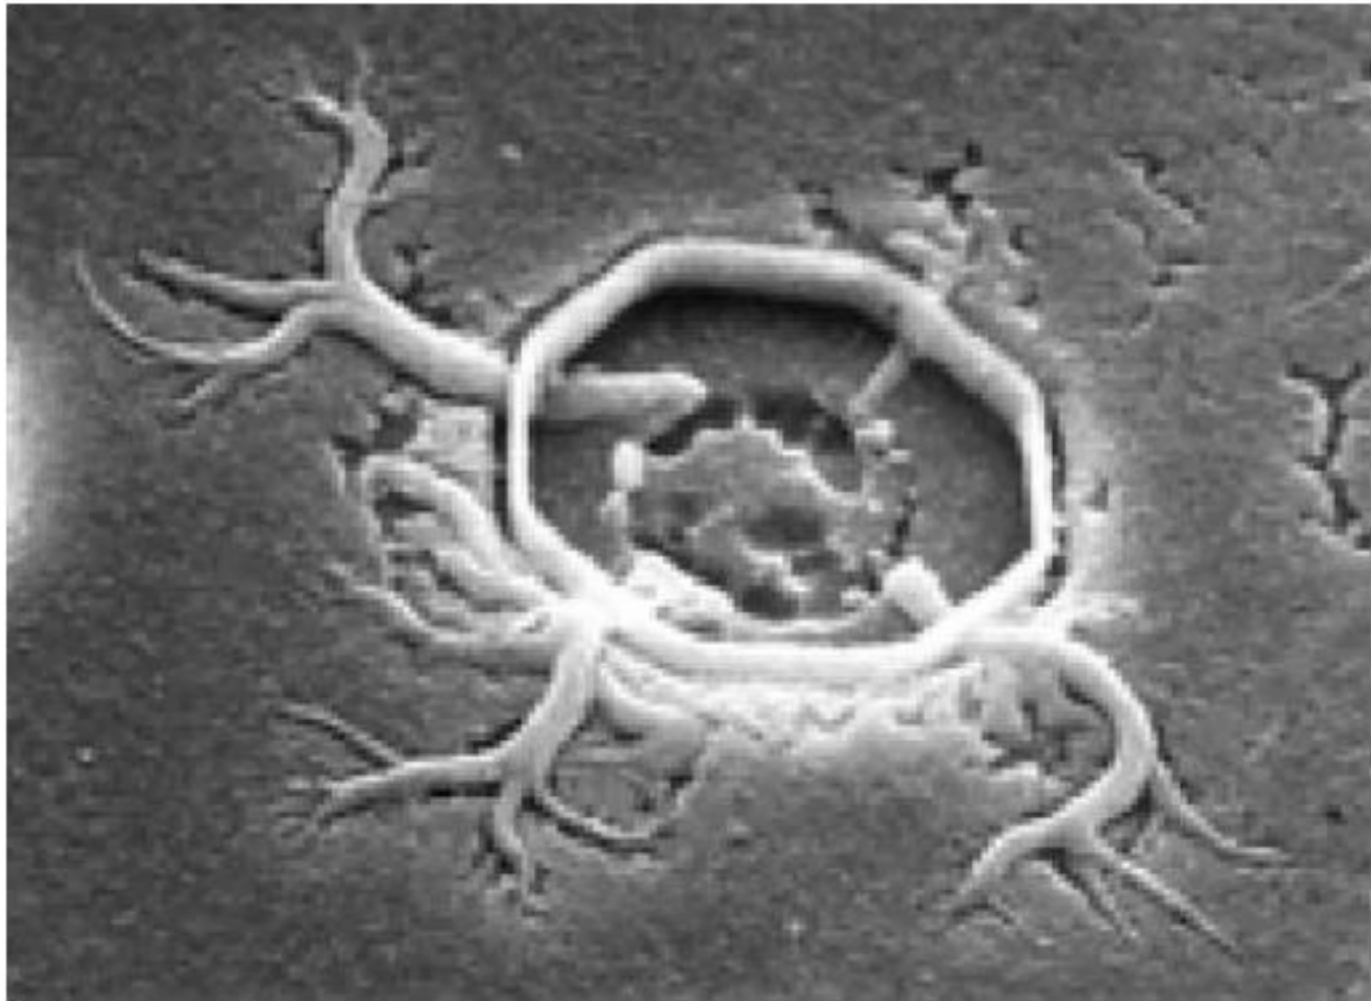
Fig. 18. Polysilicon filamentation in an IGBT as a consequence of a short circuit between gate and emitter, due to pre-damaged insulation during wire bonding (SEM image, 2000 \times).

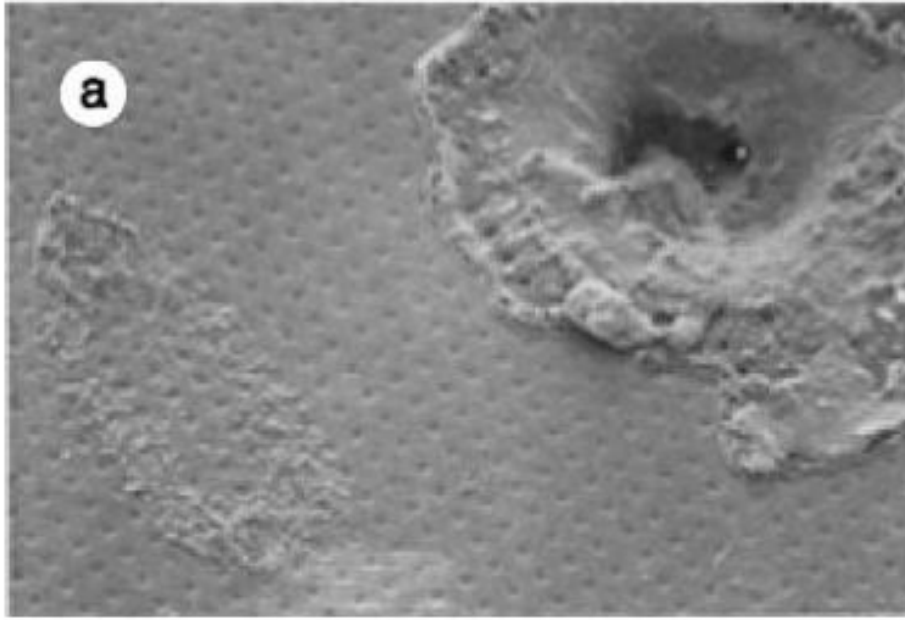
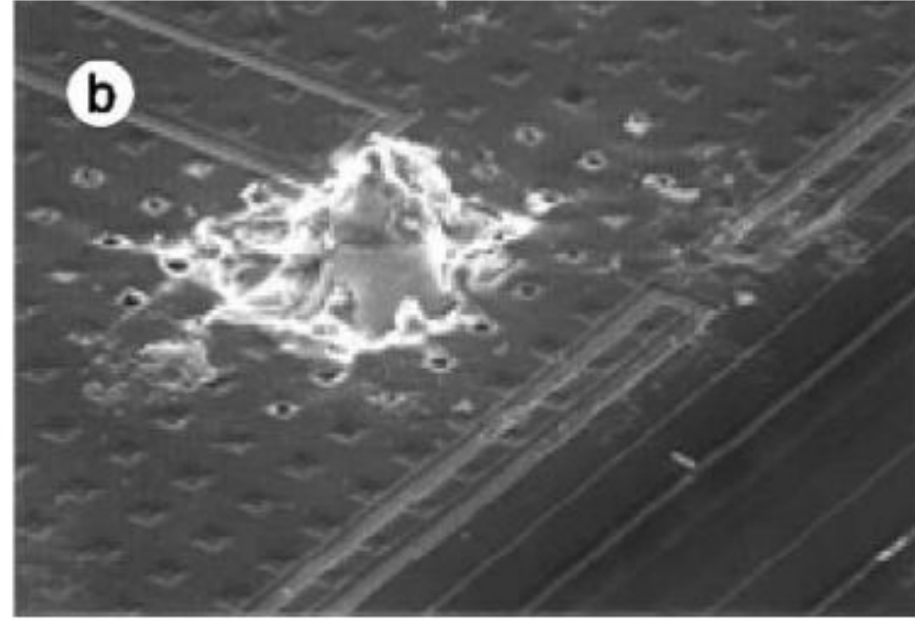
Fig. 20. (a) Melted pit in an IGBT due to a latch up event, which occurred in conjunction with bond wire lift off (SEM image, 50 \times). (b) Same effects than in the previous image but localized to some few cells (SEM image, 90 \times).
