Extreme ice-jam flood at the junction of the Sukhona – Yug – Malaya Northern Dvina Rivers near the town of Velikiy Ustyug in spring 2016

Mikhail Georgievsky

(State Hydrological Institute, St. Petersburg, Russia)

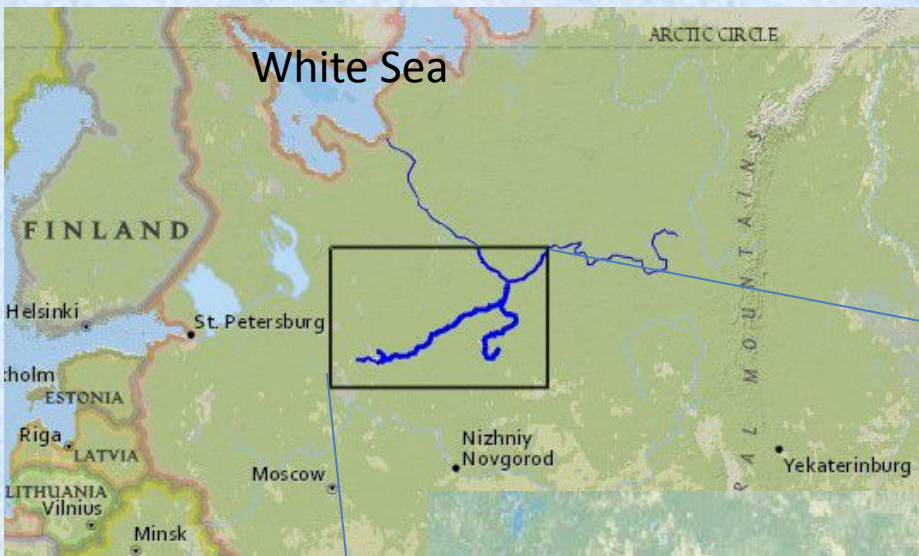
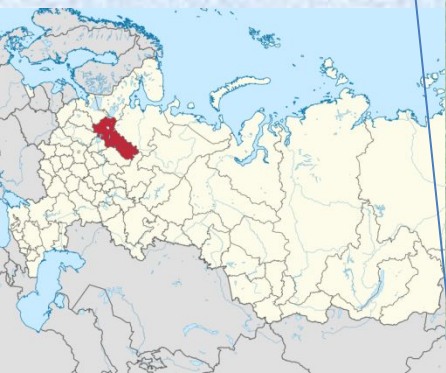
The Sukhona joins the Yug near the town of Velikiy Ustyug, forming the Northern Dvina, one of the biggest rivers of European Russia

The Sukhona is 558 kilometers long, and the area of its basin 50 300 km²

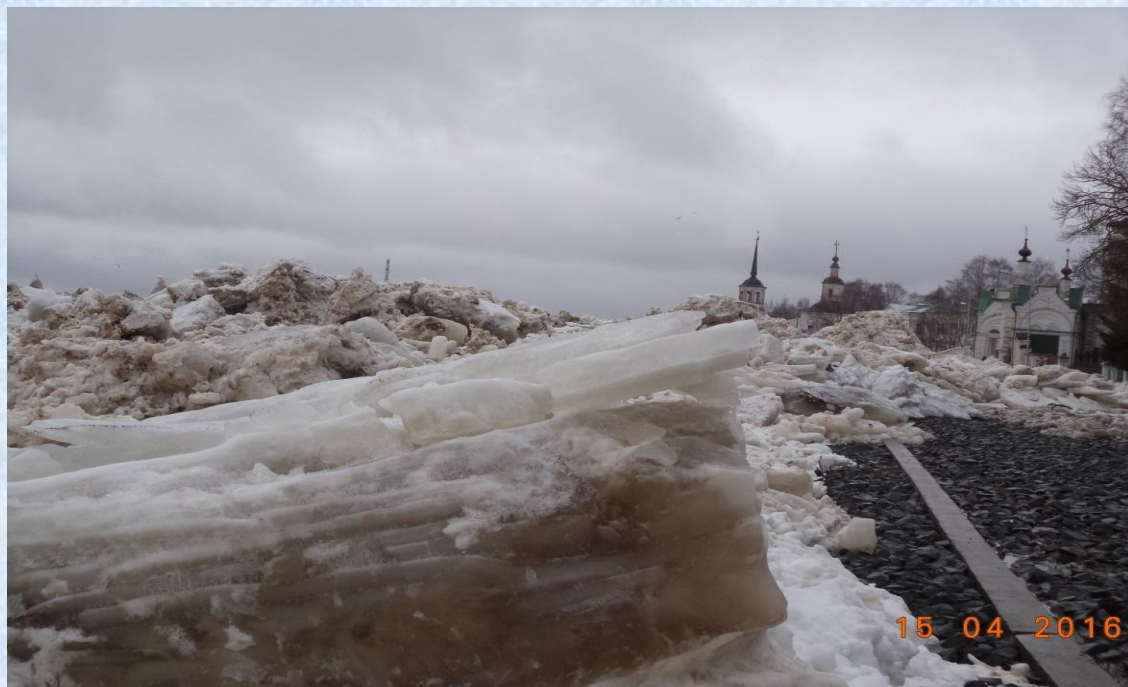
Embankment in Velikiy Ustyug
April 15, 2016

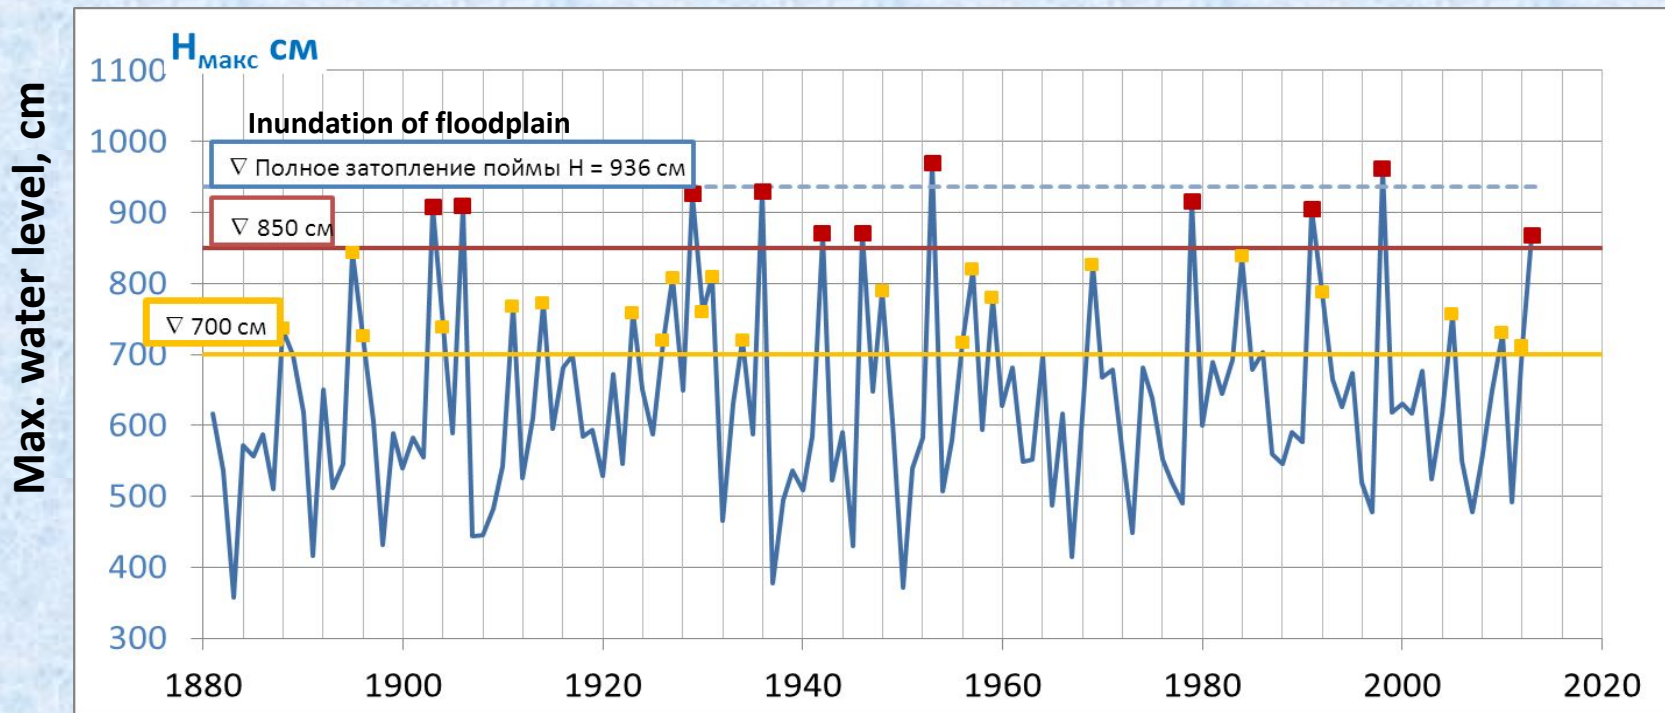
During 1877-2013 (observation period) there were 11 floods with the rise of the level above 8.5 m and 22 floods with the level rise above 7 m

Most floods were caused by ice jams

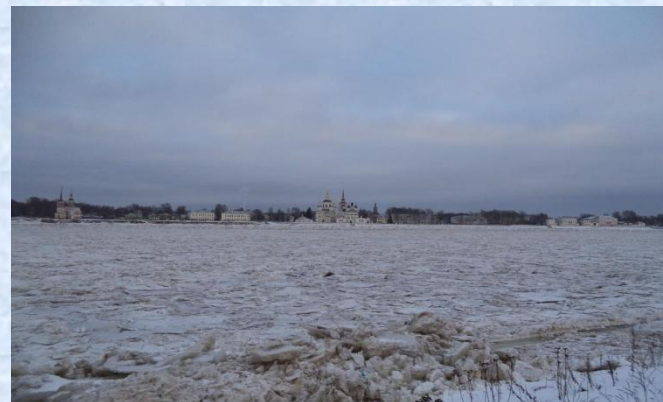
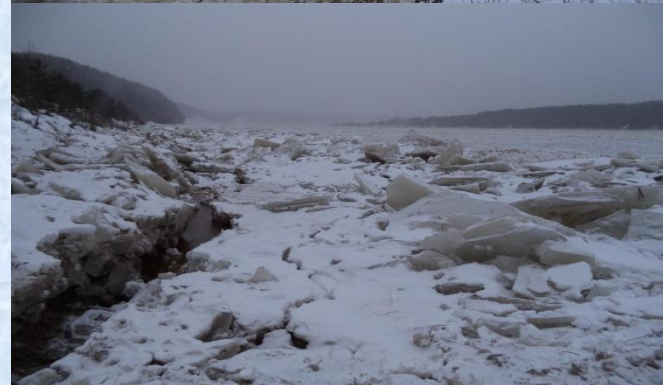
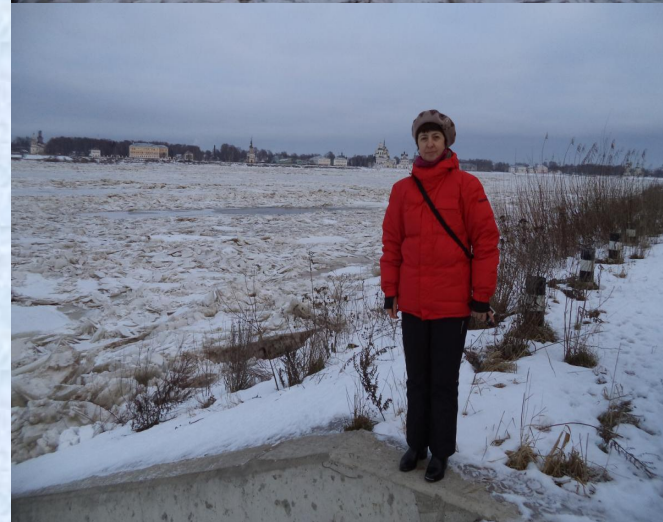
**Ice jam on the Sukhona River
November 26, 2015**

Наиболее мощный осенний затор льда образовался на выходе реки Сухона на реку Северная Двина, ниже г. Великий Устюг. 23 декабря у г. Великий Устюг был зафиксирован самый высокий уровень воды для декабря за весь период наблюдений 1881-2015 гг. - 674 см, превысивший среднемноголетний ледоставный уровень на 4-5 м.

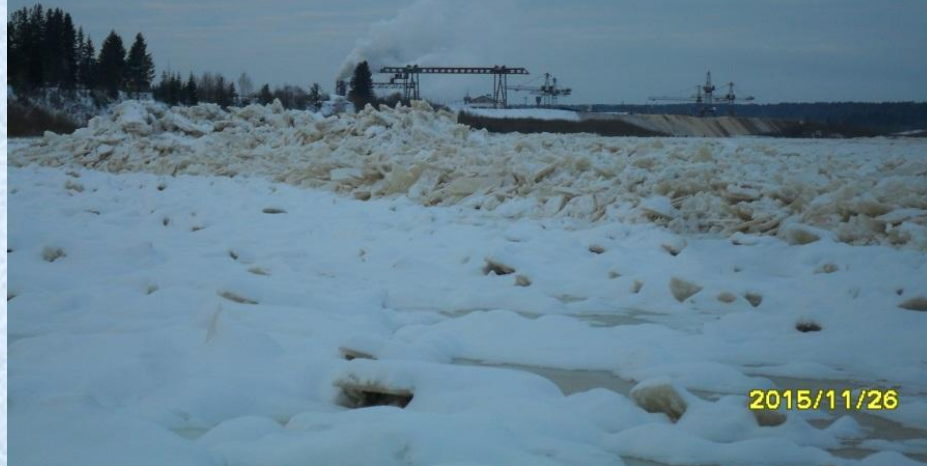
2015/11/26

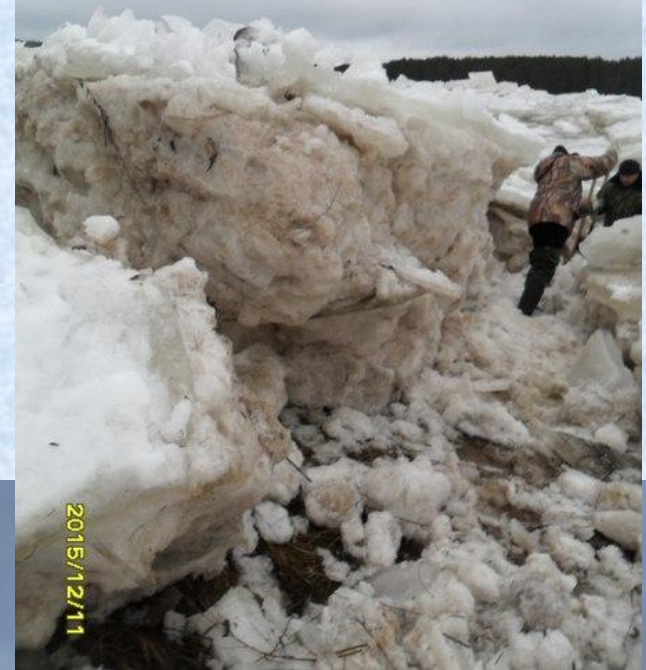
**Ice piles
December 12, 2015**

2015/12/11

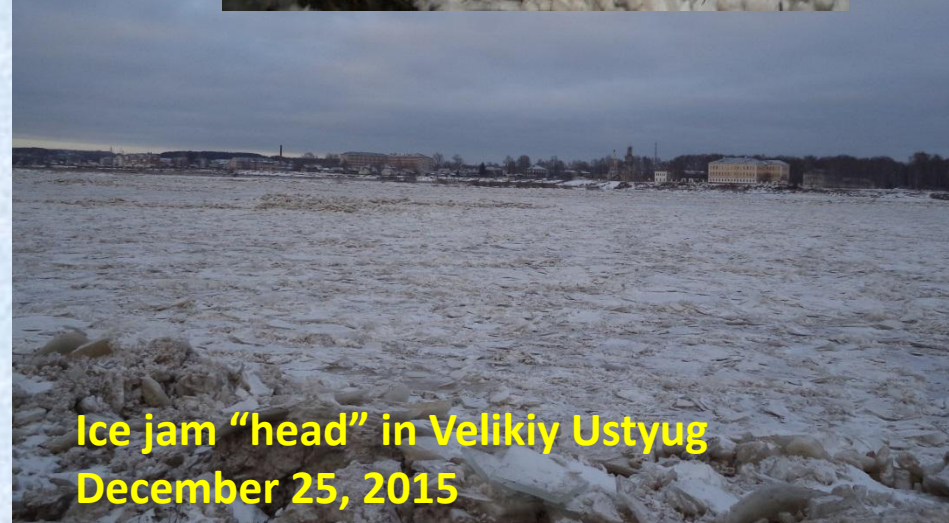
**Ice jam "head" in Velikiy Ustyug
December 25, 2015**

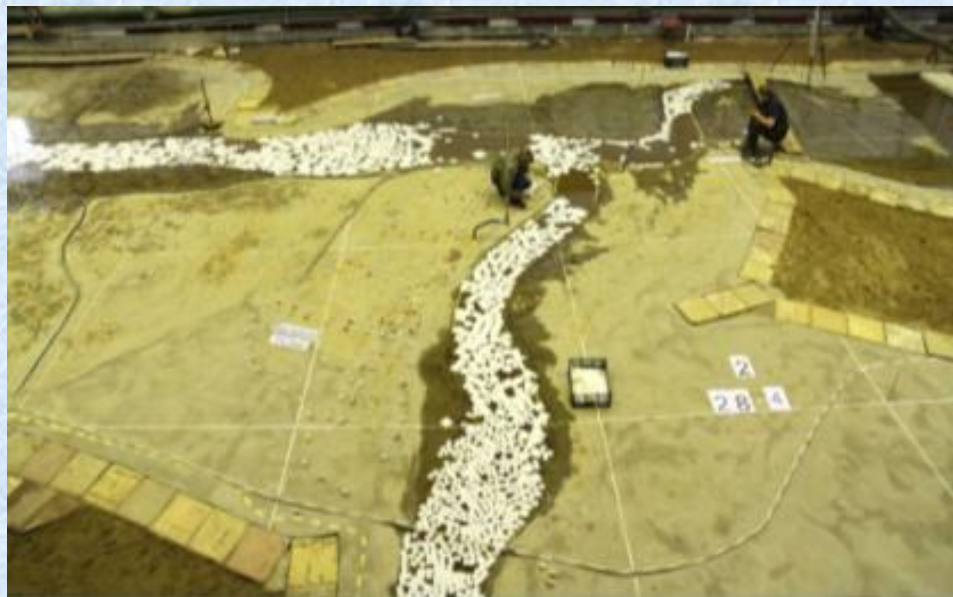
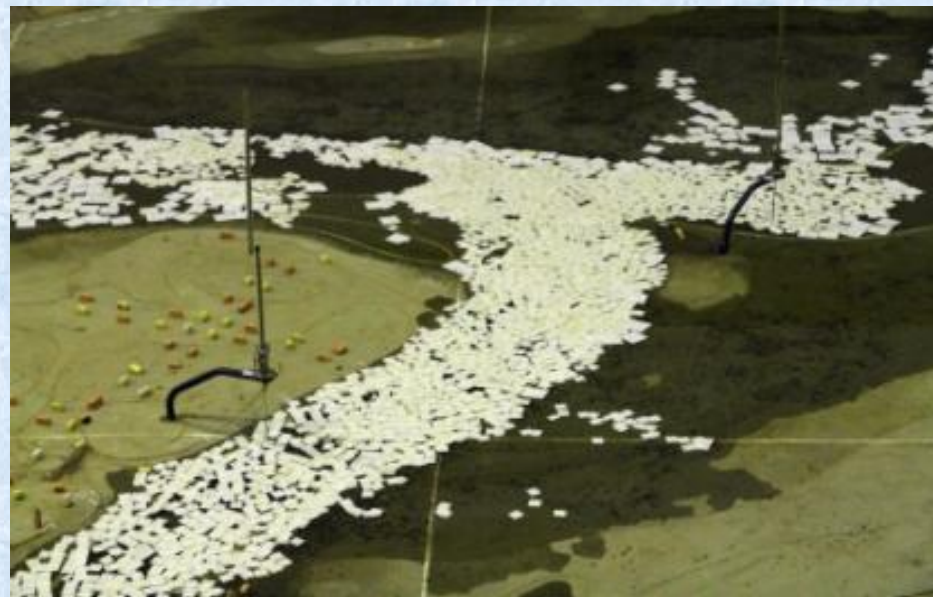
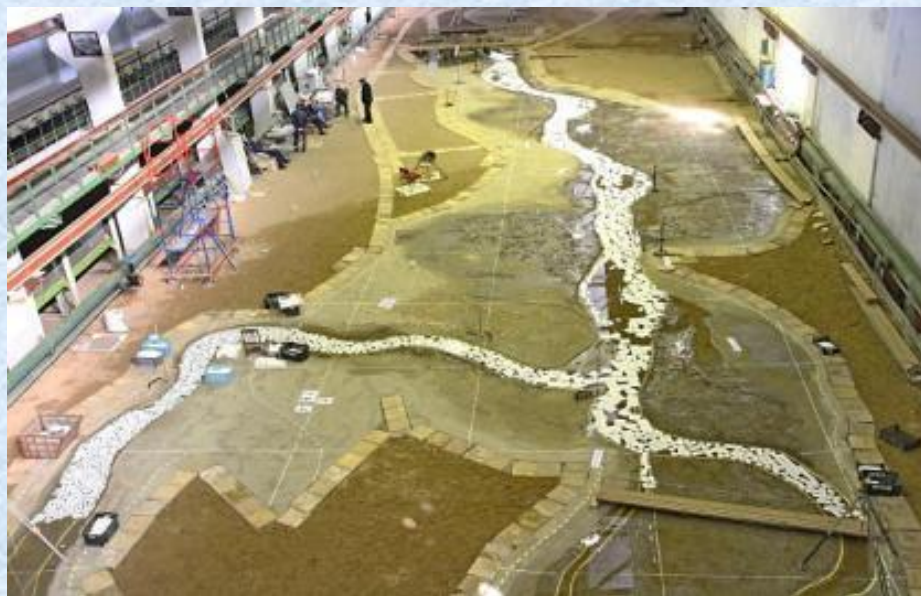
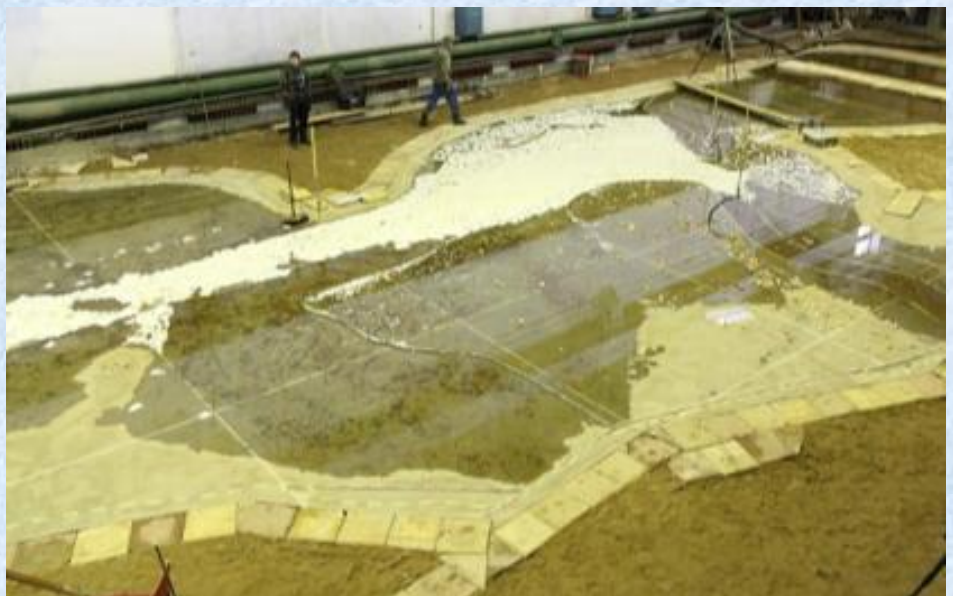
Model of the junction of the Sukhona, the Yug and the Northern Dvina rivers created in the framework of the specialized research project (2013-14) by the department of channel processes of SHI

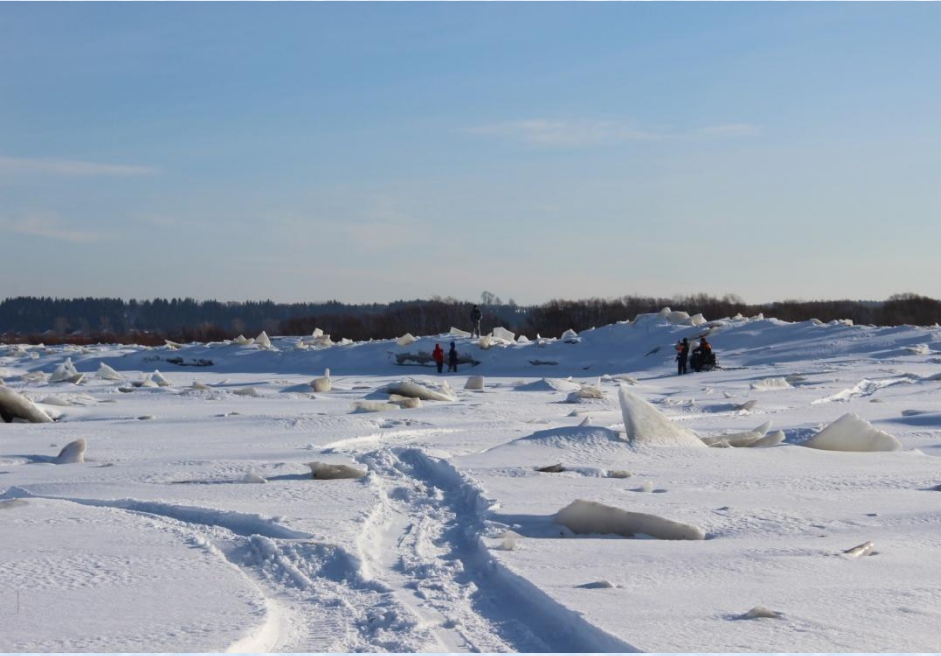
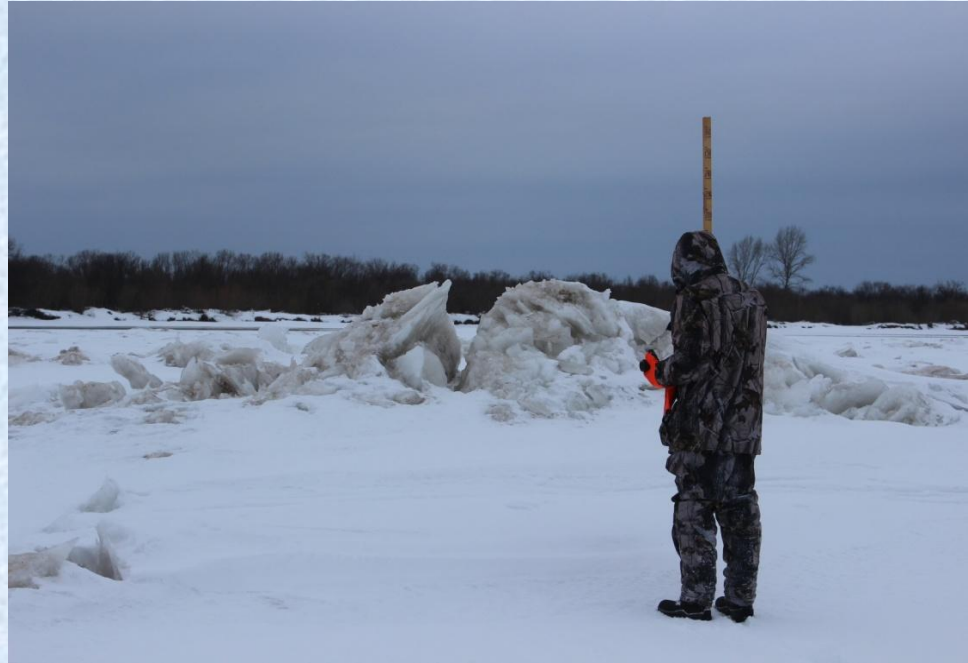
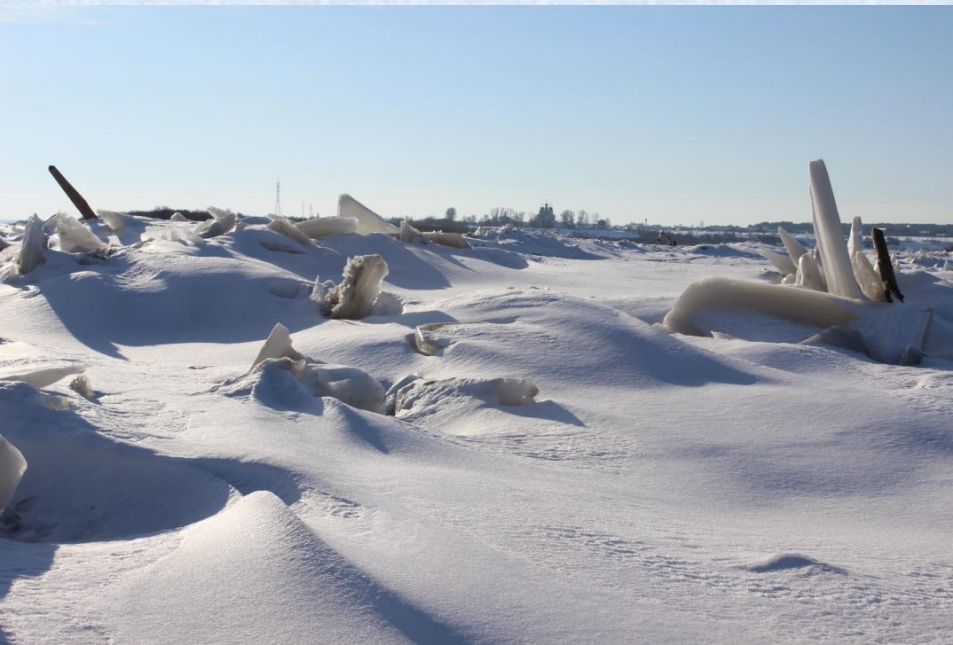
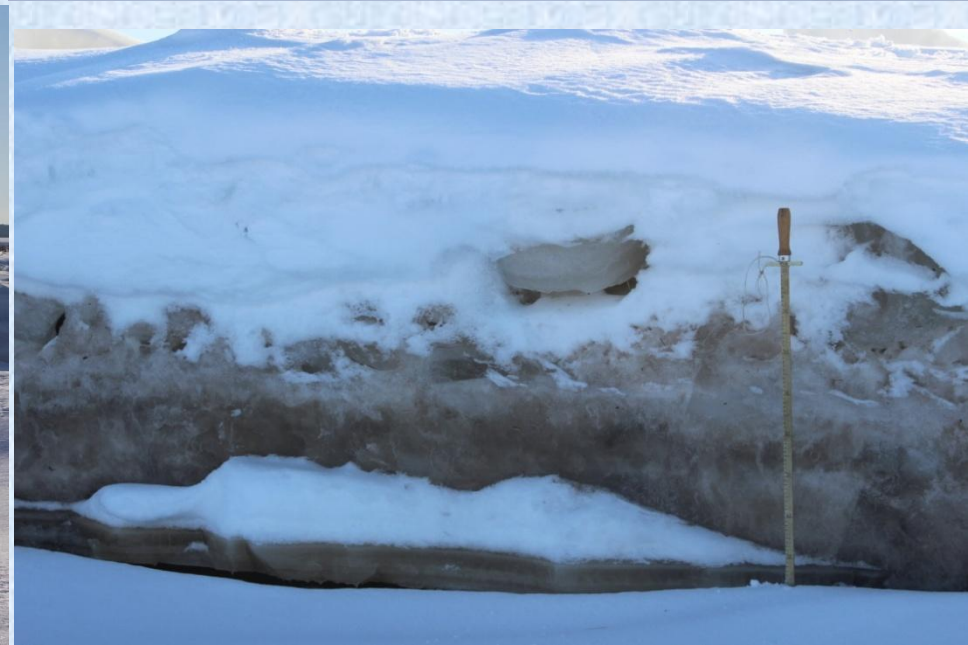
Formed ice jam

Ice cover was drilled along a cross-section line usually in 30-50 meters (depending on the width of the river and the state of the ice cover). Then at each point the following characteristics were measured:

- depth of the river (direction and velocity of flow in some cases);
- thickness and structure of ice cover layer;
- thickness of the slush layer (brash ice layer);
- height of snow cover (SWE);
- height of nearby hummocks (torosses);
- photo and GPS fixations.

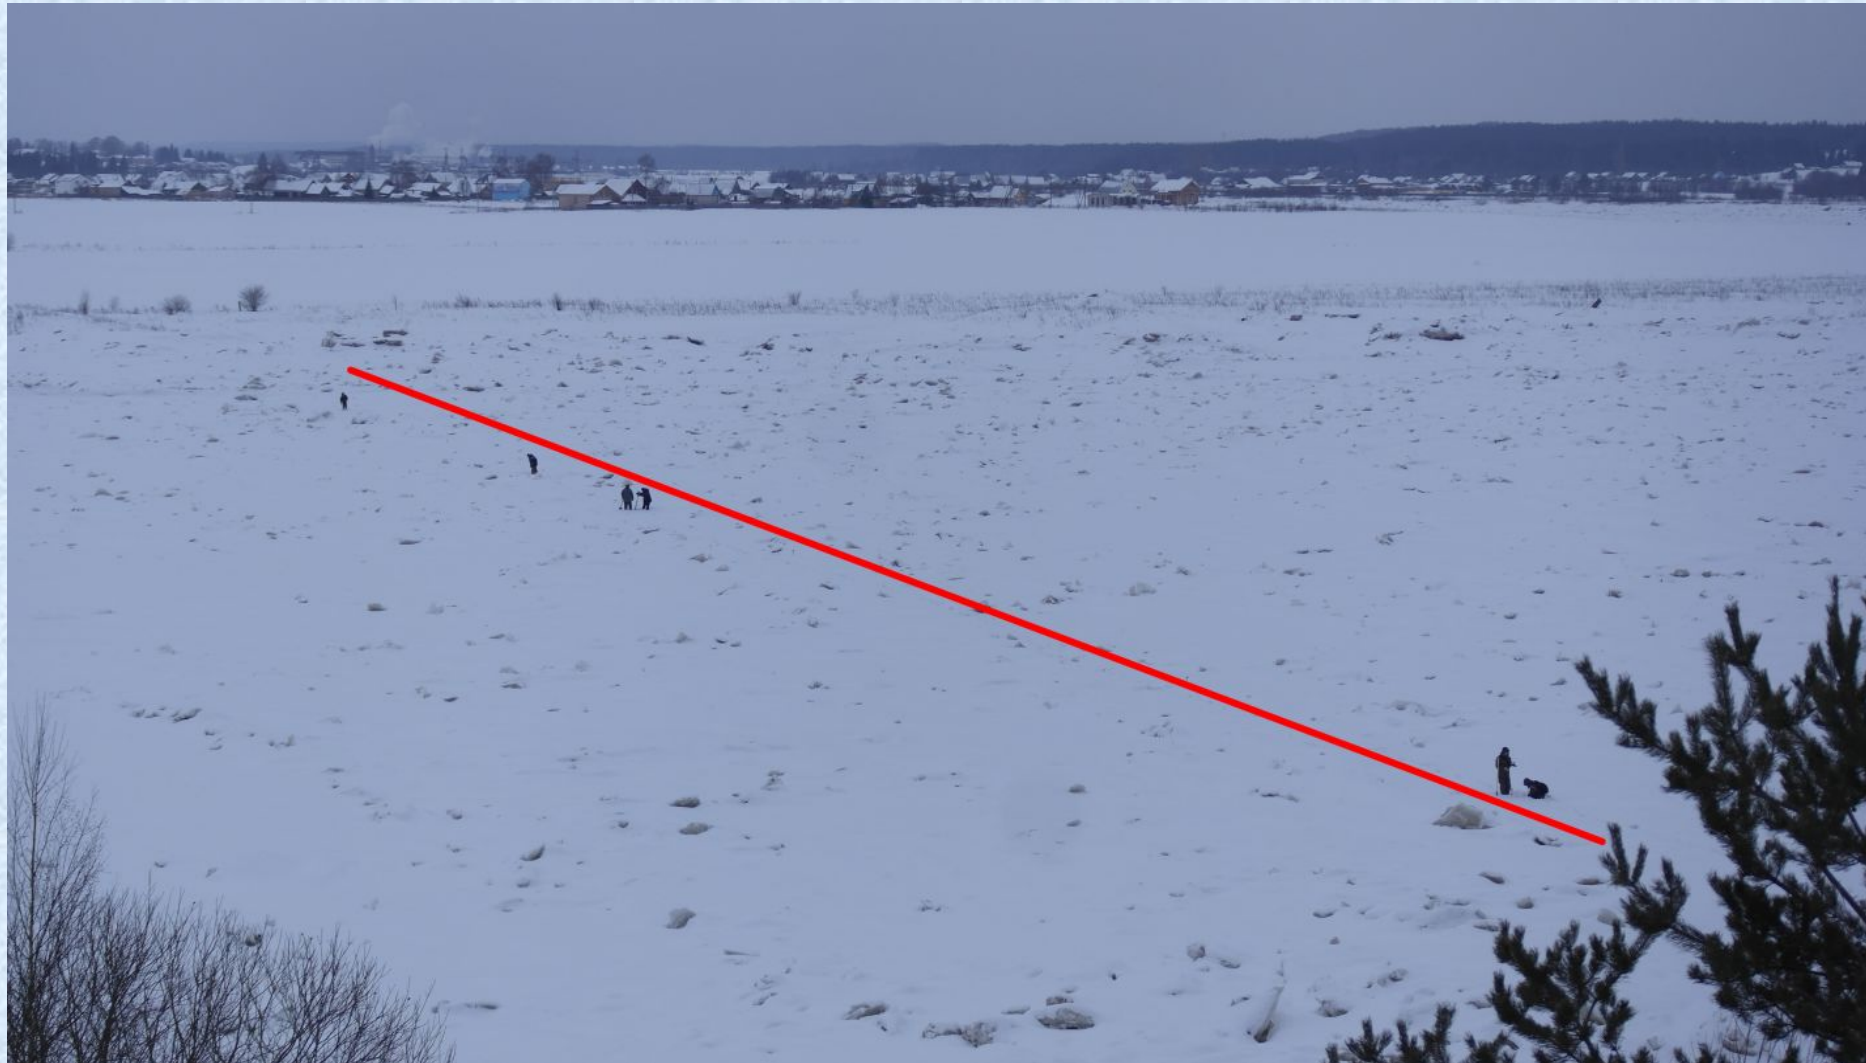
Implementation of hydrological measurements along the cross section No. 16 (red line) (500 m upstream of the road bridge in Velikiy Ustyug)

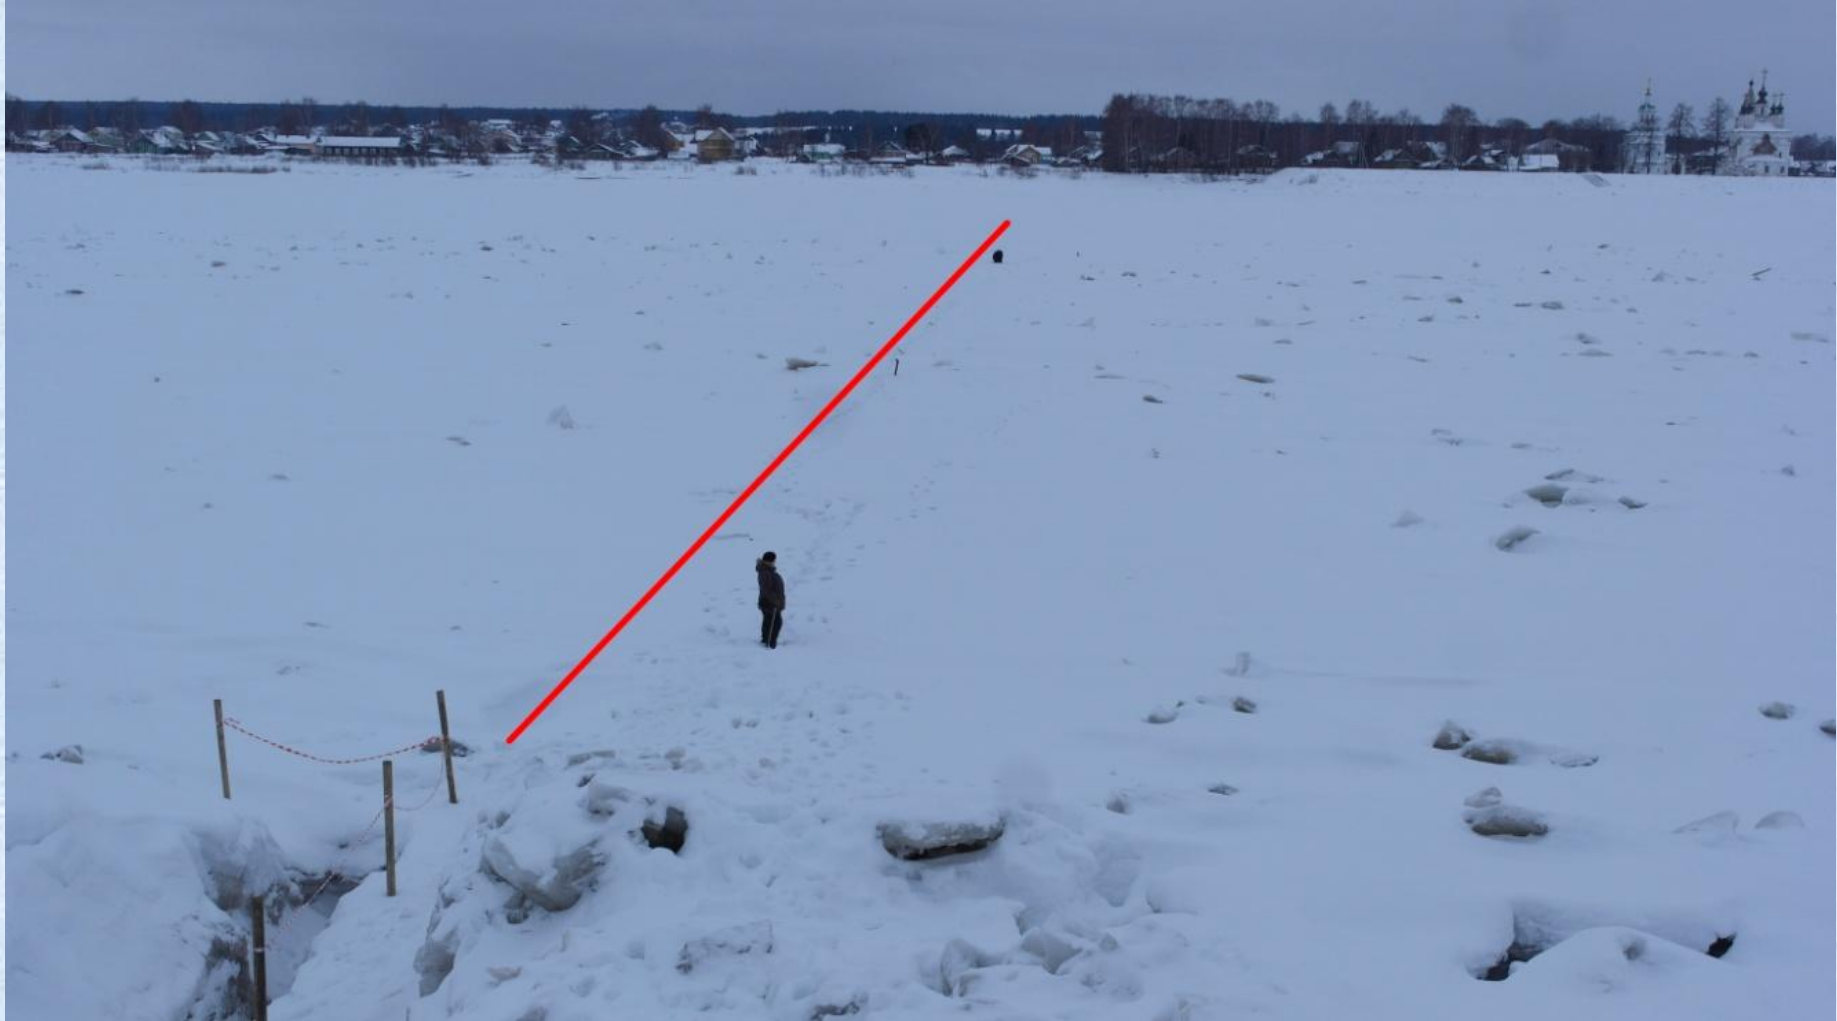
Implementation of hydrological measurements along the cross section No. 14 (red line) (at Velikiy Ustyug gauge station)

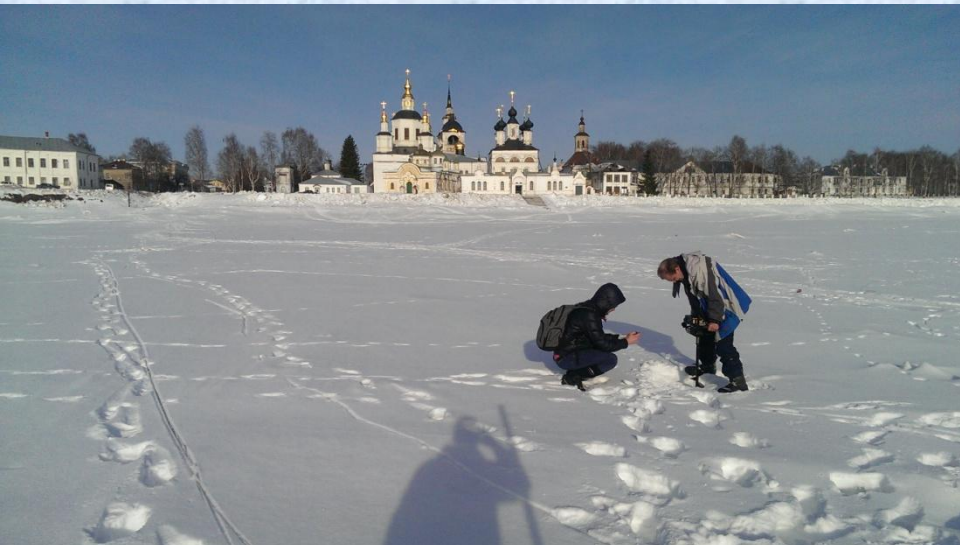
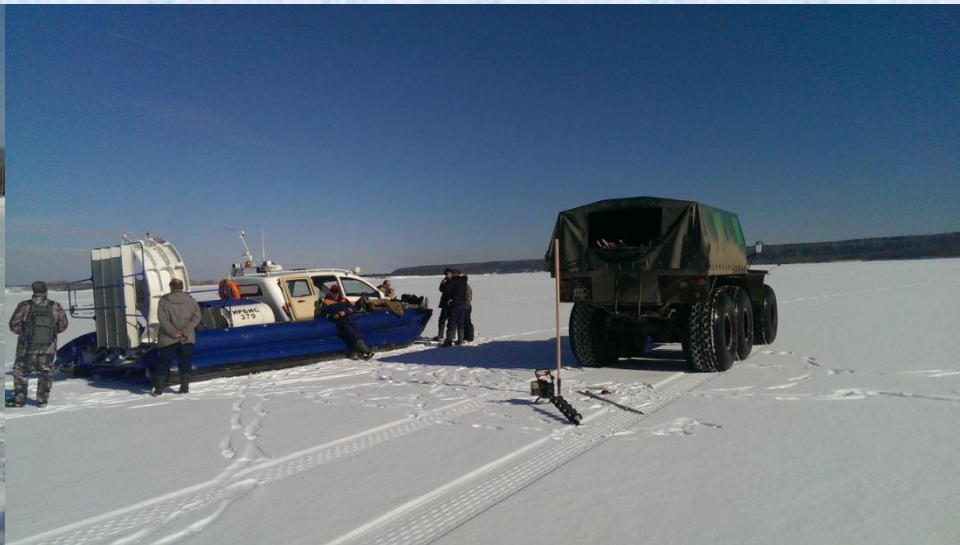
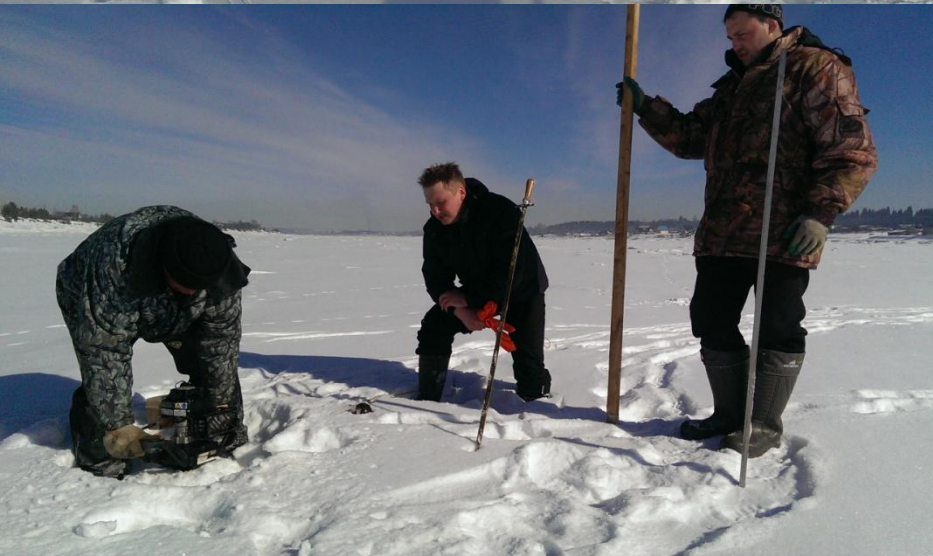
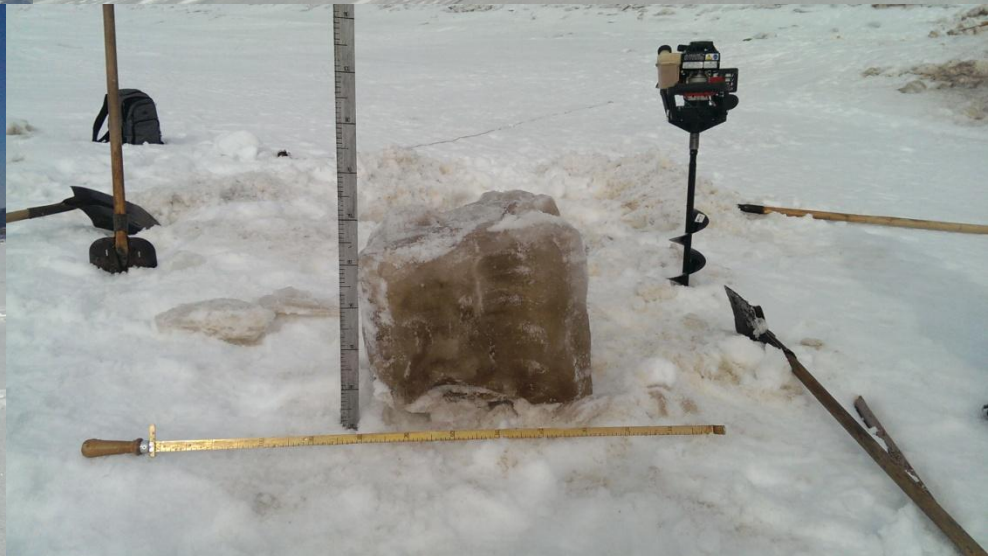
At the end of March 2016, repeated measurements were made at the cross-sections located at the most significant sections of the ice jam.

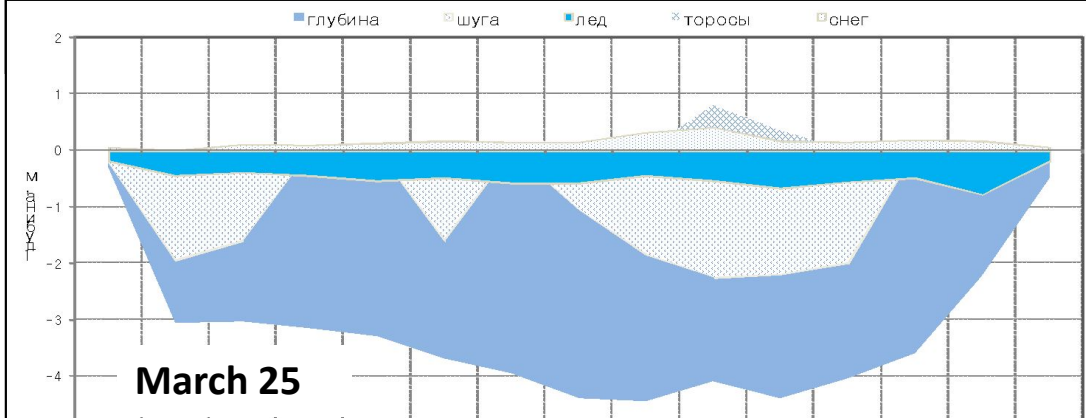
The analysis of the field research results carried out in February and March on the Sukhona River (profile section No. 4)

Area of ice:
increased by 56 m²

Area of ice brash:
decreased by 64 m²

- **During the interval between measurements in February and March, ice thickness increased and the slush layer decreased.**

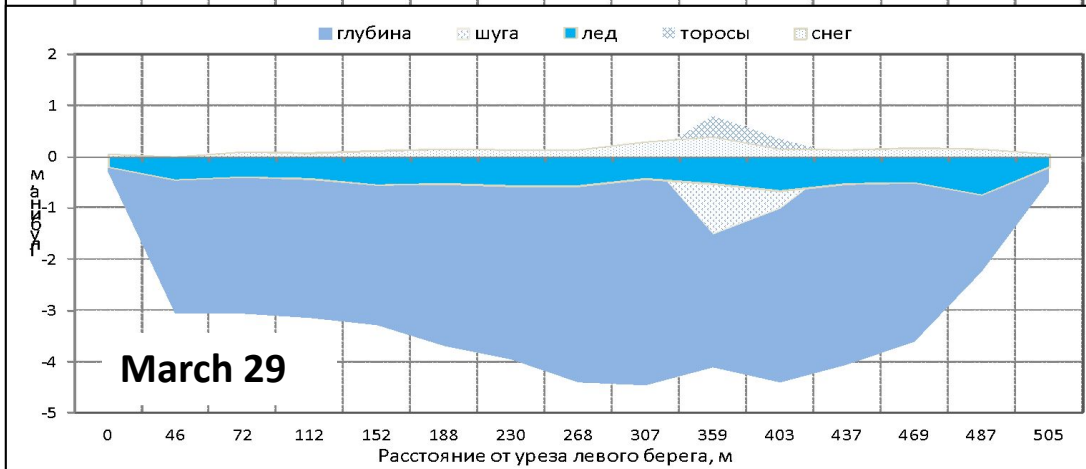
March 25, 2016
Implementation of blasting upstream of the river

Area of ice:
didn't change

Area of ice brash:
decreased by 416 m²

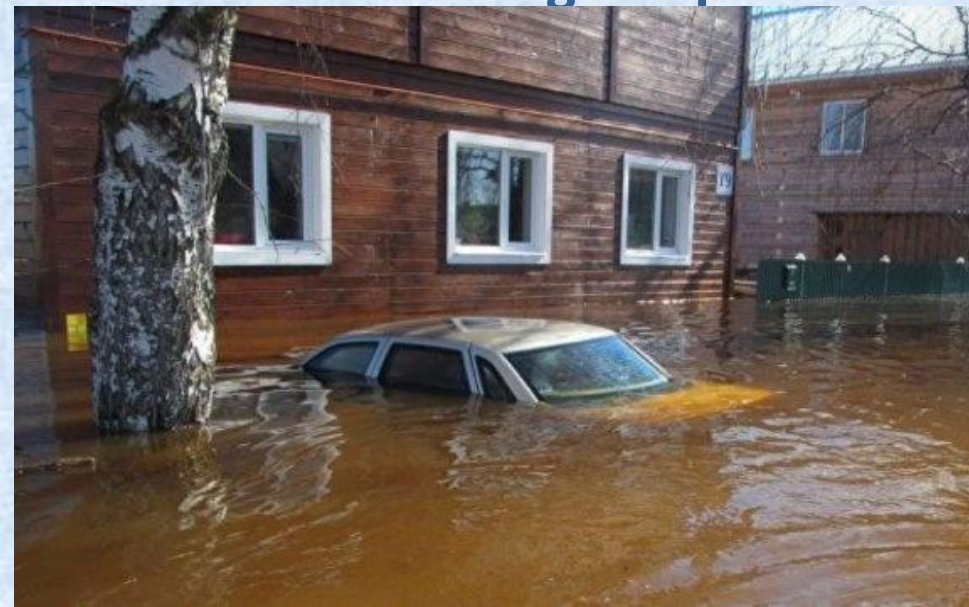
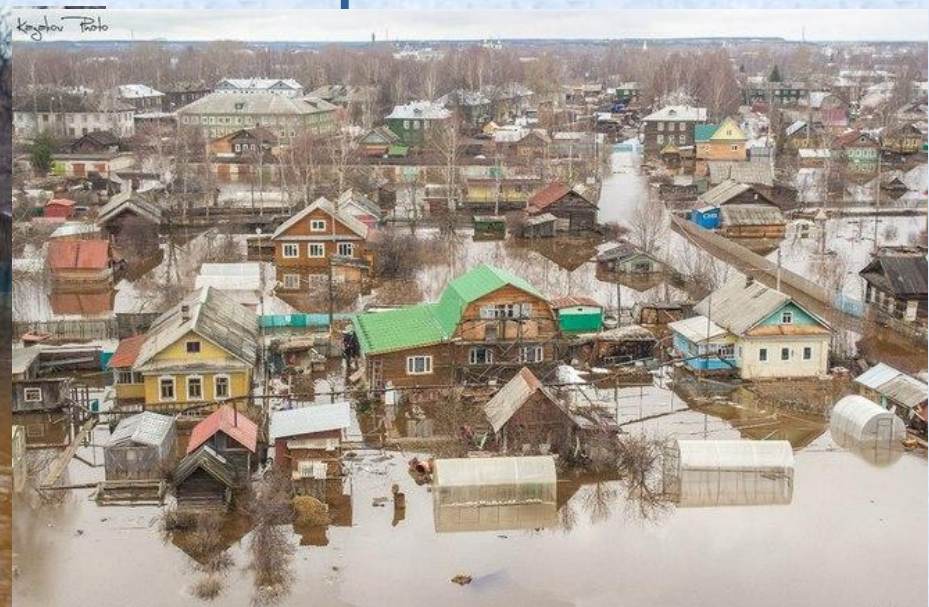
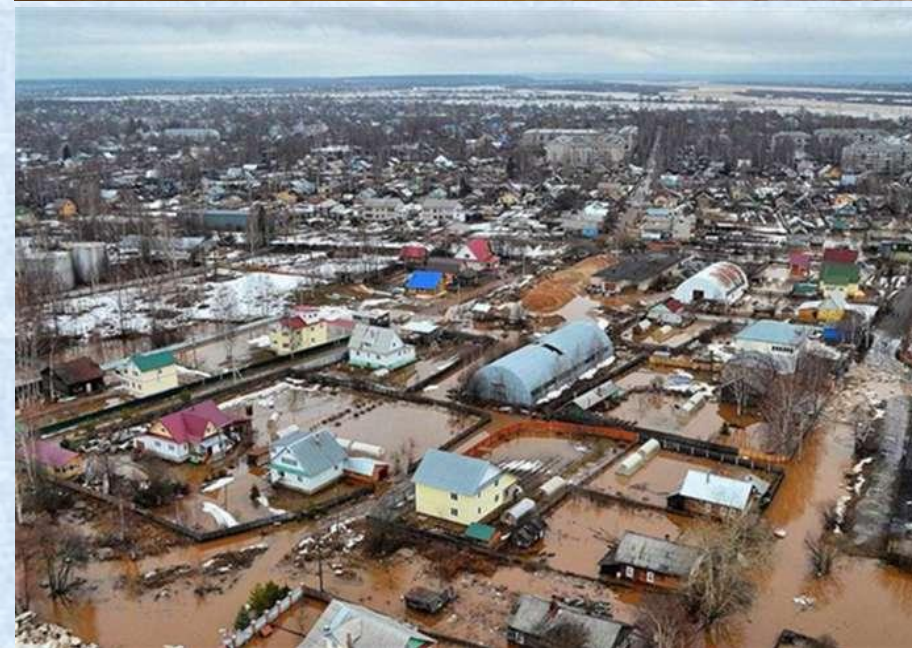
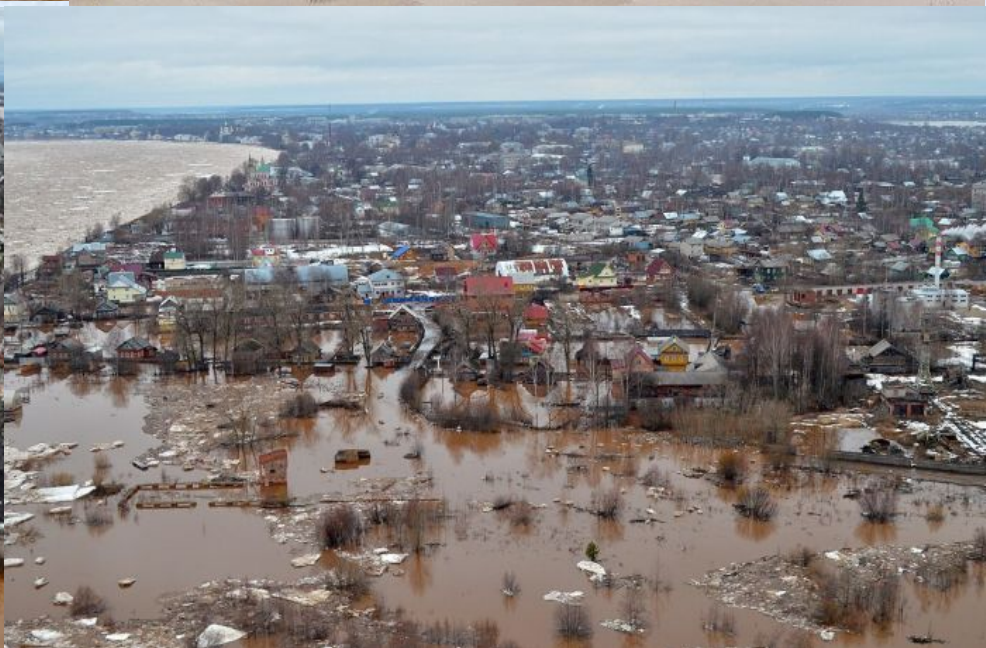
Catastrophic ice-jam flood in Velikiy Ustyug and its environs during in April 2016 and its consequences

За время стояния затора в г. Великий Устюг и населенных пунктах вокруг него было затоплено 22 населенных пункта, почти 3 тысячи придомовых территории с населением 7,5 тысяч человек.

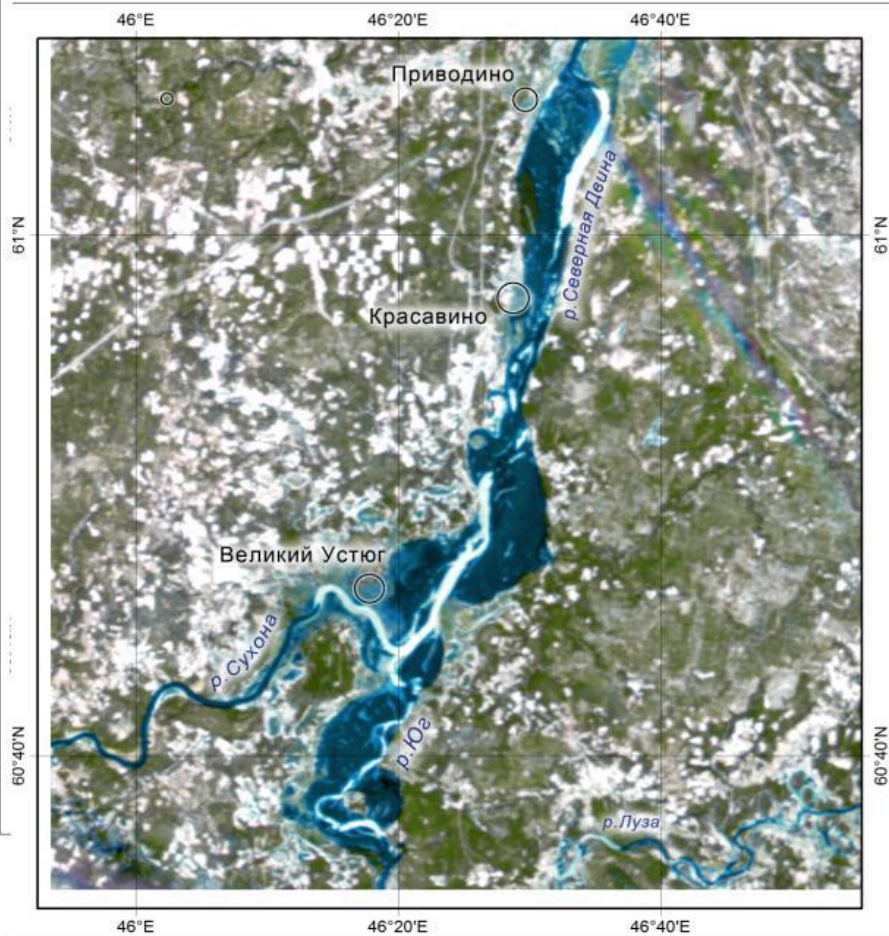
ИСЗ "Метеор-М" №2, КМСС, разрешение 50 м, 18.04.2016 06:39 UTC
спектральные каналы R: 0,76-0,90 мкм; G: 0,63-0,68 мкм; B: 0,535-0,575 мкм

Цветосинтезированное изображение р. Северная Двина и ее притоков
