T.Bechtel, S.Ivashov, V.Razevig, V.Zhuravlev, L.Capineri, P.Falorni
USA Russia Italy

**Using of holographic subsurface radar at the surveying
and reconstruction of cultural heritage objects
in Russia and Italy**

IWAGPR21, Valletta, Malta, 1-4th December 2021

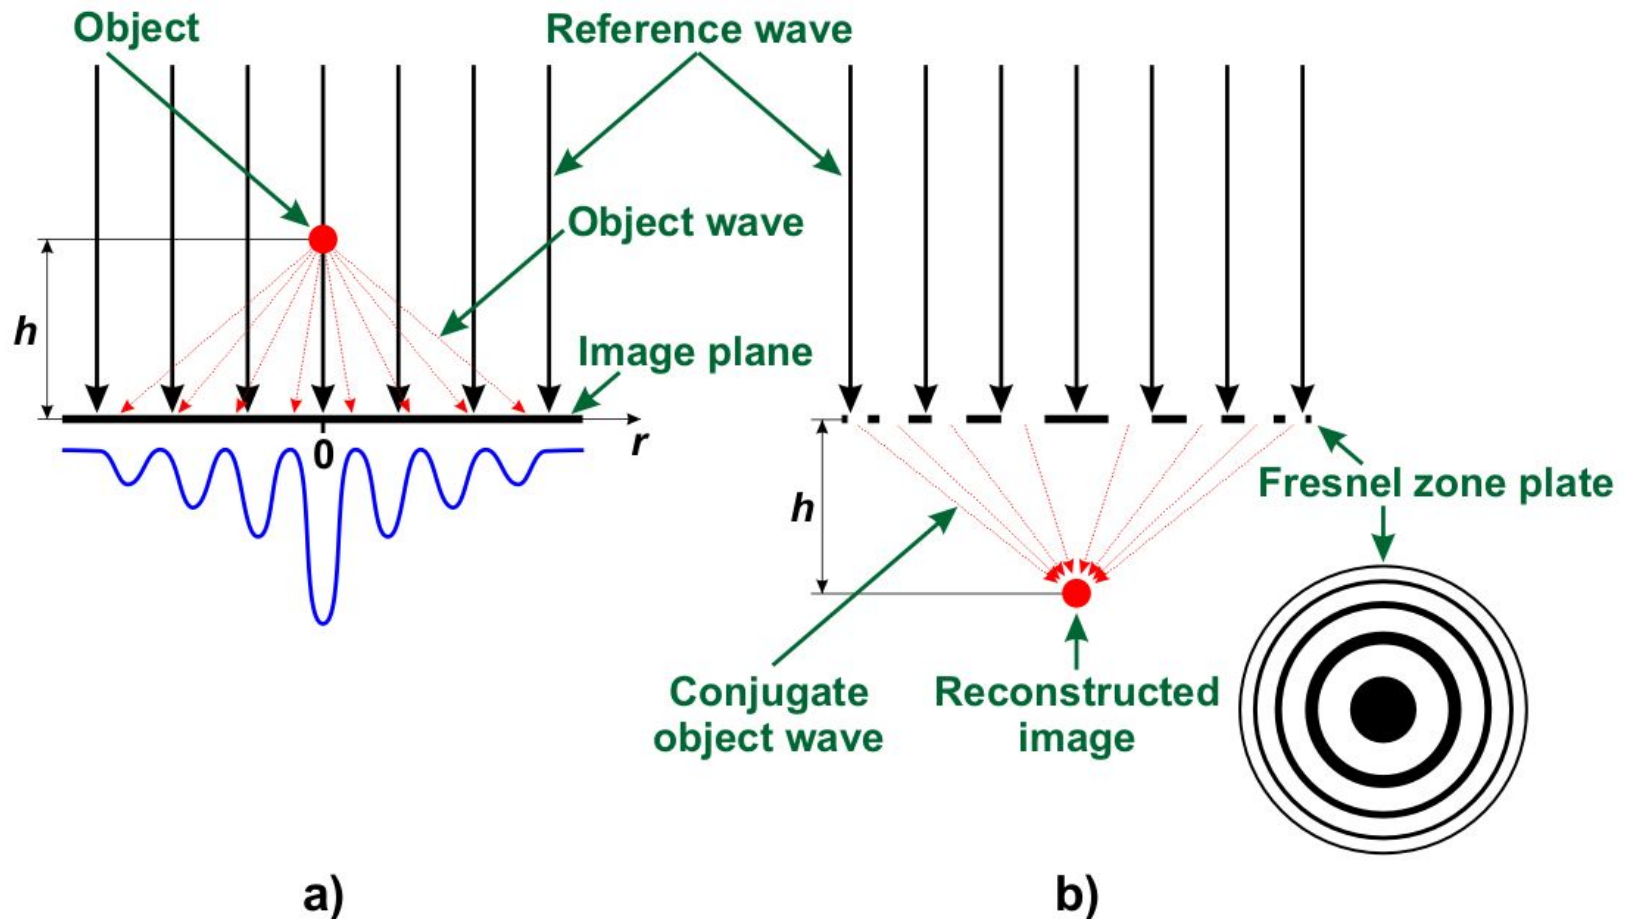
Recording a Point Source in Optical Holography and its Hologram Reconstruction

- a) Hologram registration
- b) Hologram reconstruction

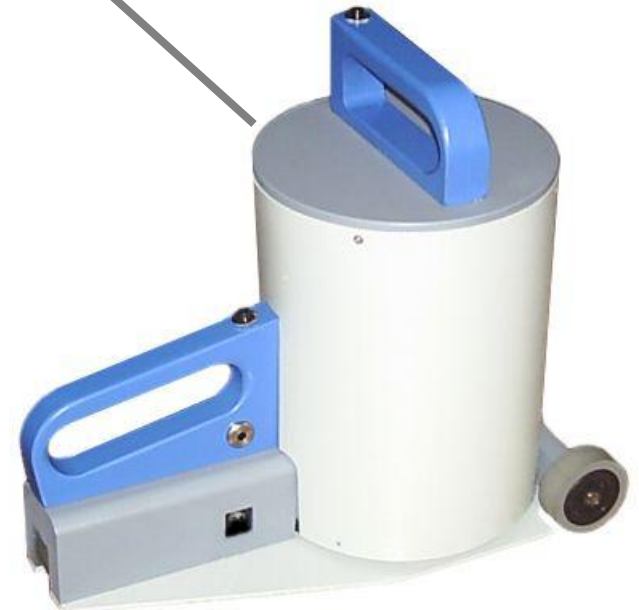
RASCAN-4/2000
2 GHz

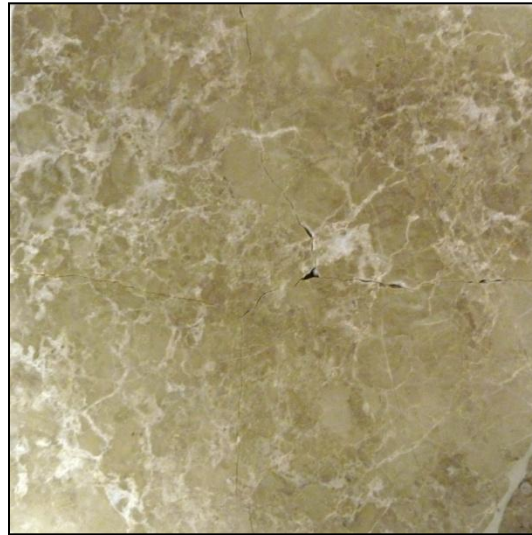
Cracks Detection

A 30cm by 30cm piece of marble contains two nearly invisible, hairline cracks; one vertical and one horizontal. At left is a RASCAN-4/4000 image of the slab with the cracks barely dampened using a fine paint brush, and right shows an IRT image of the same. In both cases, the moisture highlights the cracks. IRT image spans 1.8°C.

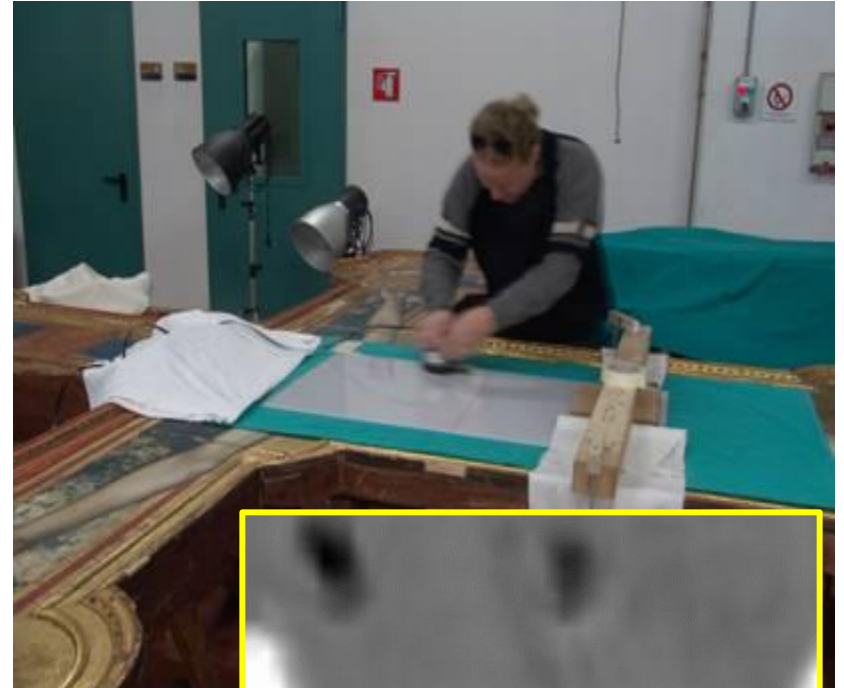
Investigation on the Croce di S. Marco

Spurt of blood.

One of the peculiarities that emerged during the survey is the presence in the radar images of a shape that follows the sketch of blood coming from the wound on the rib.

The presence of this trace was unexpected on the area painted on the golden plate. In fact, it is not plausible that a dielectric layer with a thickness of less than one tenth of a millimeter can modify the module or phase of the reflected wave.

The hypothesis that seems to be more plausible is that the paint used for the san-gue sketch contains metallic elements, and therefore can be assimilated to a non-perfect conductor. In this case, the electric field would be only partially canceled, thus resulting in a variation of phase different from 180° , from which the image above.

In the images relating to the three intermediate frequencies of the CROSS polarization the metal nails are clearly visible, which are used to hold the structural parts of the wooden cross together.

Always in CROSS polarization the image relative to the frequency of 3.7GHz shows in a particularly clear way the contrast between the area laminated in gold and the area painted on wood. In this image is clearly visible a puff placed at the blood sketch on the side.

Also in this scan the images of the fixing nails are confirmed, this time better visible in the images related to the PARALLEL polarization. Note that this scan is done in an orthogonal direction with respect to the previous one.

At the three higher frequencies, both in CROSS polarization and in PARALLEL polarization, numerous striations are visible, compatible with the flaming of the underlying wood.

This second hypothesis is confirmed by the analyzes carried out previously by the Opificio delle Pietre Dure of Florence, which highlight the significant presence of lead in the paint of the blood sketch.

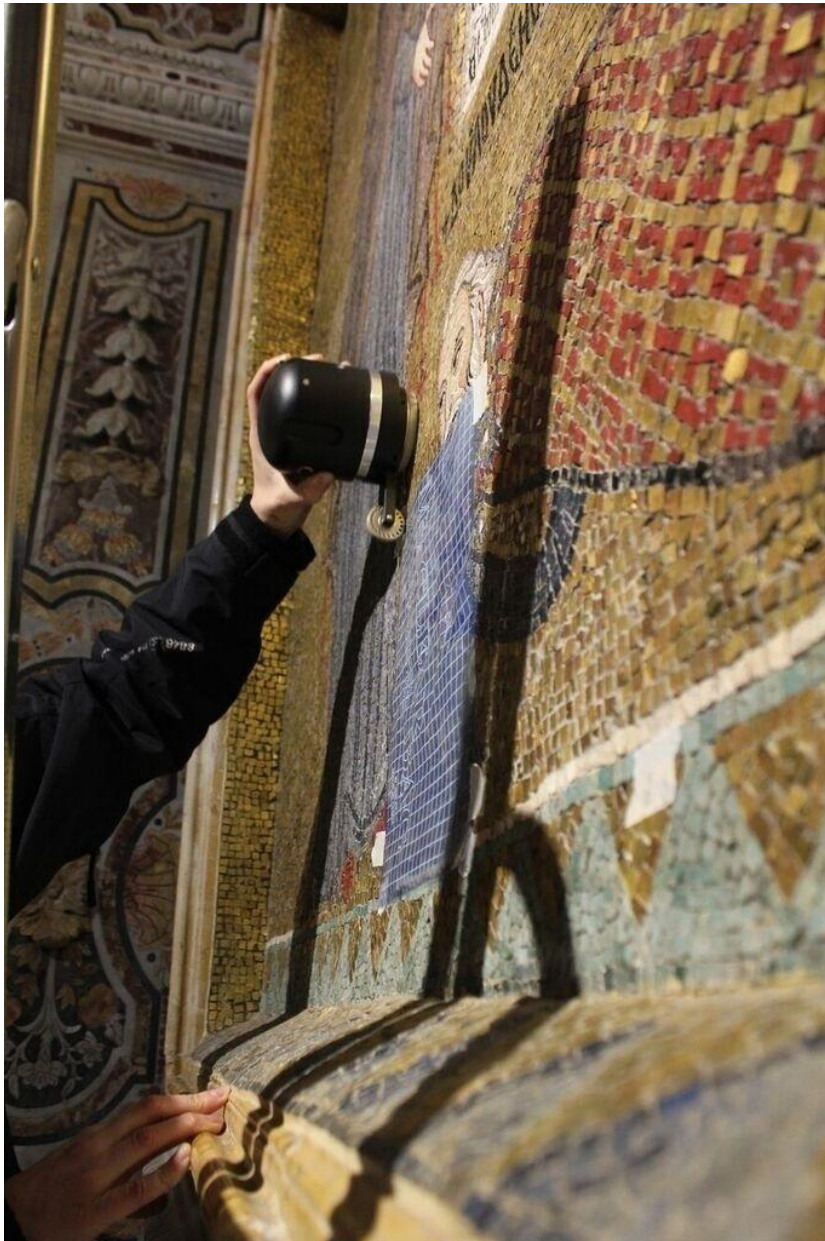
Wall mosaic "Dedication of the Church to the Virgin" investigation by RASCAN radar of the University of Padua (Italy).

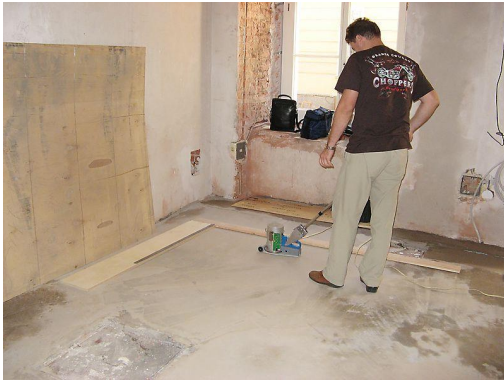
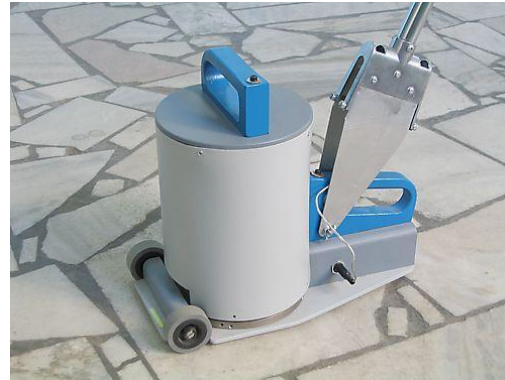
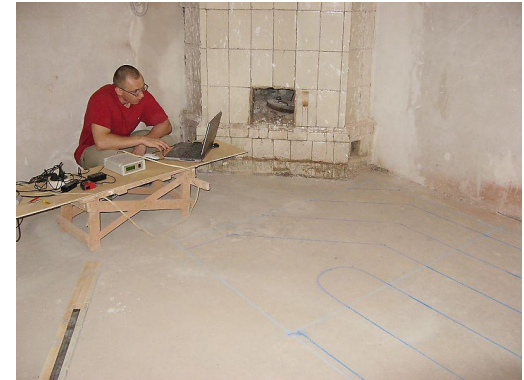
Holographic subsurface radar RASCAN-4/2000in work.

The survey was performed by holographic subsurface radar RASCAN-4/2000

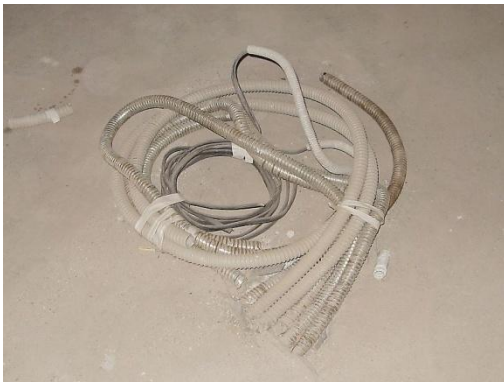
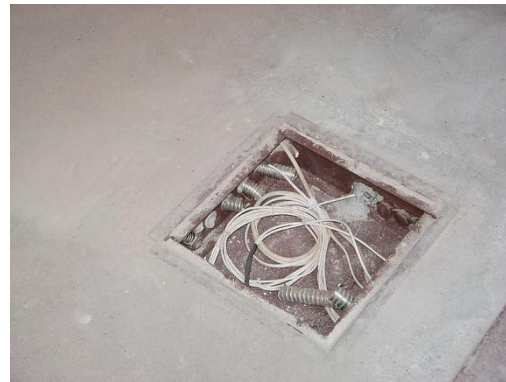
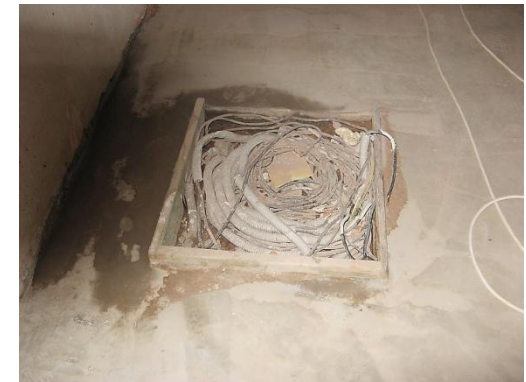
Wells with cables in the concrete floor.

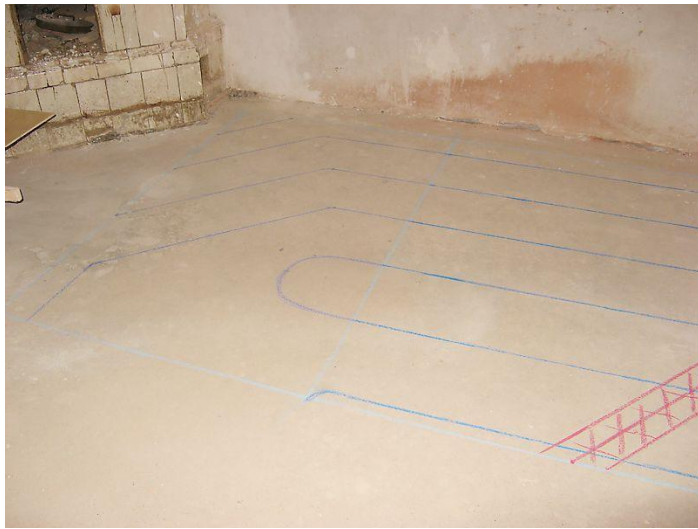
The result of surveying was drawn on the floor surface by chalk.

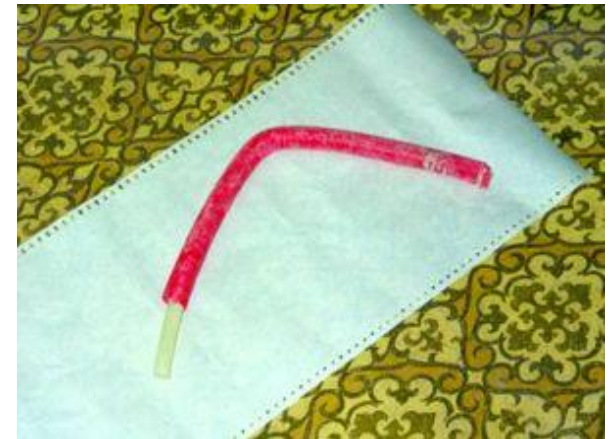
Heating plastic pipe

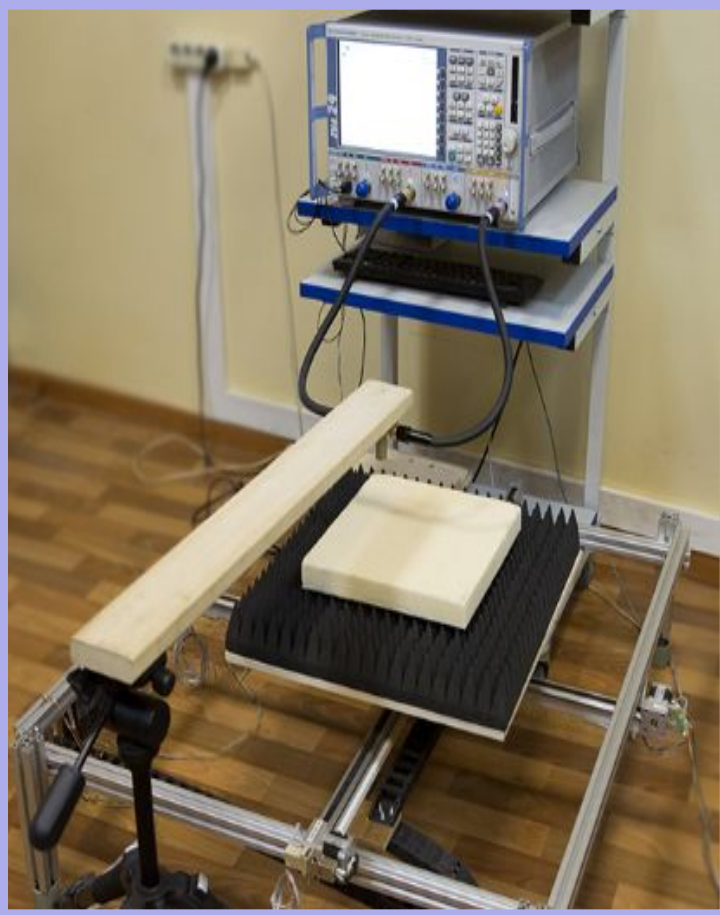
Experimental Setup

- A special experimental setup designed for subsurface radar imaging was applied, it allows sampling at arbitrary programmable points, testing various scanning and sounding parameters.
- The data acquisition is accomplished by automatic scanning.

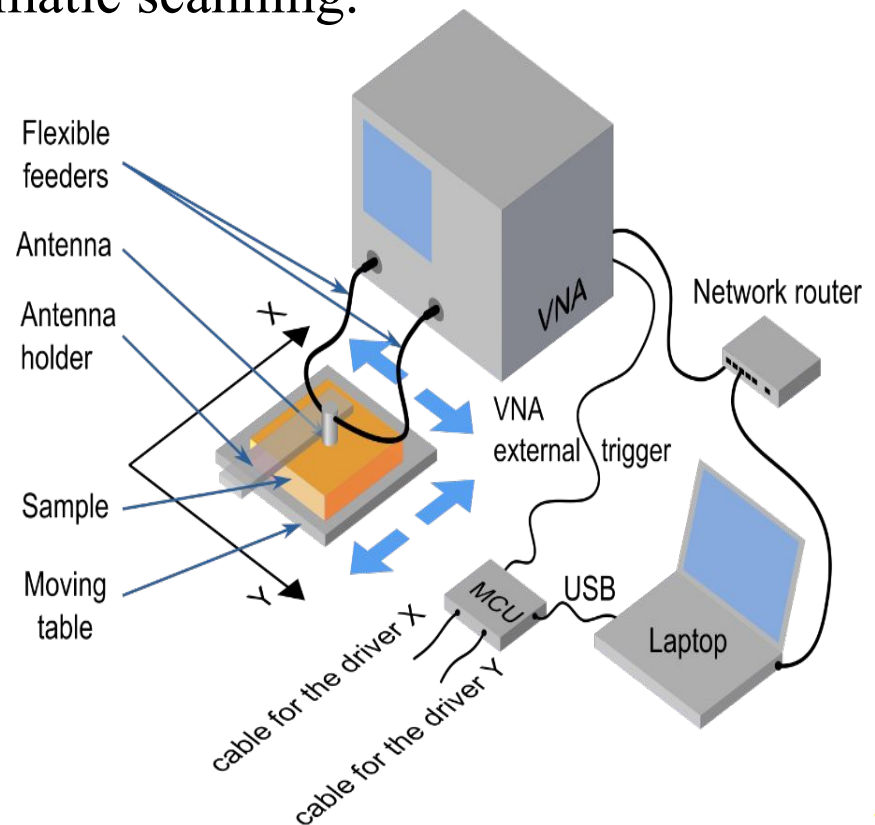
- For the reconstruction of the MW holograms back-propagation technique was applied, based on the Fast Fourier Transform.

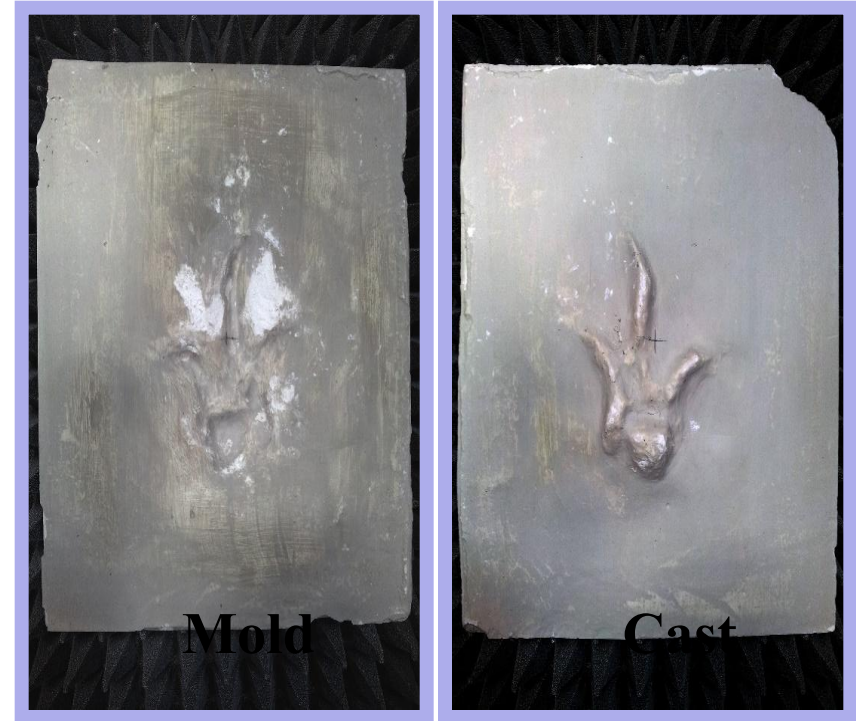
- A model mold-and-cast dinosaur track was created by making a gypsum plaster cast of an actual dinosaur track (var. *Anomoepus* from Dinosaur State Park in Connecticut, USA) and reproducing the tightly-fitting mold from this cast

- Mold: area of 255×225 mm, height of 27 mm
- Cast: same area, height of 22 mm
- The track: in the middle of the samples, 11 cm long by 7.5 cm wide

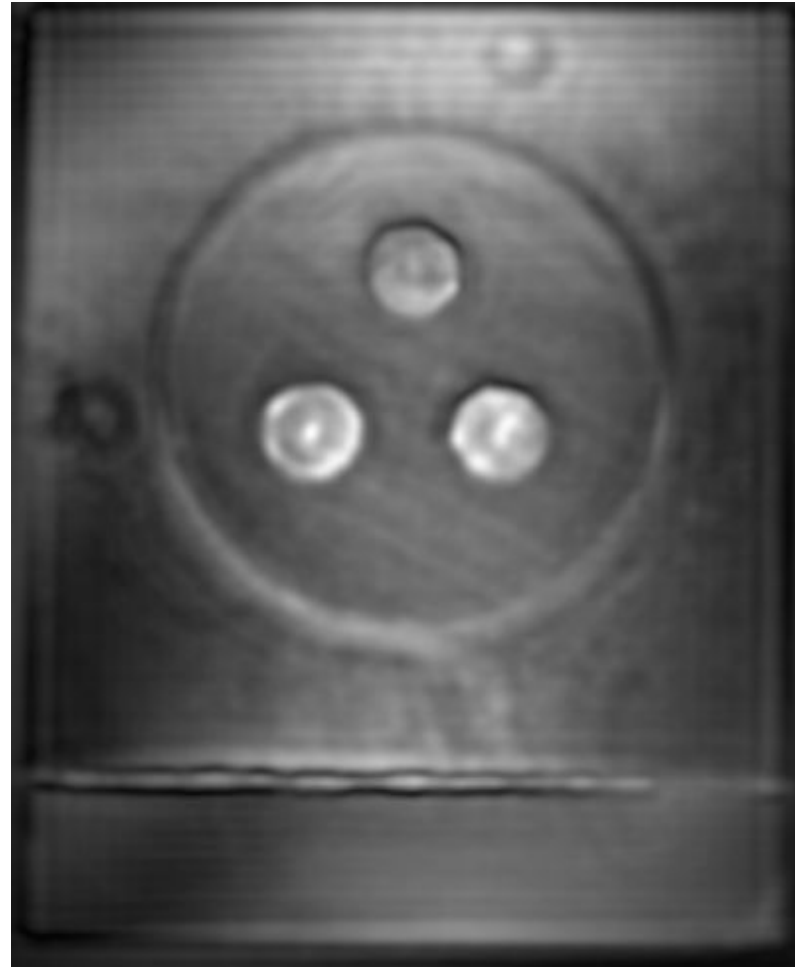
MW hologram reconstruction

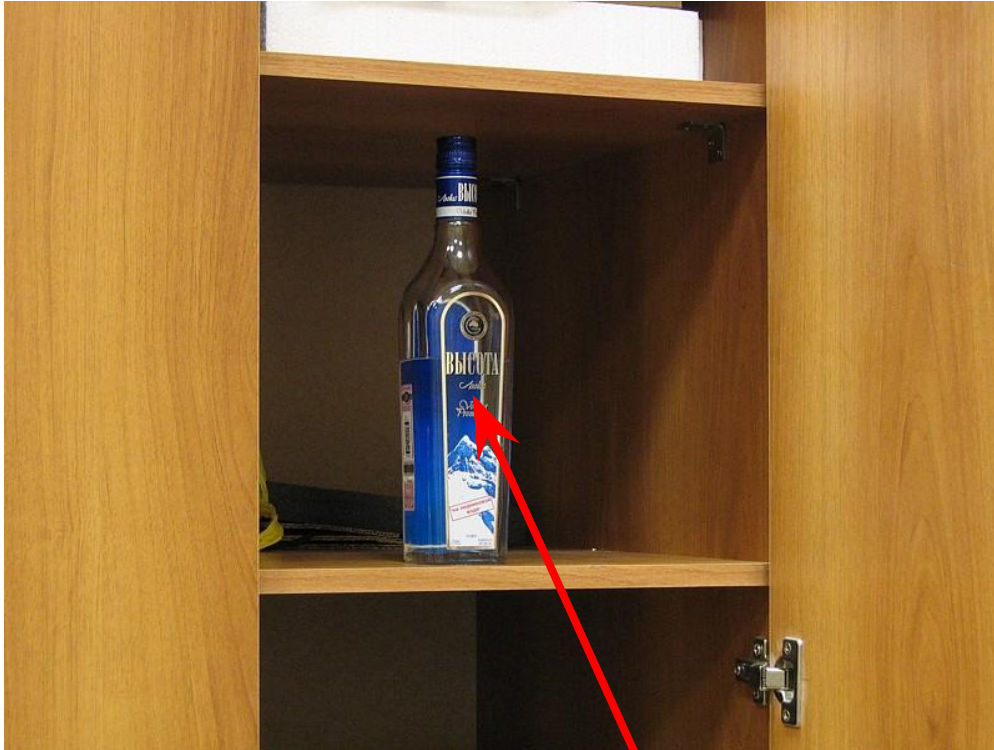
**The radar image of vodka bottle
is obtained by RASCAN-4/4000
inside of cupboard**
