# iRADVC7000/9000s

- 1.Coating error
- 2.Coating failure at rear side of sleeve
- 3.Toner leaking

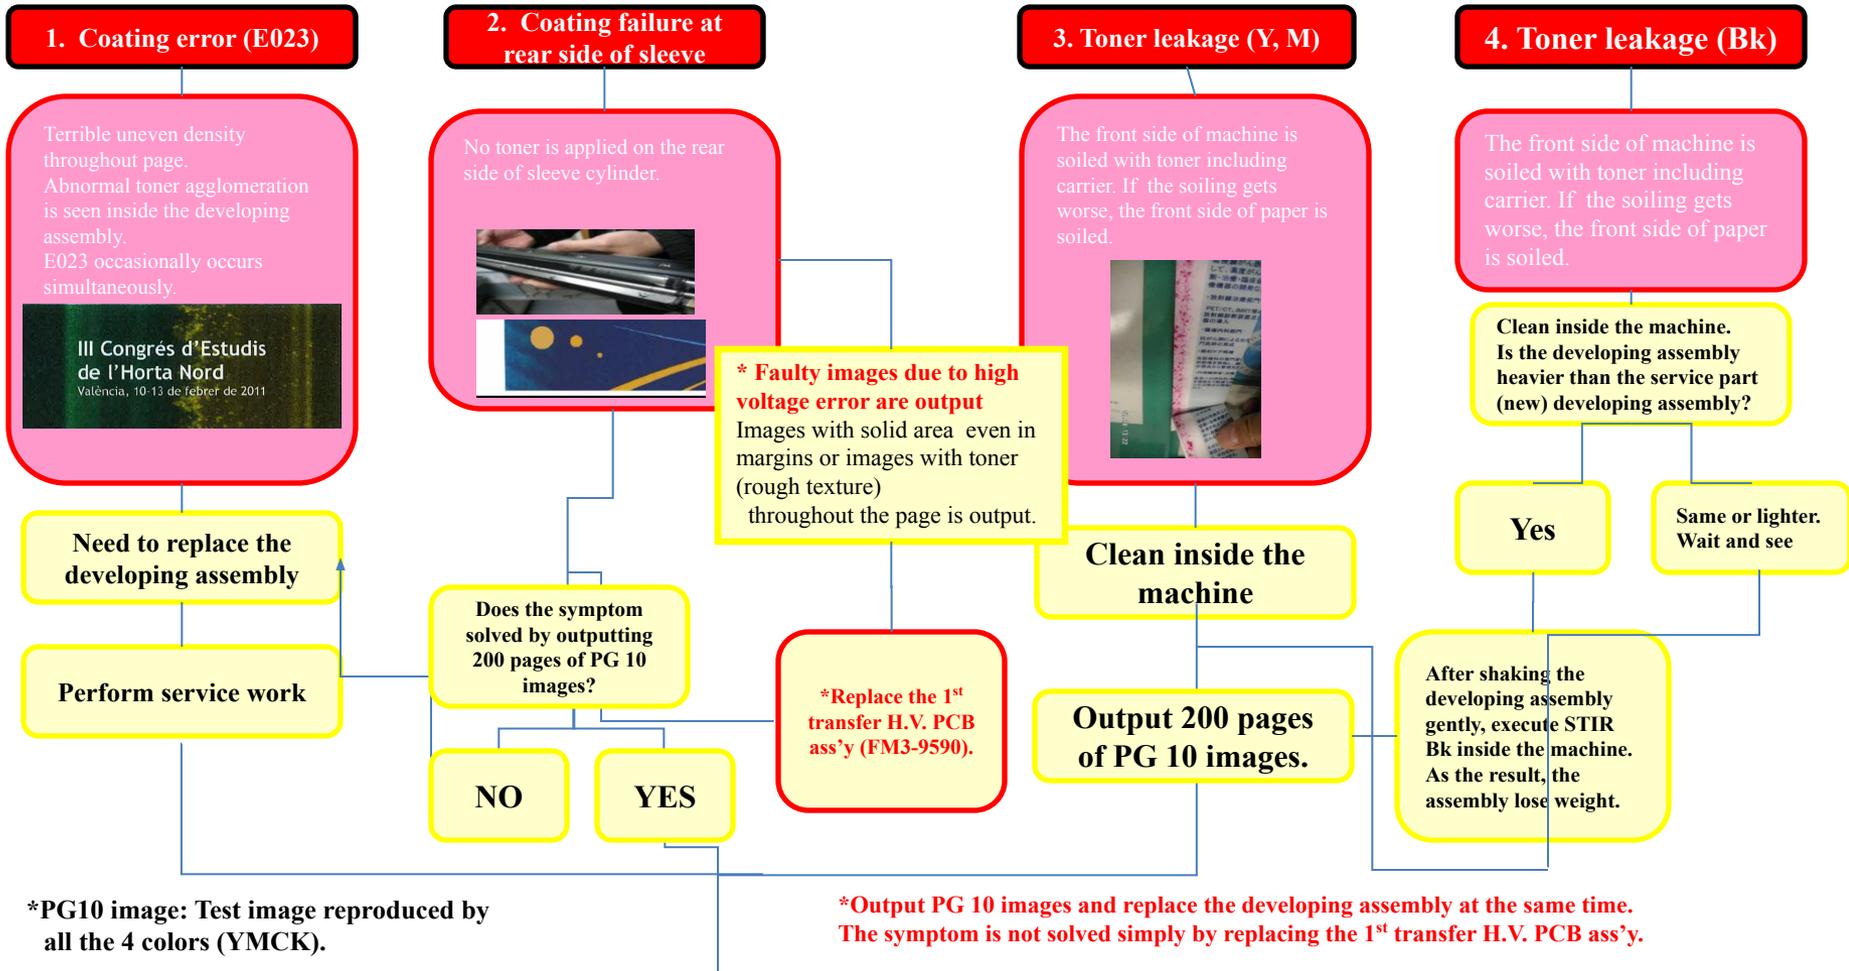
# Service work: Workflow

### **A. Temperature rise inside of the machine**

The fluidity of toner inside the developing assembly deteriorates.

This prevents the smooth circulation of toner, and causing toner to tend to remain unmoving inside the developing assembly.

**A. As the measure against the temperature rise inside the machine, place the machine far away from the wall as much as possible, and replace the 3 filters regularly.**

- Distance between the rear side of machine and the wall: preferably 10cm or more
- Filter (3 filters) replacement intervals: every 500K images
