Fig. 1. Schematic representation of the multilayer in a multi-chip module of type A (a) and of type B (b).

Fig. 2. (a) Temperature swing distribution at the interfaces of both stacks in Fig. 1 (black: type A, white: type B); a-b: Si, b-c: Si-solder, c-d: solder-Cu, d-e: Cu-ceramic, e-f: ceramic-Cu, f-g: Cu-solder, g-h: solder-base plate. (b) Temperature at the interfaces for a dissipated power of 100 W and a heat sink temperature of 40 °C (black: type A, white: type B).

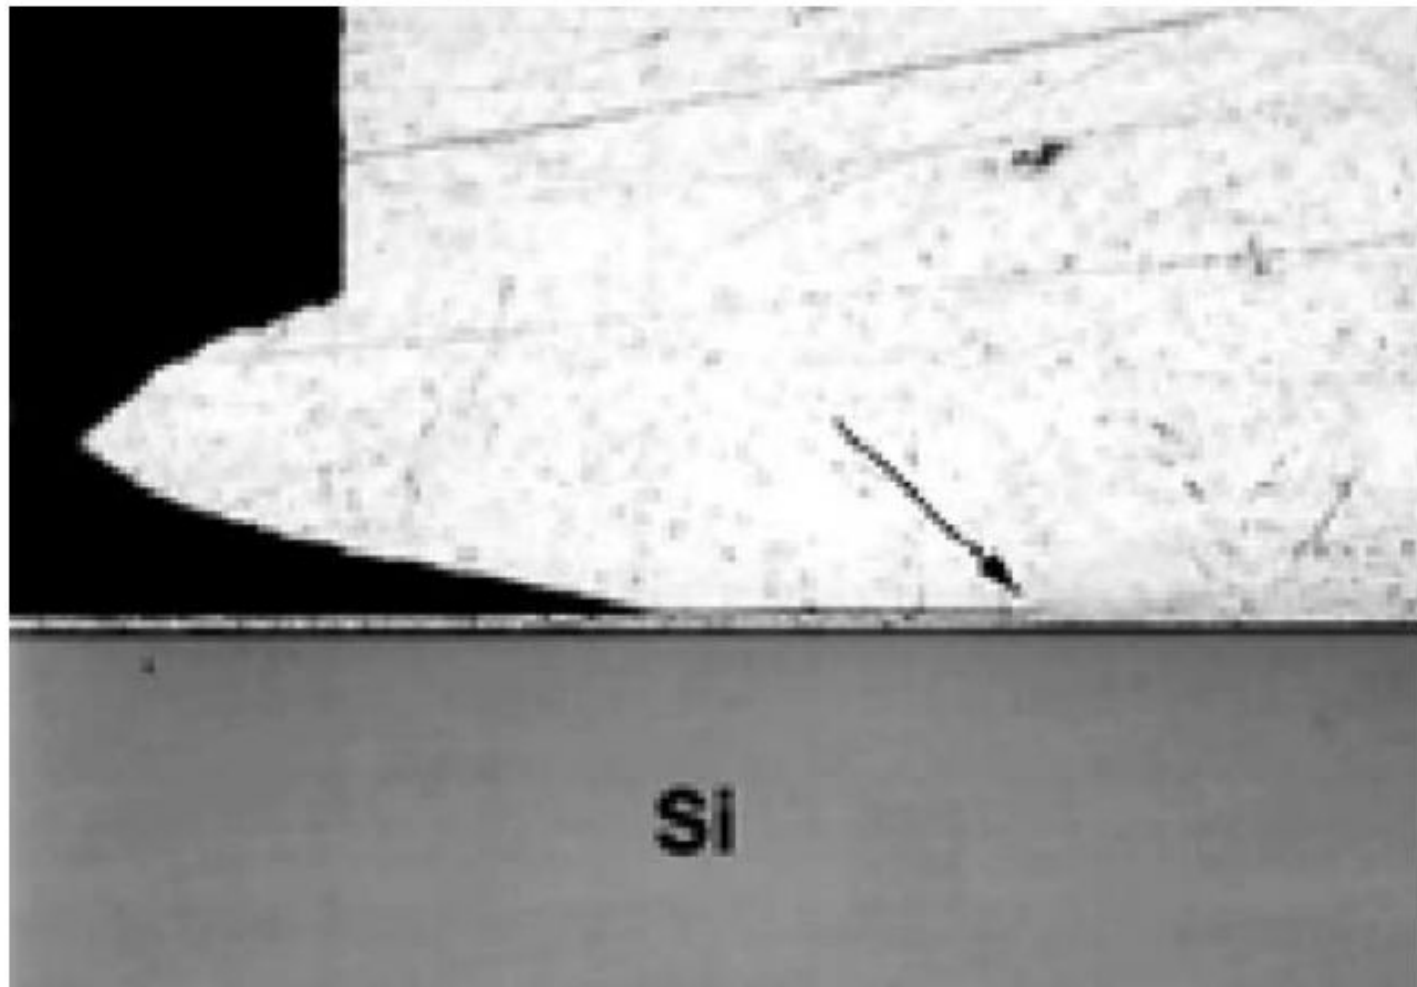
Fig. 4. Cross-section of a virgin wedge bond (tail side) on aluminum metalization, showing the transition to the interdiffused region (optical image, 120 \times).

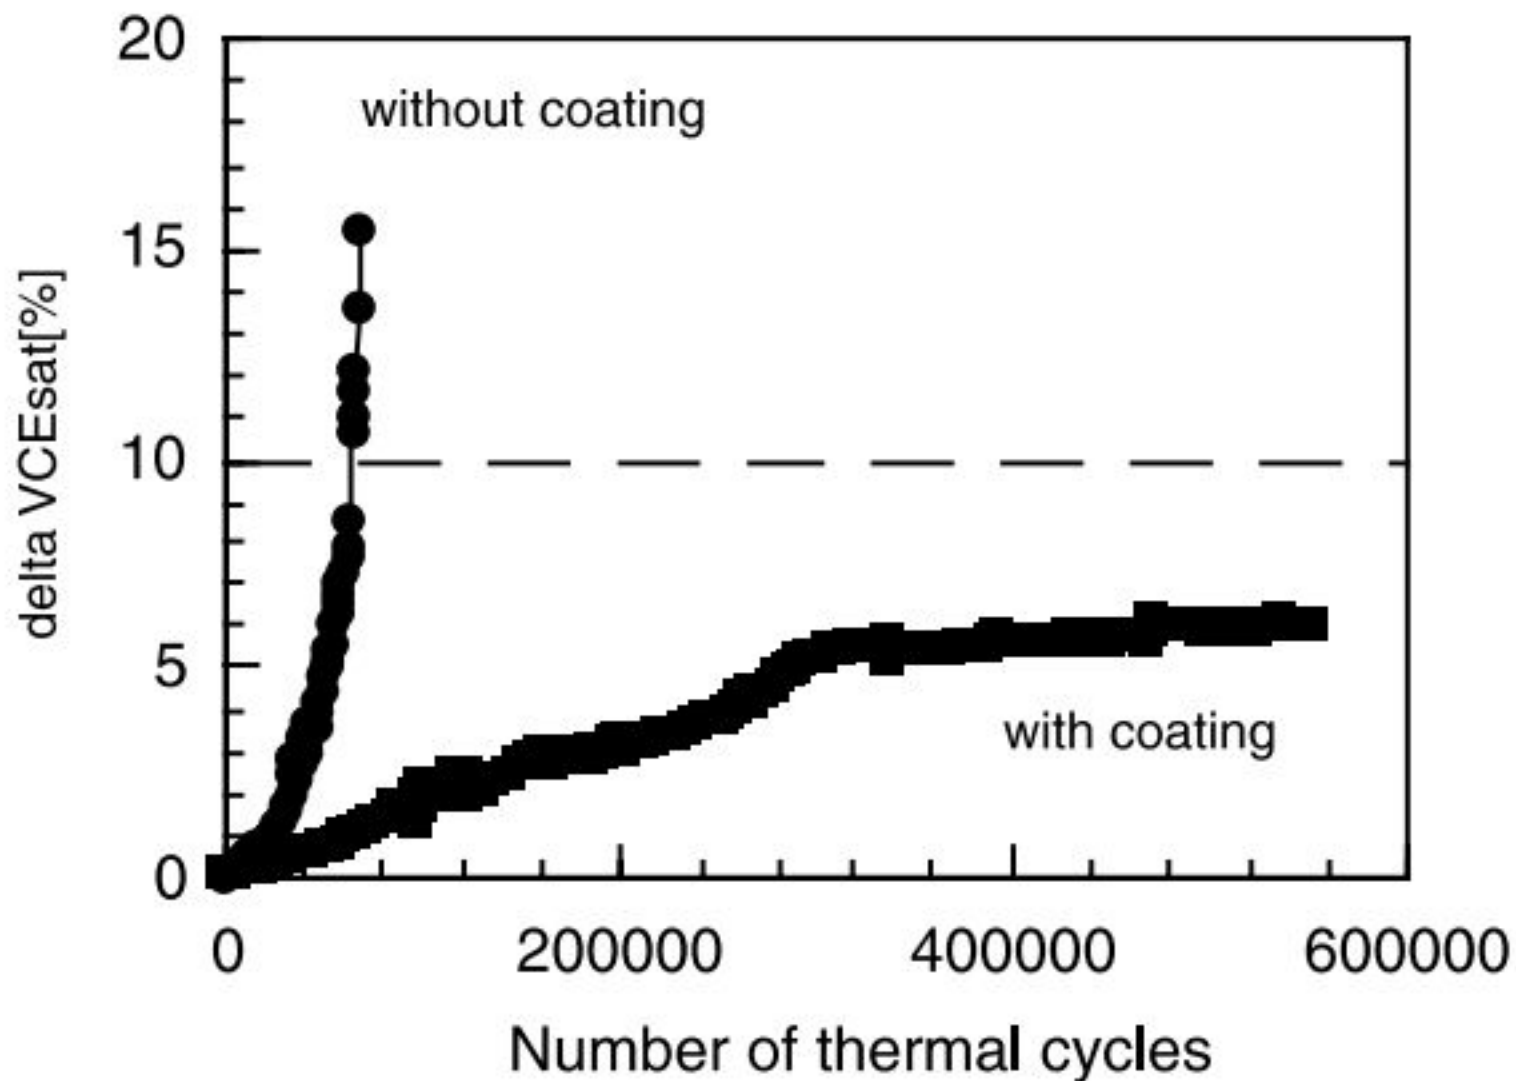
Fig. 6. Degradation of $V_{CE\text{sat}}$ in an IGBT module without and with a polymeric bond wire coating layer; $T_l = 65\text{ }^\circ\text{C}$, $T_h = 125\text{ }^\circ\text{C}$, $t_{\text{on}} = 0.8\text{ s}$, duty cycle 0.5.
