CCTV Headquarters, Beijing

A Structural Design Overview

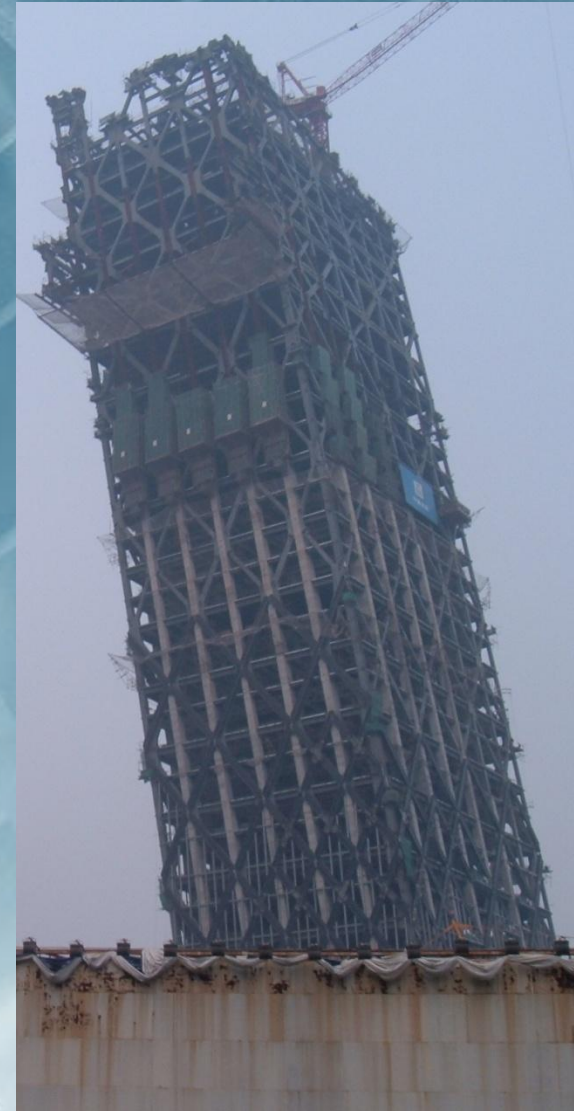
- Can be constructed of either:
 - Steel (most common)
 - Timber
 - Reinforced Concrete
- Steel is typical because of high tensile and compressive strengths
- Essentially marrying columns, diagonals and bracings into one system
- Not a new technology, used in early aviation and small-scale structures

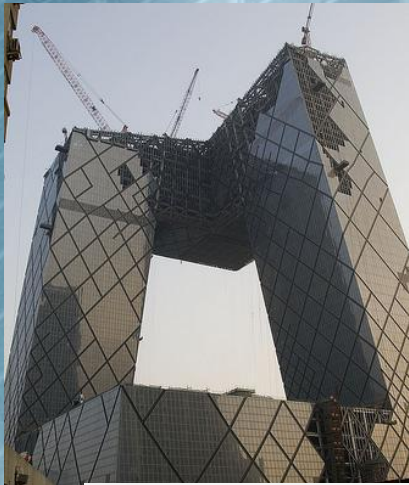
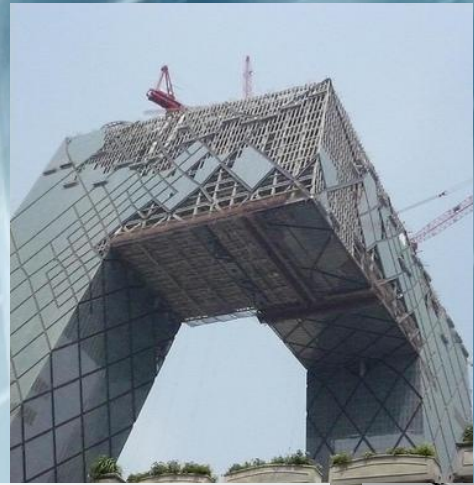
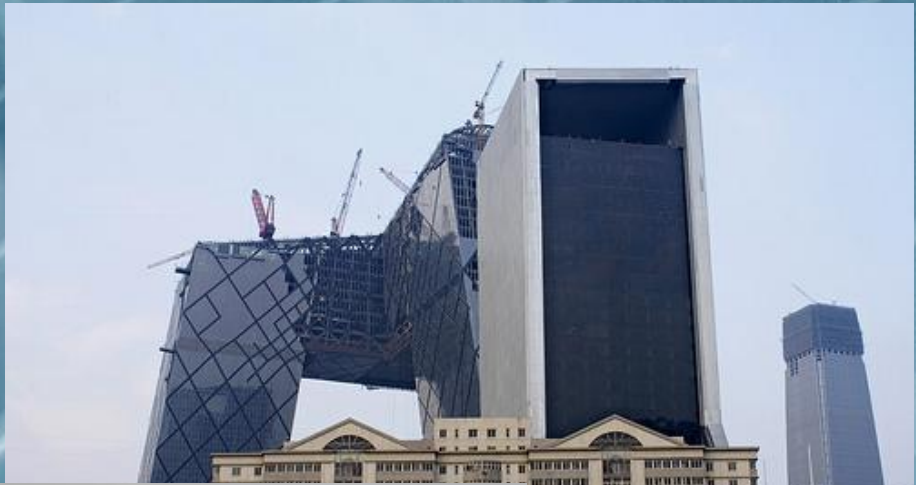
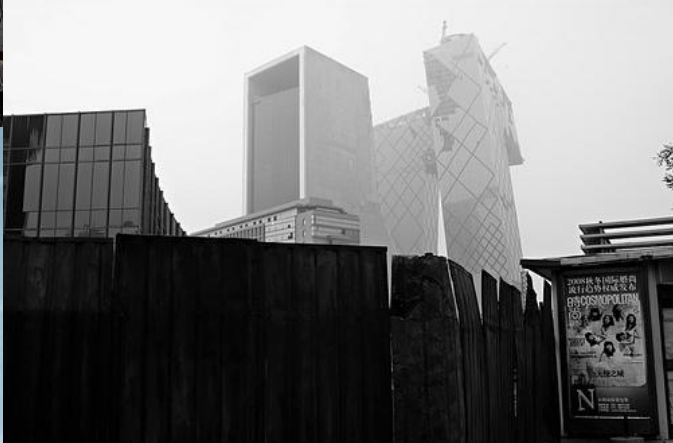
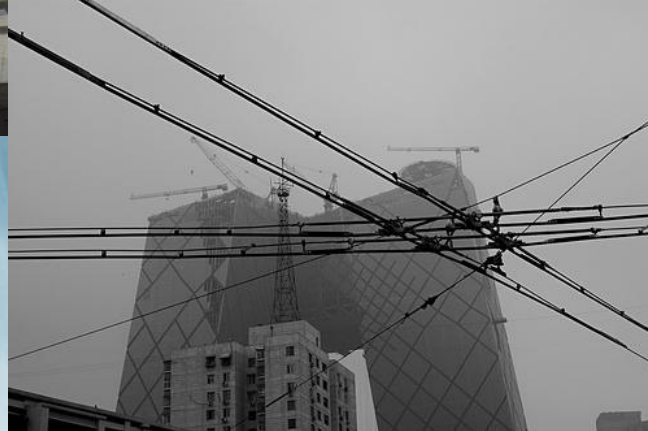
Dated June 2008

Latest Pictures of the Building
